CAIRO

FUNERARY COMPLEX OF AMIR KEBIR QURQUMAS FROM JANUARY 1 TO APRIL 31, 1995

Jarosław Dobrowolski

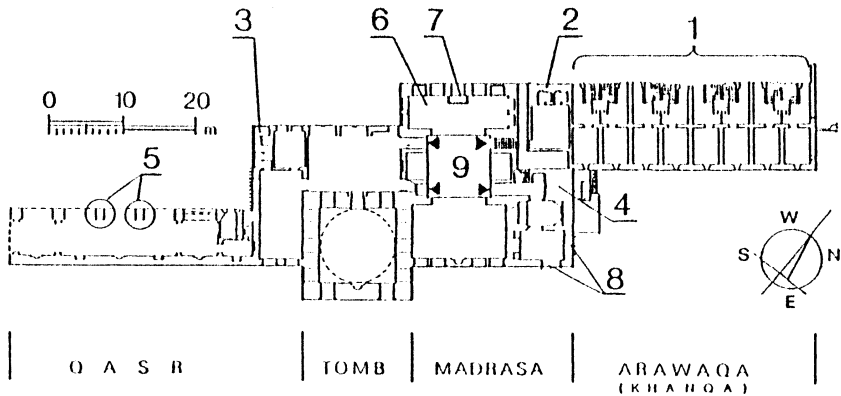
Fig. 1. Funerary complex of Amir Kebir Qurqumas in Cairo:
key plan (consult the text for descriptions).

The work, which is a continuation of previous season's tasks, aimed at rendering the ruined building structurally sound and safe for visitors (Fig. 1:1). A partial reconstruction of the western outer wall was necessary to restore the collapsed parts of the walls and vaulted ceilings, so that in future the structure can be properly protected from rain. Approximately 35% of the wall was reconstructed, including two decorated doorways which were patterned on the remnants surviving in the southern and northern ends of the wall (none of the original doorways had been preserved in full).

Original lintels, reused as doorsteps, were recovered and reinstalled. The only surviving original section of the much-rebuilt wall was in disintegrated condition and dangerously inclined outwards. Its facing was dismantled and the original stone blocks were reassembled in their proper positions (Fig. 1:2).

Six out of ten of the minaret's marble columns (Fig. 1:4), which had been broken in the October 1992 earthquake, were braced with 15 cm-wide brass rings made of 6 mm sheet and bound with brass bolts. A new marble column shaft was installed to replace the one that was destroyed completely in the earthquake. The original capital was retrieved and reinstalled. With these operations completed, the provisional wooden propping installed in 1992 was removed.

By the end of April 1995, the walls and vaults of the ground floor were completed. Work began on building up the modest remnants of the upper storey walls (only two stone courses preserved) to enable proper protection from water.

Replacement and repairs of defective roofs continued. A small openwork brick vault over the toilet area in the founder's residence (*qasr*) was repaired and covered with waterproof plast-

er. An identical vault was reconstructed over an adjoining room (Fig. 1:3).

Reinforcement of the pillar foundations in the ground floor arcade of the *qasr* was started in April 1995, following designs prepared by Dr. G. Bogobowicz in 1993 (Fig. 1:5). The work proceeded under the supervision of Eng. Nazmi Daoud. Reinforced concrete banks were introduced around the pillars to widen the foundations. Steel anchors remain to be added in the upper storey walls and the defective roof cover still needs to be replaced.

In the *madrasa* (Quranic school and mosque), decorated wooden ceiling panels from the western area, which had been taken down for conservation in 1992 (cf *PAM VI*, p. 23), were reinstalled in their original positions (Fig. 1:6).

The gallery, which is accessible through a passage inside the upper storey walls, is set upon the western wall in the western *liwan* of the *madrasa* (Fig. 1:7). This arrangement, which was rare when the complex was built in the early 16th century, became fairly popular later on in Ottoman times. Considering the gallery's importance for the general layout of the building, hardly apprehensible while the *dikka* was missing, the decision was made to reconstruct it. Plans prepared in 1993-1994 were based on an examination of preserved remains and a comparative study of relevant material from contemporary monuments (Fig. 2). The wooden cantilever beams of the reconstructed gallery have been anchored with a steel I-beam concealed in the wall. The surviving fragments of original palm wood beams were infused with a solution of Paraloid B72 in toluene. New parts were treated with linseed oil and stained with natural pigments.

Grilles were installed in the large windows of the *sabil* (public fountain dispensing water as charity: Fig. 1:8). Wrought-iron grilles (dating to the 19th/20th century and originally used probably elsewhere within the same complex) were placed inside the wide frames for turned-wood grilles. This restoration followed the solution applied in the neighboring complex of Sultan Farag Ibn Barquq.² The new grilles conform with the general style of the

Double-leaf doors with turned wooden grilles above them were installed in the four corners of the courtyard (originally covered with a wooden roof) in the *madrasa* (Fig. 1:9). Although original doors have not survived, the new ones follow the general design, based on information in the foundation deed, examinations of on-site evidence and comparative studies of a similar door preserved in the tomb of Sultan al Ashraf Qait Bay.³ An incised geometrical pattern replaced the deep-carved decoration
