ALEXANDRIA

KOM EL-DIKKA PRESERVATION WORK 1996/97

Wojciech Kołataj

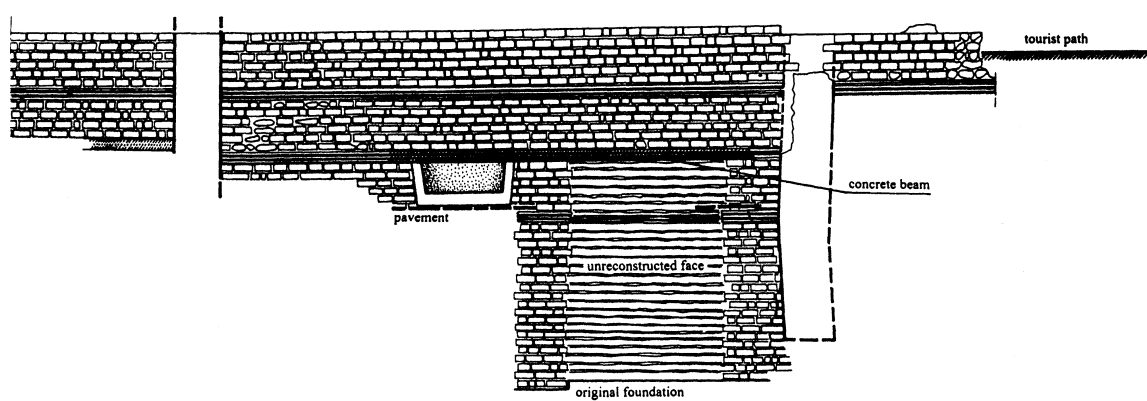
Work was completed on the final landscaping of the southern end of the eastern wall of the corridor. A large part of the face of the upper wall was completed and the top of the wall was insulated. Test trenches dug along the southern end of the wall (western face) that separated the cistern from street R4 revealed that the structure was preserved to a depth of c. 5 m above sea level. A partial reconstruction of the western face of this wall was begun in accordance with the original work program, resulting in a total of 9 m² being reconstructed over the season (fig. 1).

*Fig. 1. South end of the wall (western face) separating the cisterns from street R4.
Drawing W. Kolqataj.*

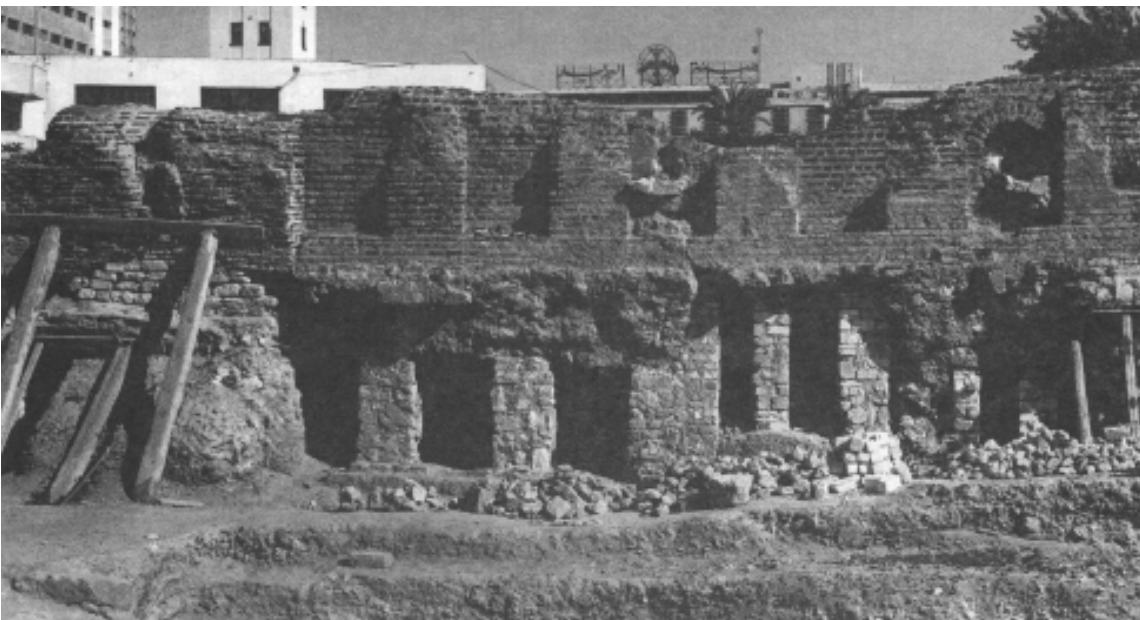
*Fig. 2. Northern facade of the cistern.
Photo W. Jerke.*

Clearing of the northern facade of the cistern in 1995/96 had revealed a dangerous overhanging of the upper parts of this elevation. Almost the entire length of this facade (c. 50 m²) was cleared this year, providing visible proof of the fact that practically the entire cistern complex stands on top of

a number of extensive voids created by the caving in of the structures that had lain underneath. The work was extremely dangerous, requiring the most endangered fragments to be cleared and protected on a step-by-step basis. Since protection in this case does not concern a historic building (cistern) and in any case it is only a structural reinforcement of fragments threatening to collapse, the supporting walls and pillars, of which a total of 17 m² was constructed, were made using a semi-cement mortar (fig. 2).

Investigations of the northern cistern facade proved that it had been robbed out in the Middle Ages in a section 20 m long and 2.50 m or more high. The reconstruction of this wall facing will be completed next year.

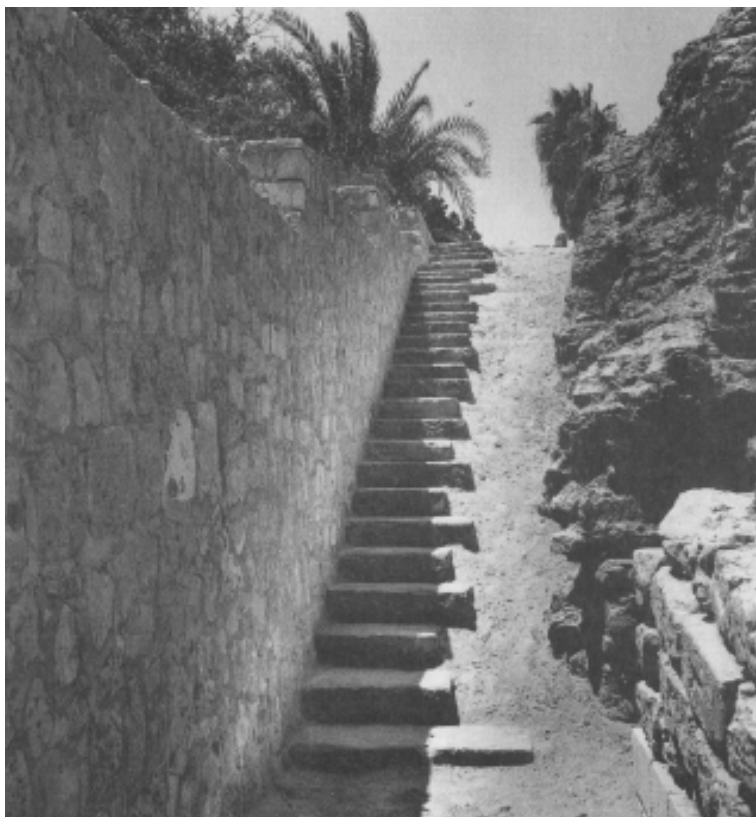
*Fig. 3. New stairs and revetment wall at the southern edge of the cistern.
Photo W. Jerke.*

With respect to the *Zona Monumentale* landscaping project, it should be noted that 2,000 m³ of excavated soil were removed from the area of the bath's *frigidarium*, as well as modern deposits from the surface layers in the area between the theater and the bath complex. Besides, a total of 25 m of pavement and steps was laid along the southern perimeter of the site, using basalt slabs and basalt and granite cobblestones recovered from the debris accumulated in the modern layers (fig. 3).
