CONSERVATION WORK

in the funerary chapel of Meref-nebef

Zbigniew Godziejewski

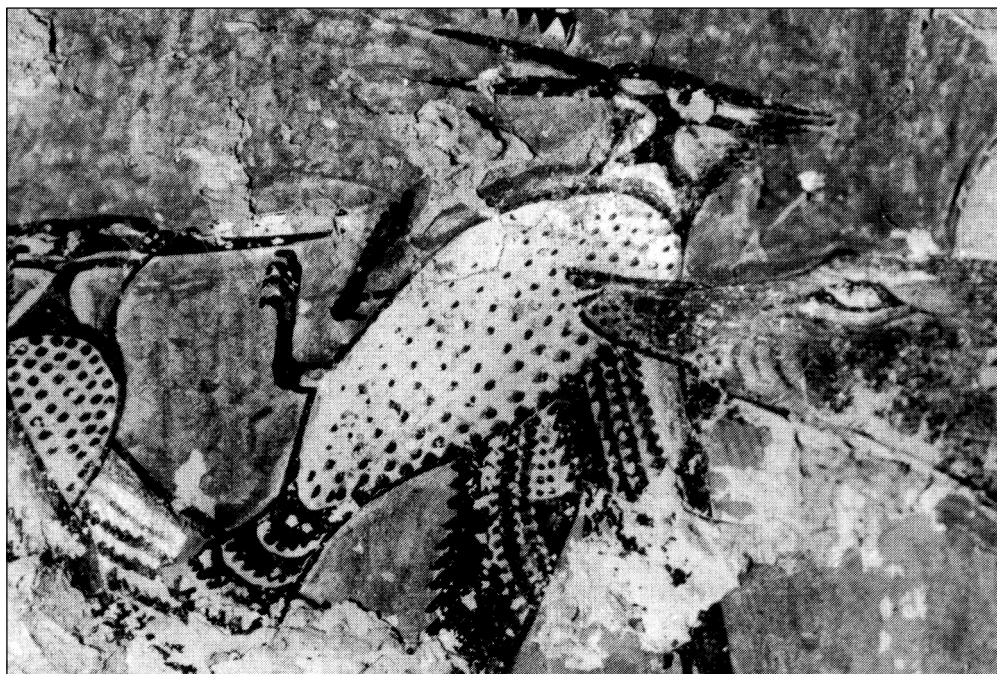
*Fig. 1. Detail of hunting scene on the eastern wall of the chapel, after conservation
(Photo Z. Kość)*

In the case of wall decoration inside the chapel and on the door jambs, conservation consisted of the following procedure: Thin fragments of polychromy were reattached to the wall with Primal E330 (as above). Also used was a Paraloid B72 solution in toluene (5%) whenever the ground needed to be reinforced.

Small, very friable fragments of the polychromy (in the zone just below the ceiling and in the central parts of the "false doors") were reinforced with Paraloid B72 in toluene (3%) prior to reattachment. The same solution was used to reinforce the falling and crumbling surface of the southern wall in the part which is void of polychromy. Any existing painted fragments surviving directly on the stone surface were safeguarded using Japanese tissue paper. Their fastening to the walls required a special mastic which was made of Primal E330 (10%) with filler containing chalk and sifted sand (1:1), the substance having the consistency of a watery paste. Upon fixed in place, the Japanese tissue paper was removed from these fragments using acetone enriched with toluene to dissolve the Paraloid solution.
