# CAIRO FUNERARY COMPLEX OF AMIR KEBIR QURQUMAS

## Restoration Project Progress Report, 2000

# Jerzy J. Kania

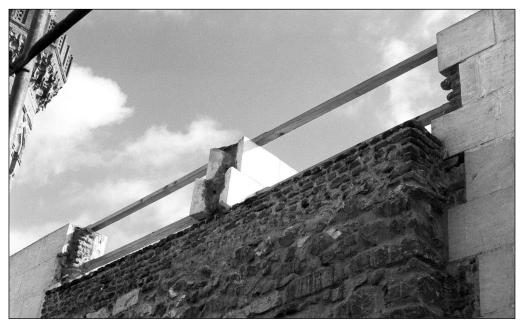
Fig.1. Khanqah. Upper part of the northwestern elevation crowned with a safety balustrade between newly reconstructed Mamluk-like sections (Photo J.J. Kania)

wooden balustrades and safety grasps, installed along the top of the outer walls of the entrance facade (northwestern). In view of the fact that parts of the reconstructed wall, having received the form of Mamluk times, were now raised in certain sections of the facade, the level of the balustrades was also varied accordingly. Between the "Mamluk" stretches, a double-level balustrade, 1.10 m high for adults and 0.60 m for children, was installed (*Fig. 1*). A similar principle was followed along the

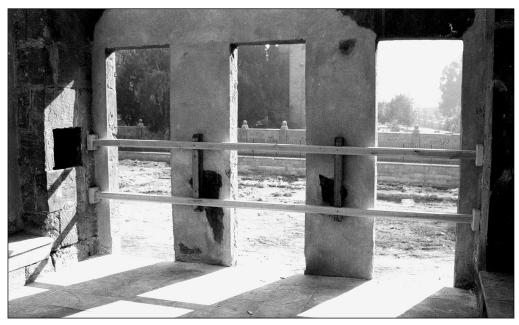
Fig. 2. Khanqah. Upper floor of the southeastern outer wall. Safety balustrade viewed from the interior (Photo J.J. Kania)

front elevation with the dominant window openings on the upper floor. The vertical wooden elements permitting the horizontal balustrades to be installed were concealed on the inside of the structure and attached to the pillars between the walls (Fig. 2). The predominant horizontal articulation of the modern safety elements is intended to achieve their visually neutral character. Tourist traffic flow will be channeled through four (of eight) staircases, which have been reconstructed with historical accuracy and only these have been equipped with vertical ladder-like safety grasps in the inner spaces between particular flights. The ground floor part of the building, which served both now and in the past as the entrance to the particular residential units,

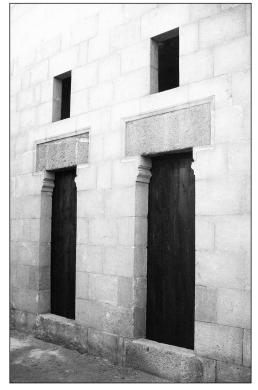
Fig. 3. Khanqah. Lower part of the restored northwestern elevation. Two entrances leading to the separate residential units. State after mounting the wooden shutters (Photo J.J. Kania)

was fitted out as much as possible with reconstructed door carpentry. Two outer entrances were fitted with wooden doors mounted in appropriately shaped frames in the reconstructed parts of the elevation (Fig. 3). Barred window openings also reappeared in this fragment of the facade, the windows provide light for the vestibule from which there is access to a staircase and a vaulted storeroom. Following the Egyptian sides' suggestions to adapt these rooms for non-troublesome forms of usage, singlewing wooden doors have been installed in all the storerooms. The doors are fitted with wooden bolts reconstructed on the basis of parallels (*Fig. 4*). The six external openings without frames will be protected with onepiece openwork grids of steel.

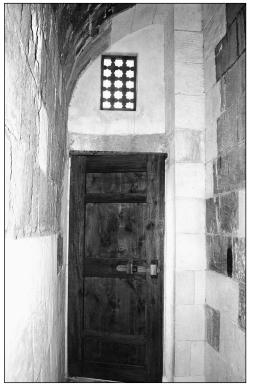
Fig. 4. Khanqah. Outer door with transom window and wooden lock in place (Photo J.J. Kania)

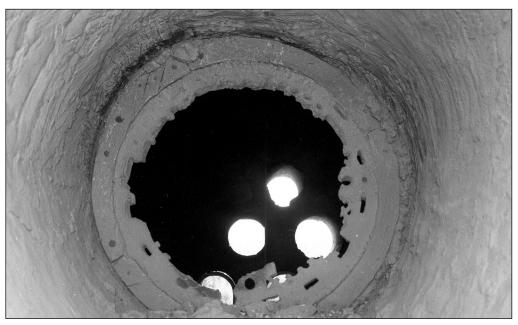
The stone-domed mausoleum is being returned to its former architectural glory in view of its sepulchral and religious function. One of the elements reconstructed this year were the so-called *qammariyyat* or window screens. Very modest remnants of wooden frames and stucco edging had survived in the oculuses alone, flush with the transitional zone of muqarnas (Fig. 5). The surviving pieces of the *qammariyyat* still in place were studied. The loose, broken pieces of stuccowork and colored glass found in the debris on the lower part of the window reveal were preserved. After the surviving

Fig. 5. Qubba. Northwestern outer wall. Oculus in the transitional zone of the dome. Relics of the original qammariyya (Photo J.J. Kania)

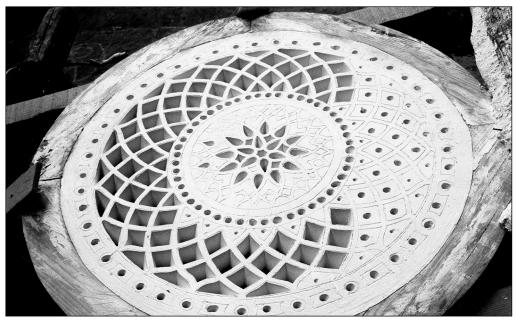
frames had been taken down, a study of the *qammariyyat* composition was carried out, identifying precisely the colors and ornament, as well as important technical guidelines for the designing work. The conceptual and technical designs, approved by the Egyptian side, were executed in the spring (*Fig. 6*). By end December all the openwork stuccowork for the openings situated above the ceiling-roofs of the neighboring *madrasa* and the adjacent side roofs of the funerary courts had been completed. The *qammariyyat* will be installed once the glass elements have been restored.

Fig. 6. Qubba. Qammariyyat workshop. Detailed view of a round qammariyya being prepared for the oculus in the mausoleum dome (Photo J.J. Kania)

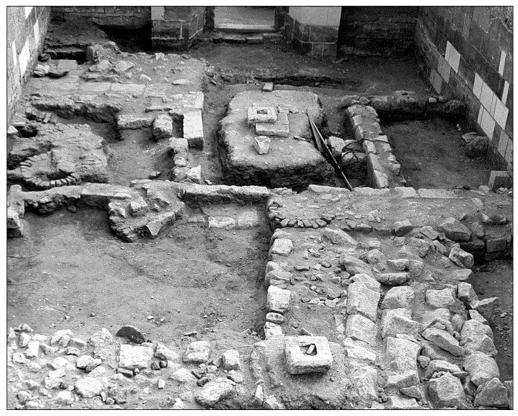
diversity of this structure over the ages (*Fig.* 7). The internal division into habitation units, domestic and industrial, the latter in the form of brick furnaces of unidentified function, has been delineated. The explorations brought to light chiefly kitchen pottery and skeletal material originating from domesticated animals.

Fig. 7. Tahuna. Eastern building. General view of the architectural discoveries made during excavations in 2000 (Photo J.J. Kania)

The outcome of archaeological research did not modify in any way the architectural-conservation conception adopted for the *tahuna*. Relics of the discovered interior walls were fully recorded and then they were protected with a layer of sifted sand, which was at the same time the bedding for stone flagging of the

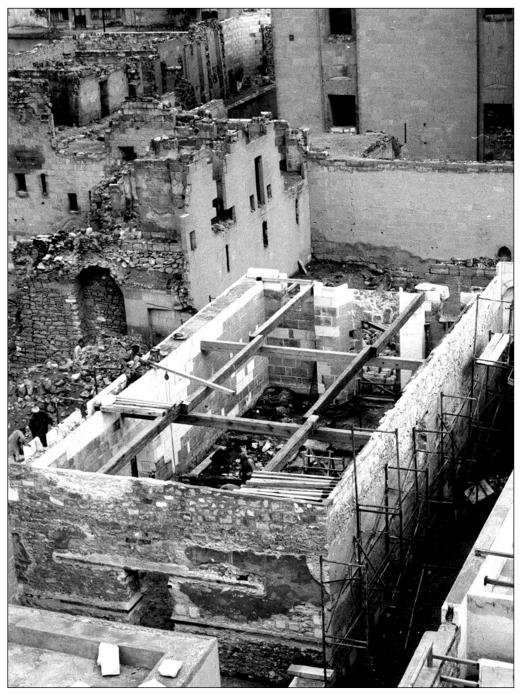
Fig. 8. Tahuna. Eastern building. The main structural timbers. State during roofing works (Photo J.J. Kania)

Ottoman period, which is to be reconstructed in the future. The outer walls of the structure, especially the tops, were reinforced to support the thrust of the wooden ceiling, which was reconstructed based on research and parallels (Fig. 8). Detailed attention was devoted to the zone bordering the court of Guirbash Qashuq, the so-called haws, where in the northwestern corner of the tahuna a reconstruction of the window opening of the old *sabil* was executed. This part of the *tahuna* is being reconstructed to serve as a stuccowork producing workshop reconstructed *qammariyyat* for mausoleums and madrasas of the Northern Cairo Necropolis.

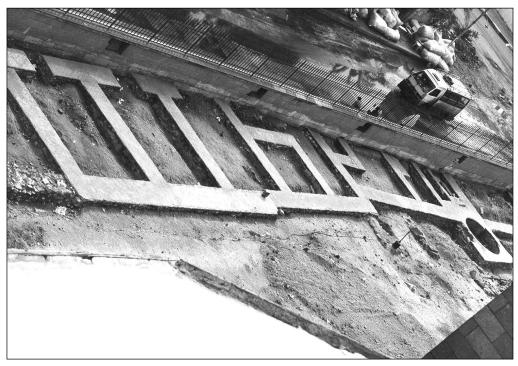
The foundations of residential units and industrial installations discovered in 1993 were now protected. Fortunately, part of the foundations were included within the limits of the conservation zone established earlier and hence on the inside of the modern fence surrounding the complexes of Inal and Qurqumas. The layout of the walls can be traced on the ground; the remnants have been protected from the elements (*Fig. 9*). This architecture is proof of the existence of a road for merchant caravans and a pilgrims' road to Mecca.

Fig. 9. Rab'a. Uncovered foundation courses of habitation units. State during preservation works. View from the roof of the madrasa (Photo J.J. Kania)
