CONSERVATION WORK, 2000

Zbigniew Godziejewski

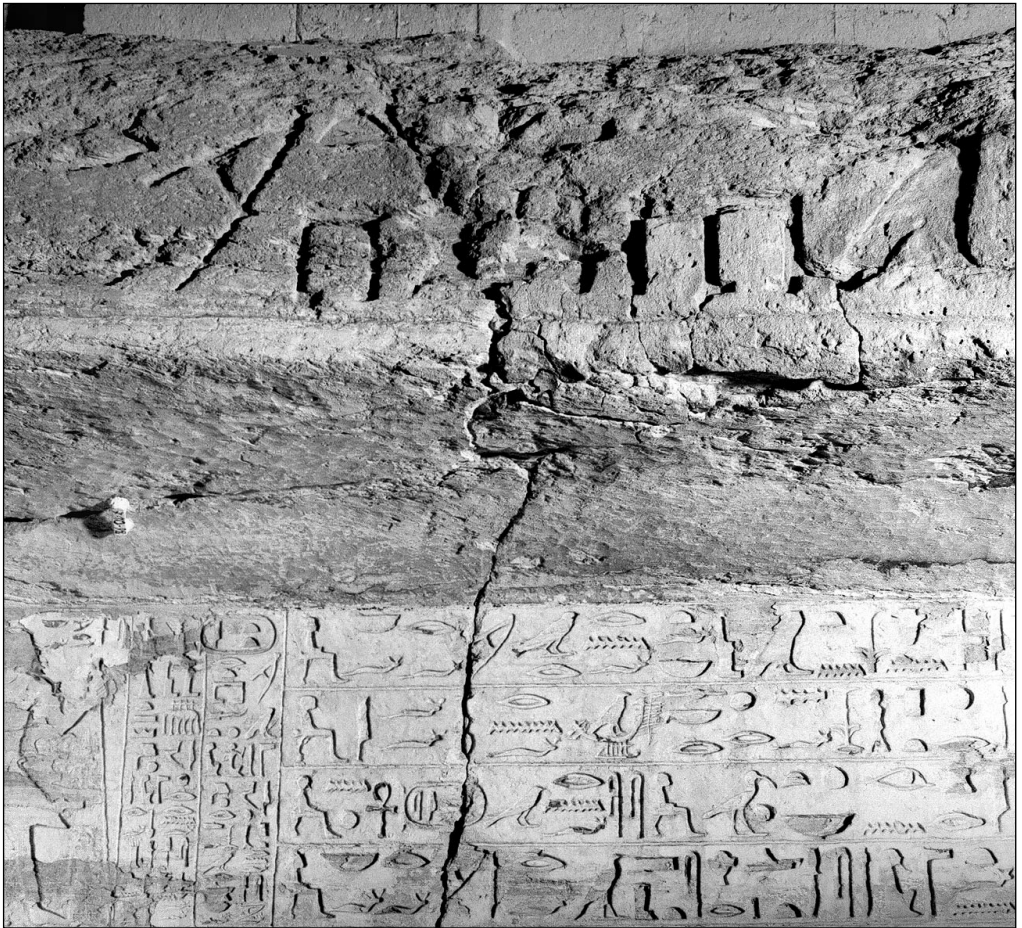
Fig. 1. Façade of the funerary chapel of vizier Meref-nebef. Re-inserted fragments of the "outer architrave" (Photo J. Šliwa)

Another ten fragments of plaster found on the chapel floor in 1997 were now re-attached to the matrix in original position. One of the main objectives of the present campaign was the conservation of the "outer architrave" in the chapel of Merefnebef. Falling fragments of the rock and three inscribed fragments made of artificial stone had to be put back in place (*Fig. 1*). The overall surface of this part of the architrave is c. 45 by 20 cm. The artificial stone turned out to be a gypsum mortar, the gypsum being no more than a filler and binder. It also contained quartz and dispersed vegetal black and loamy matter. The latter, probably originating from ground local limestone, was also used as filler. This mortar, porous and very friable, has been consolidated by means of repeated dripping with a solution of Paraloid B 72 in toluene (2-3%).

Once the falling rock fragments of this part of the architrave were removed, the inside of the rock structure was found to be completely disintegrated. Cleaning resulted in an empty space directly above the place where the fragments of rock were to be reintroduced. The "ceiling" of this empty space has been reinforced with strips of stainless metal netting overlaid

Leaving an empty space above the inserted fragments relieved the architrave at the reconstructed spot. Two of the three decorated fragments made of mortar were first stuck together, and then attached to the reinserted stone fragment of the architrave (using UHU Epoxy Quick). Given the limited adhesion surface, a kind of security hanger made of the same epoxy-covered metal netting had to be prepared

in order to prevent the fairly heavy pieces from falling. The third mortar element with a broader adhesion surface was fixed with UHU Hart. The void between the rock and the mortar elements, visible from below, has been veiled with cardboard of appropriate shape, reinforced with epoxy-covered metal netting. Joints and epoxy-covered surfaces were masked with a thin layer of putty produced on the base of Paraloid B 72 with chalk, calcareous carbonate, sand and pigment added, designed to adapt to the color of the context.

To consolidate foliating and crumbling fragments of the facade, a velostymous silico-organic impregnating substance, Funcosil KSE 300E by Remmers, was

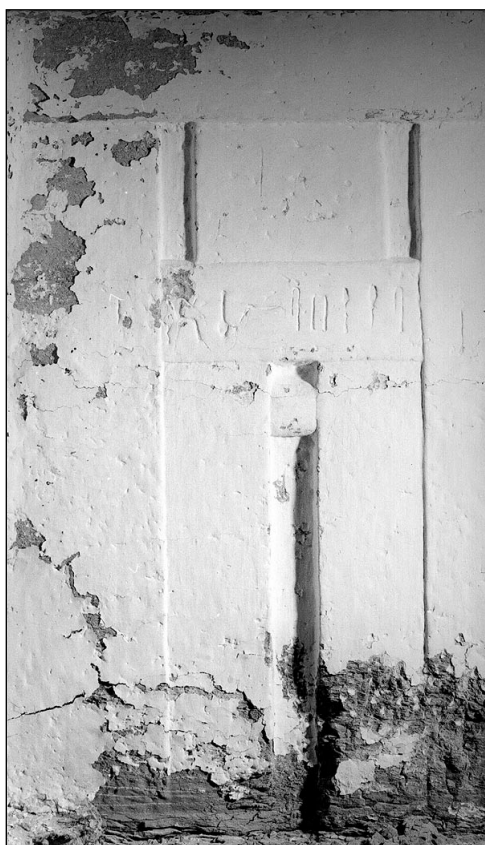
Fig. 2. False door inside the funerary chapel of Seshemnefer (Photo J. Šliwa)

The friable limestone lintel with sparse remains of a hieroglyphic inscription above the entrance to the chapel of Seshemnefer was reinforced with a solution of 2-3% Paraloid B 72 in toluene. Inside the chapel, there is a false door covered with at least three layers of lime(?) whitewash (*Fig. 2*). The latter is powdering and very rifted. A large part is detached from the bedding, which is also partly disintegrated and extremely fragile,

falling at the slightest touch. In order to make possible a facsimile of the false door without affecting the whitewash, the latter had to be reinforced and made to adhere to its background. A series of injections was made at the weakest places. Primal AC 33 in 8% water solution was used as the binder. Also in this case, a small quantity of ethyl alcohol with water (1:1) was introduced prior to the action of gluing.

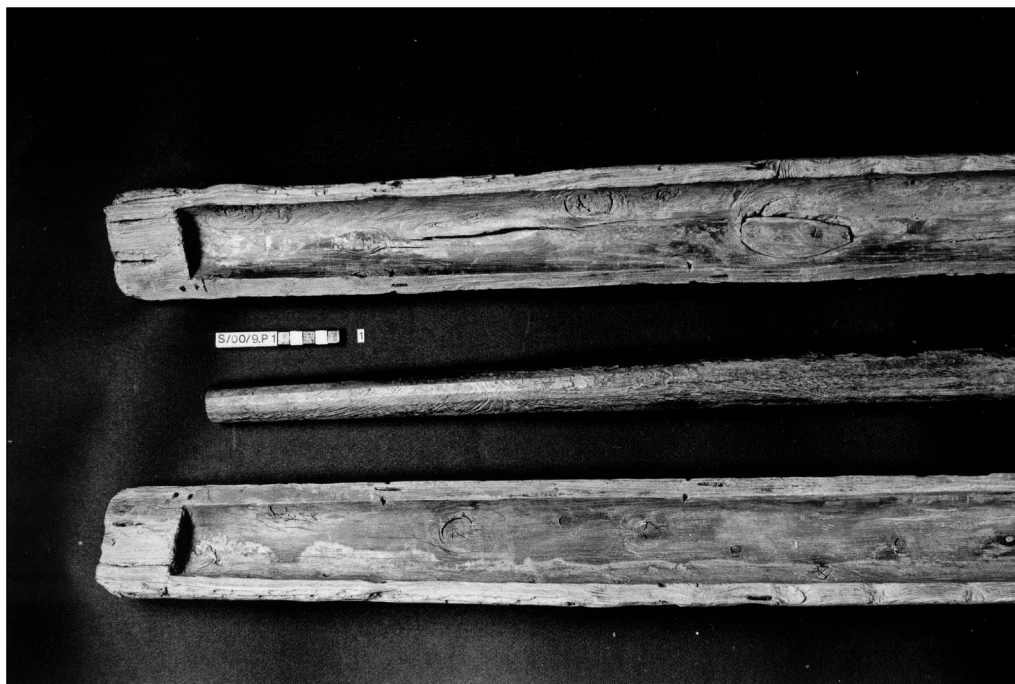
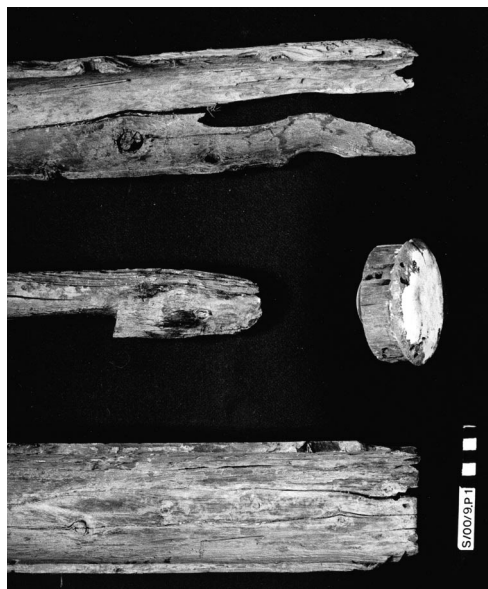
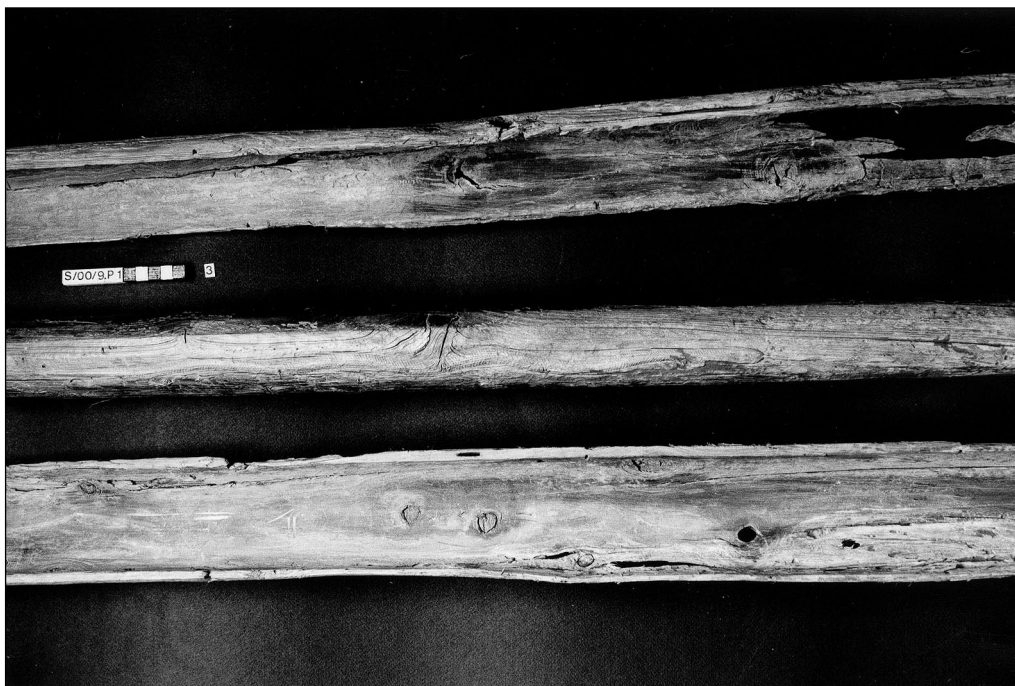
The cedar(?) wood harpoon is 2.60 m long and appears to be in excellent condition (*Figs. 3 a, b* and *c*). The insignificant deformation is due to humidity and the weight of overlying strata, including stone implements. Slight damages that are observable to the spearhead seem to be purely mechanical.

The cylindrical casing it was found in has suffered more extensive damage. The walls are very thin (8-16 mm) and the wood with its many knots is in considerably worse shape than the harpoon. The casing consists of two long, hollowed out semi-cylindrical elements, each with many taps. The top

part is considerably split and cracked. The fragments, which are partly detached from the main body, are deformed. The damages to the outside of the casing were caused by damp, as well as insects. The wooden plug at the top of the casing has concentric rifts. Its outer surface preserves a layer of whitewash (gypsum?) that is powdering.

All cracks and disconnected fragments were stuck together with the Cola Blanca wood glue. The process of gluing was followed by dripping the whole object with a solution of paraloid B-72 in toluene (5%). The aim of this procedure was to reinforce the object and protect it against changing climatic conditions. The casing and particularly its weakened parts were subjected to impregnation with a mixture of Paraloid B-72 in acetone and ethyl polyglycol in alcohol (see above).
