MAREA 2005 MASONRY CONSERVATION REPORT

Barbara Wronska Kucy*

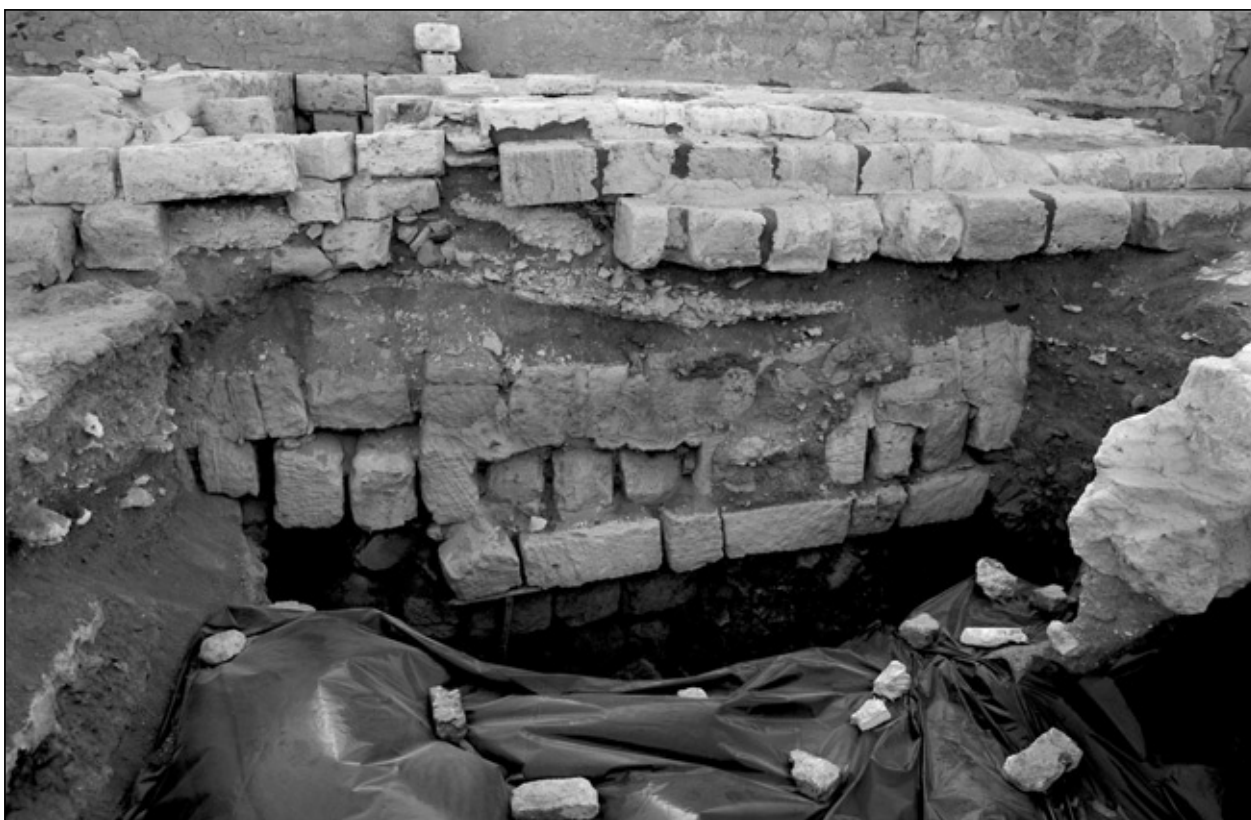
A limestone wall supporting the floor of the apse was set inside the pottery kiln and partly over the kiln grate; it extended into the kiln on both ends. This wall was constructed of randomly-laid, large limestone blocks, the irregular bond indicating its infill character. The excavated

height of this wall was approximately 2.50 m. A layer of approximately 0.40 to 0.60 m sand, clay and limestone infill separated the top of this wall from the stairs of the apse. All of the interlocking structures (wall, kiln, and apse stairs) were unstable and in danger of collapse [*Fig. 1, top*].

*Fig. 1. The apse of the Basilica before (top) and after conservation in 2005
(Photo J. Kucy)*

The first stage of the work required temporary wood shoring to be installed to support the random-block wall and the stairs above to create conditions allowing for the structural stabilization of the wall and associated structures. A wood platform was erected to provide access to all wall areas.

The masonry joints between the stone blocks were cleaned and repointed for structural stability of the wall. Missing sections of the wall were restored with limestone blocks to support still further the wall above.
