CONSERVATION WORK AT MAREA IN 2006¹

Barbara Wrońska Kucy

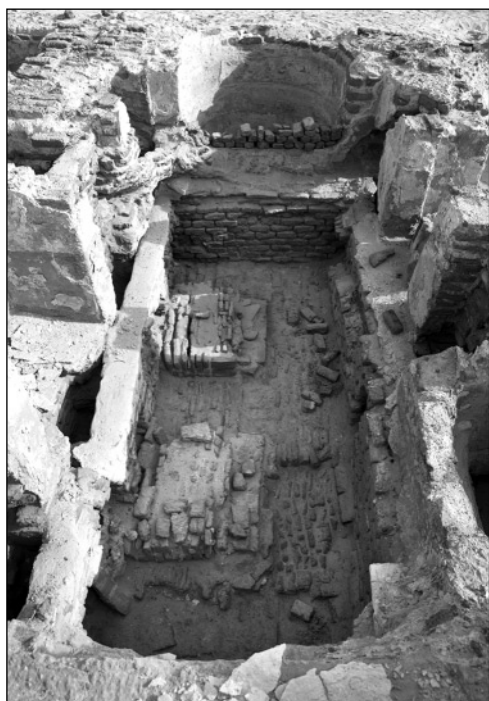
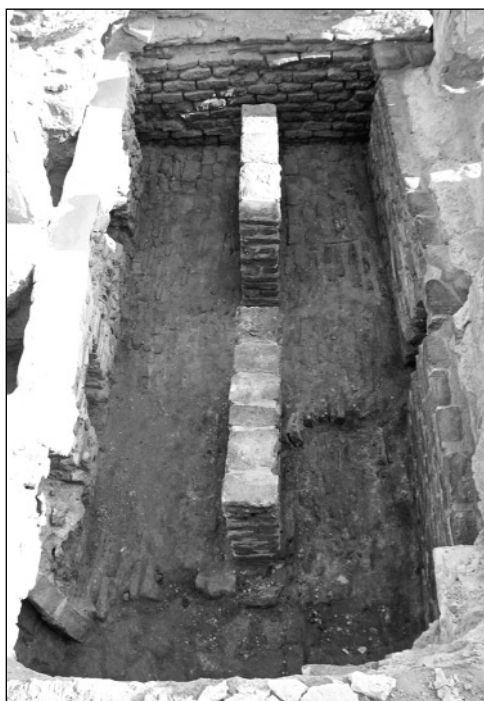
Fig. 1. Byzantine baths. Hypocaust F: before conservation (left) and after (Photo J. Kucy)

Emergency repairs were required in several areas. Work in the hypocaust (F) included reconstruction of the brick pillars (supporting the floors) and adjacent arched openings and sections of the hypocaust walls [Fig. 1].

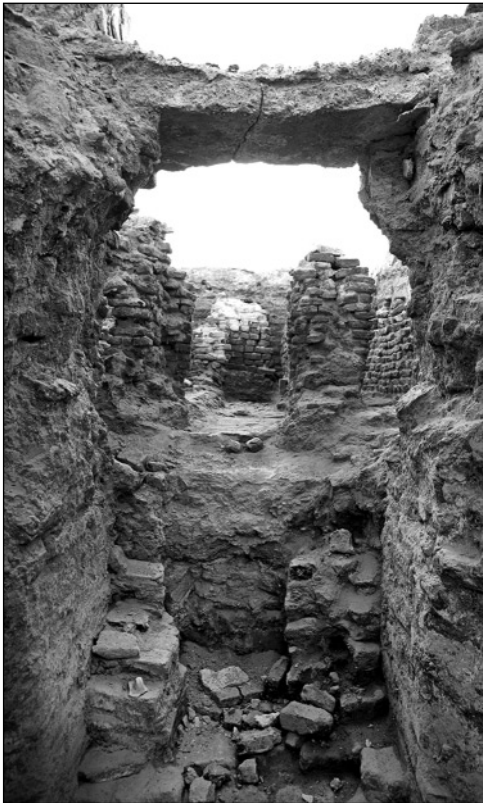
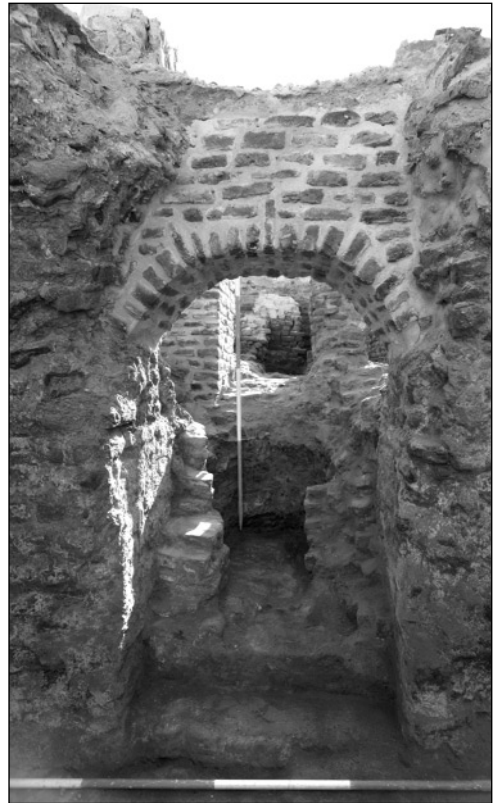
Fig. 2. Byzantine baths. Furnace O4: before conservation (left) and after (Photo J. Kucy)

An arched opening leading to the furnace (O4) between the cellar area (A2)

and (A1), and the adjacent hypocaust brick pillar and arched opening were partially reconstructed [Fig. 2].

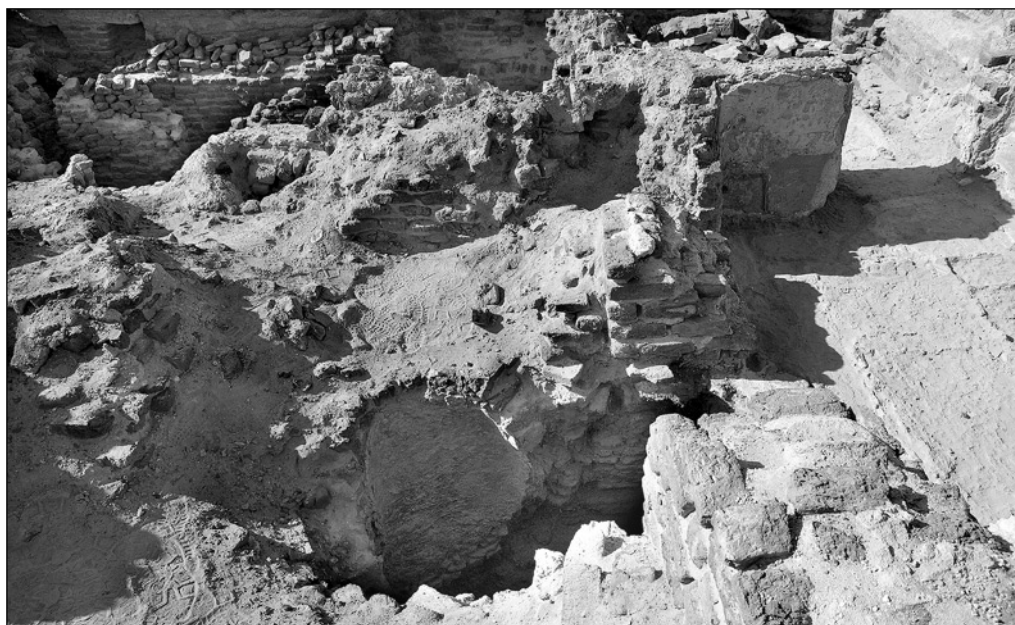
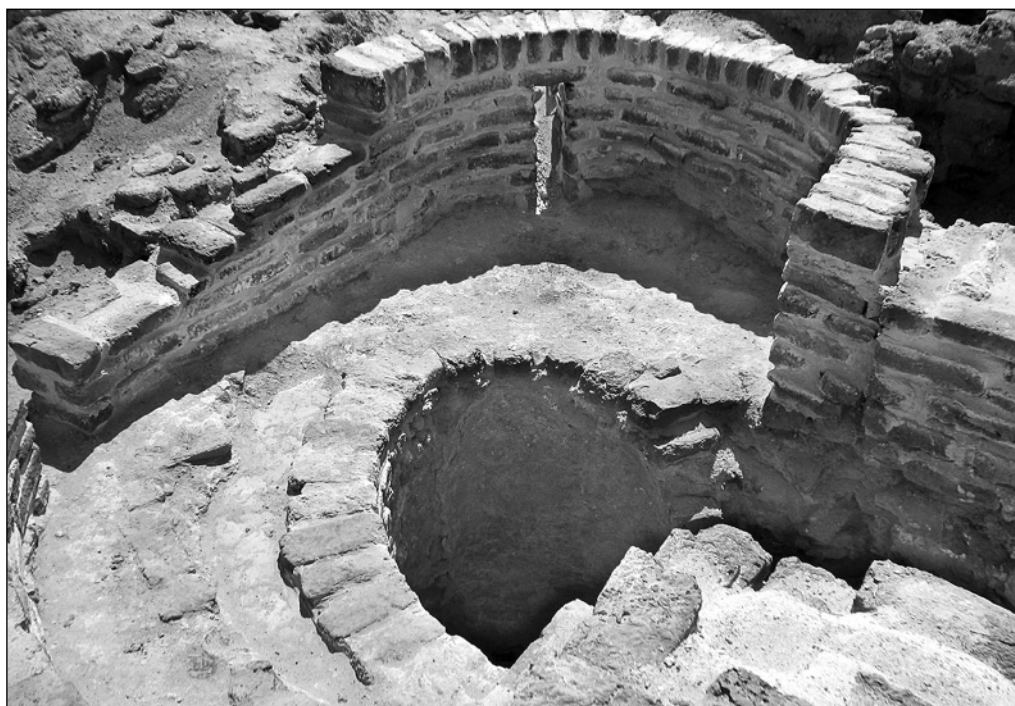
*Fig. 3. Byzantine baths. Furnace O: before conservation (top) and after
(Photo J. Kucy)*

Work around the furnace area (O) included reconstruction of the crown of the outer wall surrounding the furnace, and repairs to the brickwork of the furnace lining [Fig. 3].

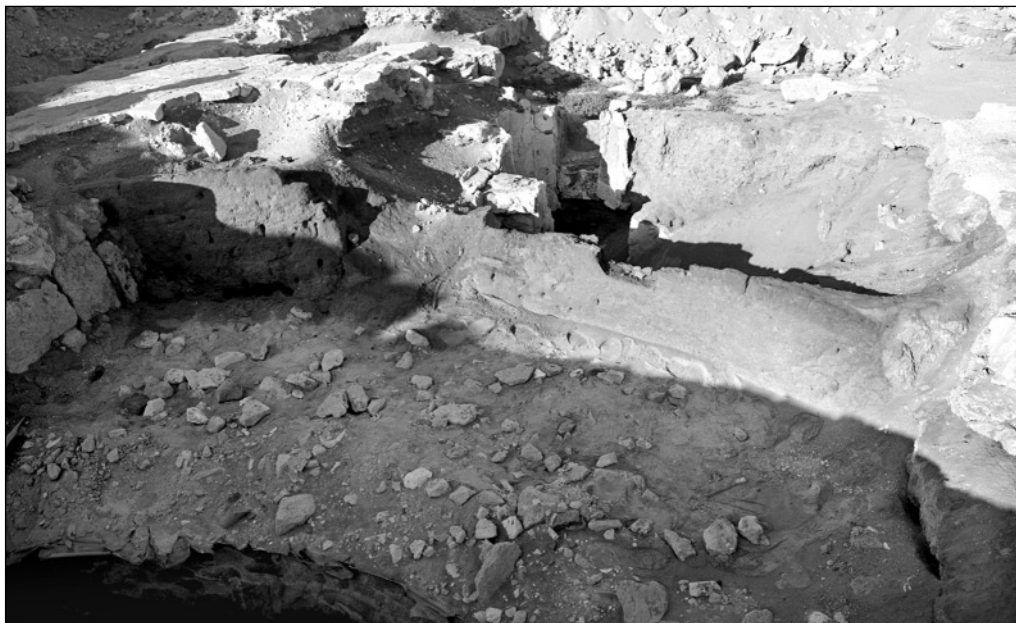
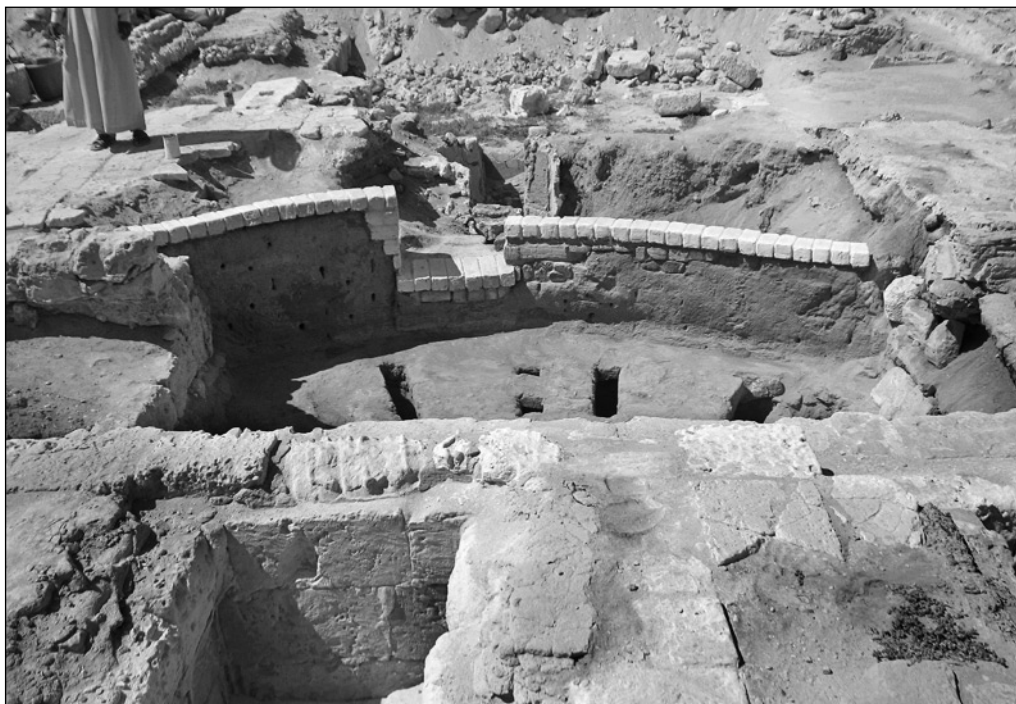
Fig. 4. Wall of the kiln for firing amphorae: before conservation (top) and after (Photo J. Kucy)

The outer wall of the kiln surrounding the grate was constructed of mud brick; it shows evidence of burning due to heat generated inside of the kiln. This burned surface was suitable for treatment with an impregnating breathable solution (30 l) of FUNCOSIL SNL (by Remmers).

The crown and outer face of the wall are severely deteriorated and have soft, powdered surfaces [*Fig. 4*]. In order to prevent further deterioration of this wall, a temporary mud-brick coping was installed, manufactured on site, using locally available clay, sand, and chopped

straw, and very small addition of cement, to increase the water resistance of the brick. This coping with pronounced drip edges, was set in a mud mortar bed (no cement added). Small sections of the wall were patched with original brick found on site, and with new mud brick. It should be emphasized that the new coping is not an attempt at reconstruction; it has been installed merely as a preventive measure against the elements. The mud coping can be removed in the future, if required for the following conservation seasons.

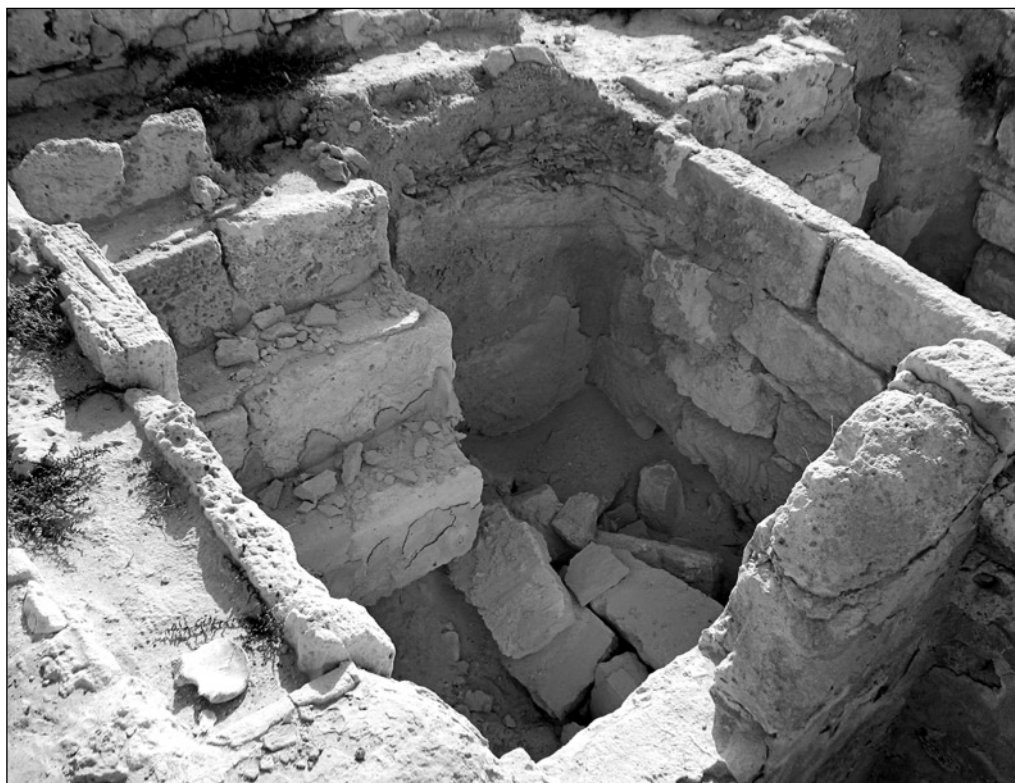
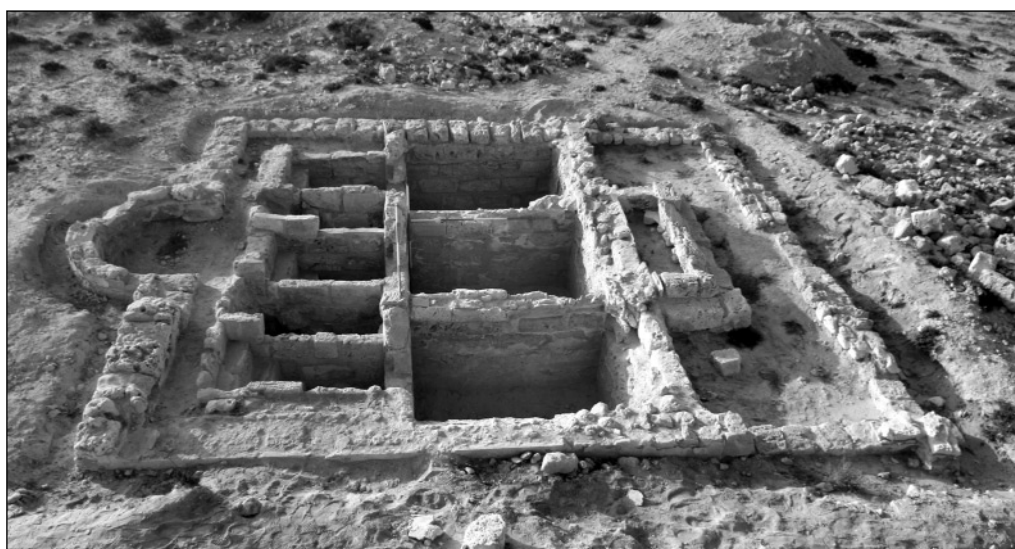
*Fig. 5. Funerary chapel: before conservation, detail (top) and after (general view)
(Photo J. Kucy)*

The vault walls of the chapel and a footprint of the structure are preserved to approximately half a meter below the chapel floor (not existing). The interior walls of the chambers are exposed to the level of the wall footing. Due to deep excavation and loose stone bond, some partitions adjacent to the

stairs have collapsed [*Fig. 5*, top]. The reconstructive work in the chapel included reconstruction of these walls, and supporting of the stairs [*Fig. 5*, bottom]. All the chambers were backfilled with compacted dirt (post-excavation fill) in order to stabilize the wall foundations.
