CONSERVATION WORK IN BANGANARTI IN 2006

Dorota Moryto-Naumiuk

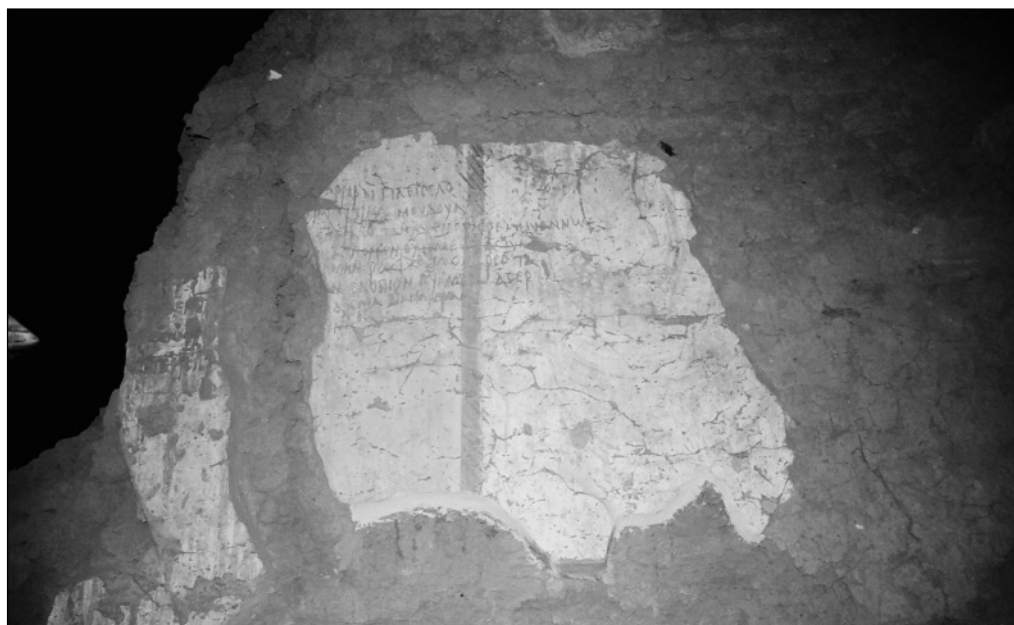
The first case is a mural with scratched inscription from Chapel 9 in the Upper Church [Fig. 1]. It was executed on a lime-sand plaster with clay added, the painting layer applied to presumably kaolin white-wash. The painting layer was whitish and ochery with a red stripe running vertically on the surviving fragment. The wall on which this inscription was found was a later partition made of mud brick that had to be dismantled in order for the excavations in the lower church to proceed. Before this could be done, the inscription had to be transferred safely and the place chosen for it was the southeastern Room 18 of the Upper Church, which had been reconstructed in previous seasons.

Fig. 1. Chapel 9. Fragment of mural with scratched inscriptions before the transfer (Photo D. Moryto-Naumiuk)

Mechanical cleaning of surface dirt and grime from the mural was the first stage. Next, a 10% dispersion of PRIMAL AC33

and polyvinyl acetate (1:1) was injected for structural reinforcement of the plaster ground. The painting layer was impregnated with PARALOID B72 in toluene (c. 3%). Cracks and losses of plaster were filled with a mixture of lime, sand and clay (coming from powdered mud brick) in proportions 1:3:2, adding a few percent polyvinyl acetate for adhesion. On-site conservation practice has shown this mortar composition to be the most effective and suitable for filling losses in murals under the Banganarti conditions.

Once the reinforcing procedures were completed, a facing of two layers of Japanese tissue paper, a layer of thin, loosely woven cotton and a layer of linen cloth, was applied using as adhesive KLUCEL G (c. 5 cm³ per 500 ml of water). The mural was subsequently cut from the wall with a saw, together with the plaster ground. The back of this layer was thinned mechanically and smoothed, after which it was consolidated with a water dispersion of PRIMAL E330 with polyvinyl acetate (c. 15%), having first lowered the surface tension with a mixture of water and ethanol. The treatment was repeated a number of times. Hollows and losses of plaster in the back were filled with putties of the same composition as those used on the face of the mural; these were sprayed repeatedly with water in order to induce lime-carbonization processes. Additional reinforcement consisted of a fine

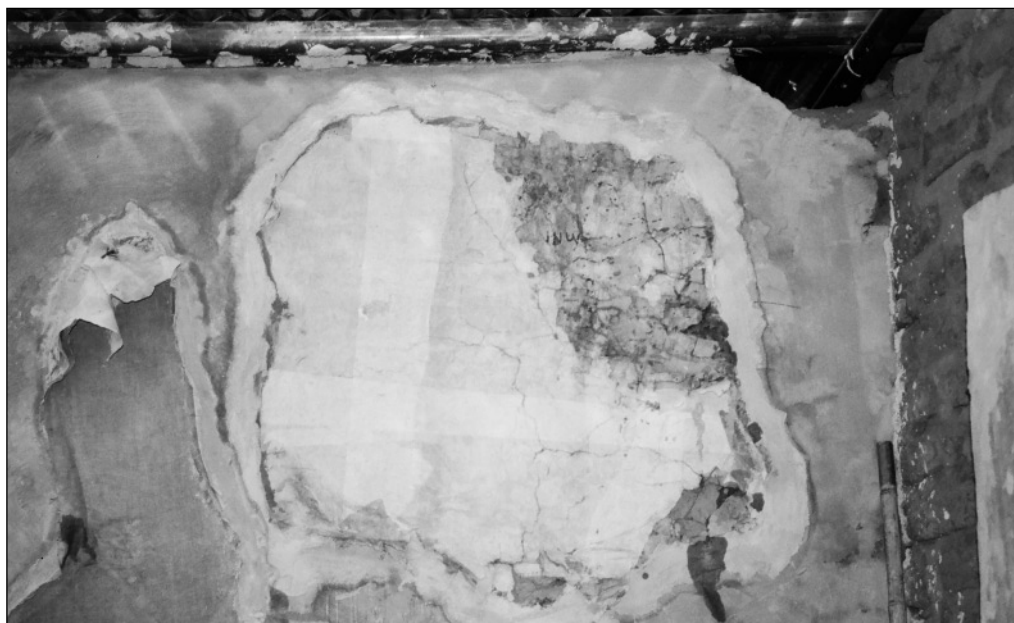
*Fig. 2. The mural after transfer to Room 18, in the course of removing the facing
(Photo D. Moryto-Naumiuk)*

The last step was removal of the facing with water compresses [Figs 2, 3]. Additional injections were made in the cracks. Ongoing conservation monitoring has shown this method to be effective.

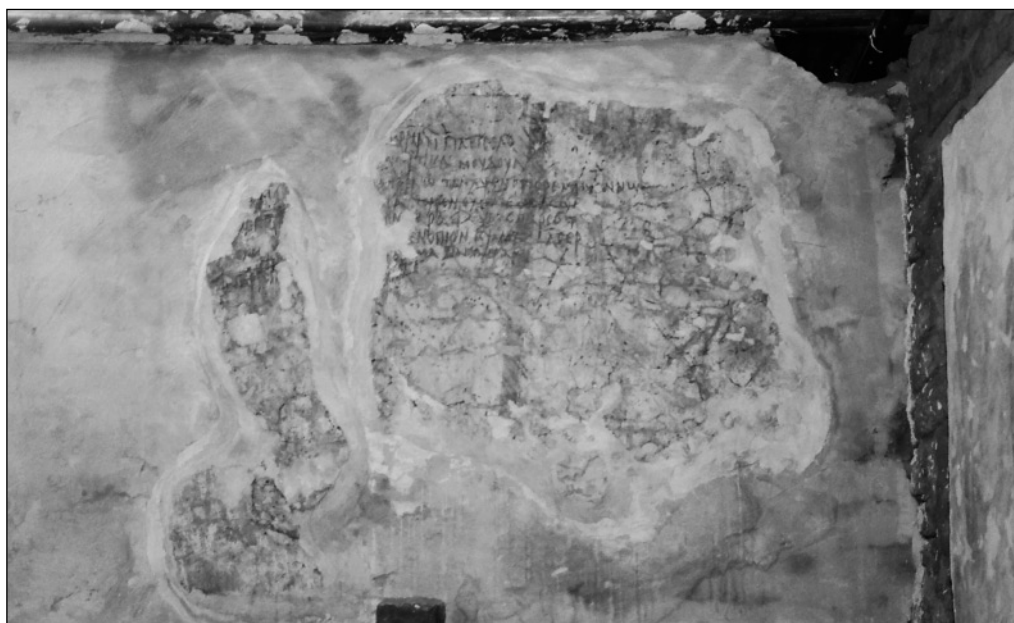
*Fig. 3. The mural after the transfer
(Photo D. Moryto-Naumiuk)*

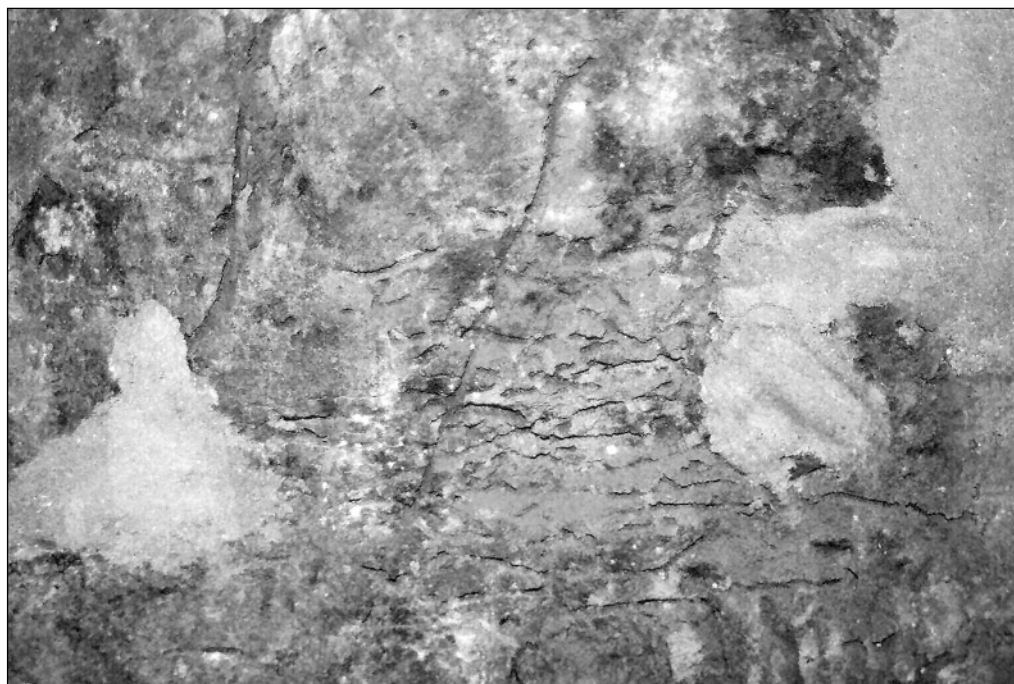
In an effort to preserve in situ the painting, which demonstrated a full gamut of possible damages [Fig. 4], a treatment aimed at structural reinforcement of the plaster ground was undertaken. Injections and drips of the same composition as used for the previously discussed mural were applied. The painting layer was impregnated with PARALOID B72 and alcohol-dissolved PARALOID B82. The surface of the mural was disinfected with a 1% solution of LICHENICIDE. This treatment concerned the heavily powdering mural depicting the Anastasis, paintings from the baptistry and the representation of St Mercurios and the *Maria Orans* icon.

and vertical insulation on the walls of the Lower Church (for fear of disturbing building equilibrium). Consequently, since water evaporating through the face of the paintings will be a source of constant salt efflorescence, drawing away the whitewash often with the painting layer, a transfer of selected wall paintings from this part of the Lower Church has been recommended.

Fig. 4. Face of mural from the Lower Church (after application of putties and preliminary reinforcing of the plaster structure), demonstrating a full gamut of damages: termite tunnels, white spots of salt crystallization – chiefly gypsum, black fungi (?) colonies (Photo D. Moryto-Naumiuk)

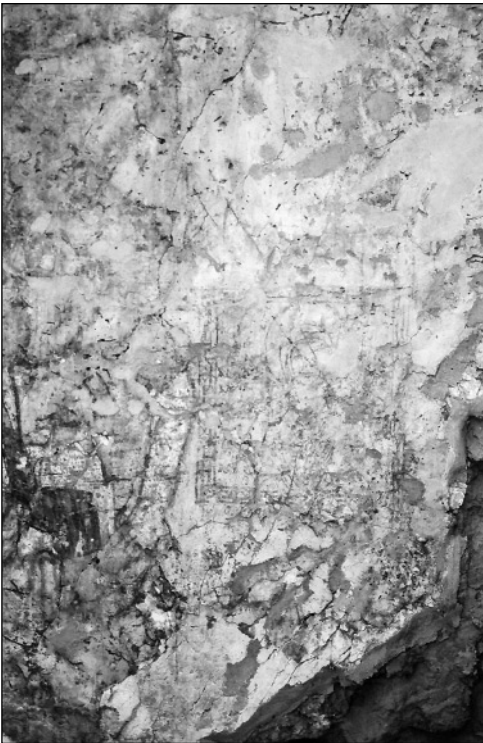
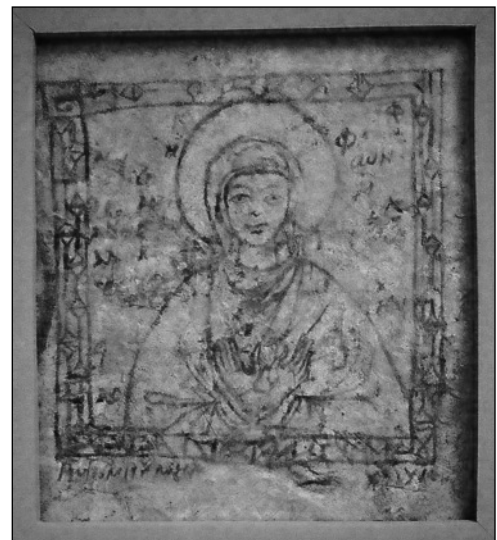
disintegrated lime-sand binder, silt compounds, pottery grits; no organic filler was determined, which, if it had been there, would have explained the concentrated activity of termites. The painting is monochromatic, the outlines rendered in black (presumably lampblack, but pigment analyses were foregone in view of the fact that the painting had been impregnated already for two years, thus falsifying the picture of the binders) drawn on a white-washed ground.

Fig. 5. The Maria Orans icon before (left) and after conservation in 2006 (Photo D. Moryto-Naumiuk)

In Poland, the facing was removed with water compresses. A large rift in the face of the figure was cut and glued. The openings of the termite tunnels were injected with PRIMAL AC33 mixed 1:8 with water and precipitated lime carbonate as filler. The surface was cleaned of discolorations and

grime with ethanol, taking care not to disturb the delicate painting layer which showed extreme sensitivity to solvents. Next, surface putties were applied, the putty in this case being acryl stuccolini colored with dry pigments.

Watercolors were used for unification of the painting layer. They are easily removed,
