# MARINA EL-ALAMEIN

## CONSERVATION WORK IN THE 2007 SEASON

Stanisław Medeksza

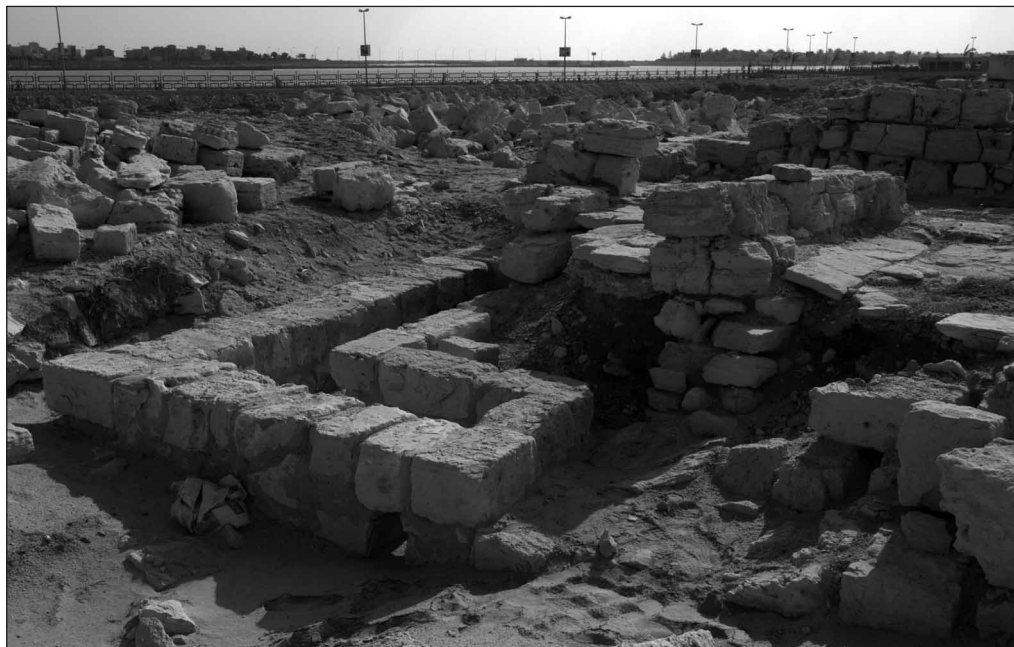
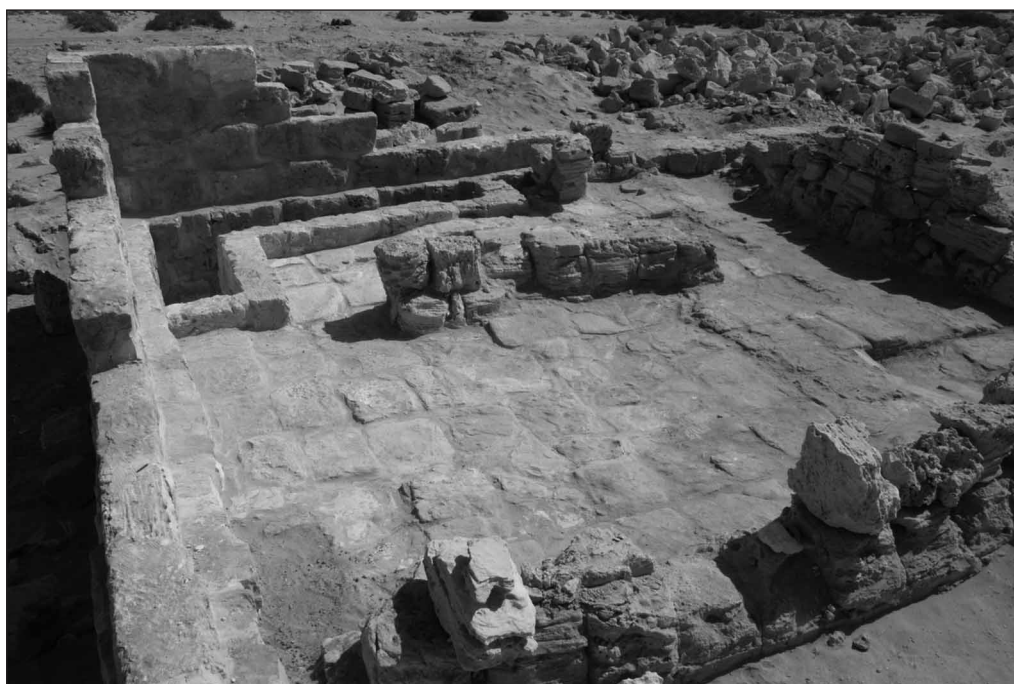
The restoration of the perimeter wall on the northwest and west sides of the house was completed in 2007, continuing the work begun in the previous season. The reconstruction of the latrine (units 1, 2, 21) in the northwestern corner of the house proceeded, encompassing the small colonnaded courtyard that was presumably connected with it. The entire bottom of the latrine was reconstructed, thus restoring the northwestern corner of the house as well [*Fig. 3*].

*Fig. 3. The latrine in the northwestern corner of House H1: before (top) and after restoration in 2007 (Photo S. Medeksza)*

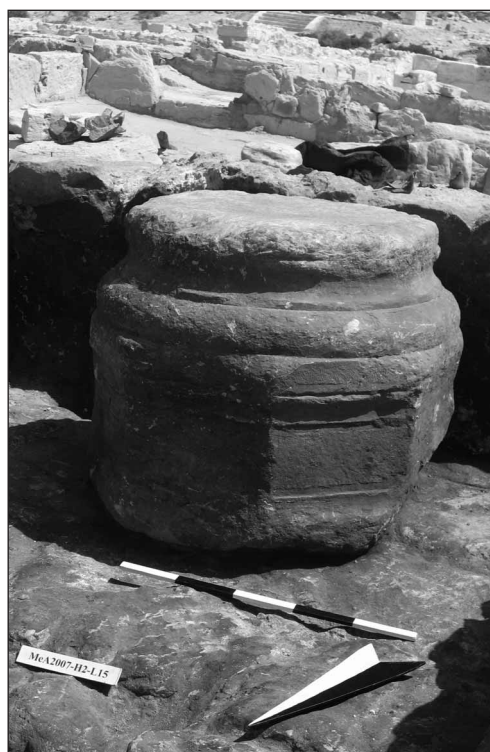
Fig. 5. *Marble Attic base with octagonal pedestal found in House H2*  
(Photo S. Medeksza)

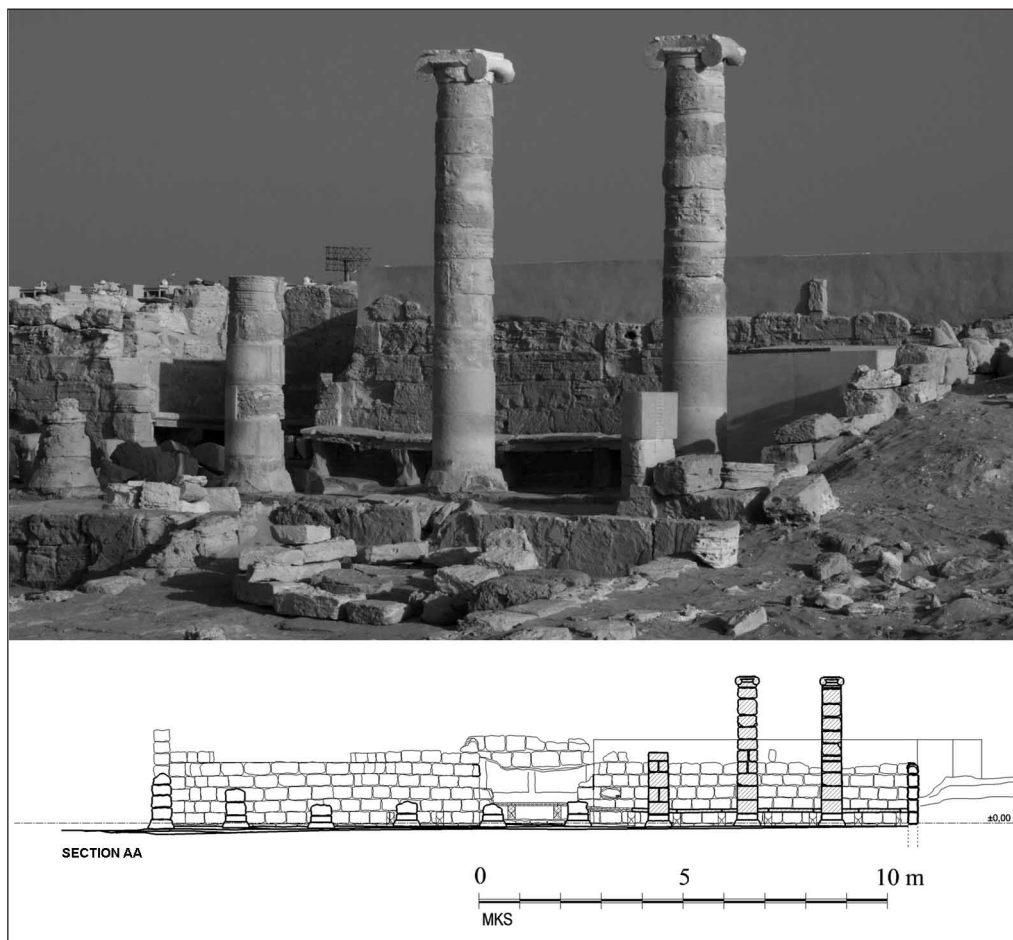
Fig. 7. South Portico with restored columns and bench in the background (top); section (AA in Fig. 6), state after the 2007 season (Photo S. Medeksza, drawing M. Krawczyk-Szczerbińska)

The columns had the bases preserved *in situ*, including in some cases the lowermost drums, which were the most damaged and eroded at the point where they had broken and collapsed. For this reason these drums, although partly preserved, were replaced in the reconstruction with replicas. The original pieces were structurally too weak to carry the upper parts of the columns. The reconstructed drums were cut from single blocks of stone unless only one half of the drum had to be replaced. They were set up on the original bases, which were in satisfactory condition and required only minor consolidation and reinforcement of the substructure.

The upper parts of the columns were reconstructed of original elements as follows (for details of the conservation methodology, see below):

Column first from the west: The four lower drums are from this column, the upper ones come from the sixth column from the west, part of which was very poorly preserved. The original top of this column, which is the

Column second from the west: Set up from original elements found near its base during excavations. Only the lowermost two were replaced with drums of identical size but better preserved, coming from elsewhere in the portico, but without exact provenience.

Column third from the west: Reconstructed to a height of 1.82 m, replacing with replicas half of each of the two lowermost drums and the entire third drum. Mounted on this were two more original drums composed of halves.

Engaged column from front row: Base *in situ*, one original half-drum and one reconstructed element.

Standard mortar was used for bonding all the restored elements (3 parts sand to 2 parts lime to 1 part white cement). The halves of two-part drums were clamped with stainless steel rods (ø 8 mm) on top.

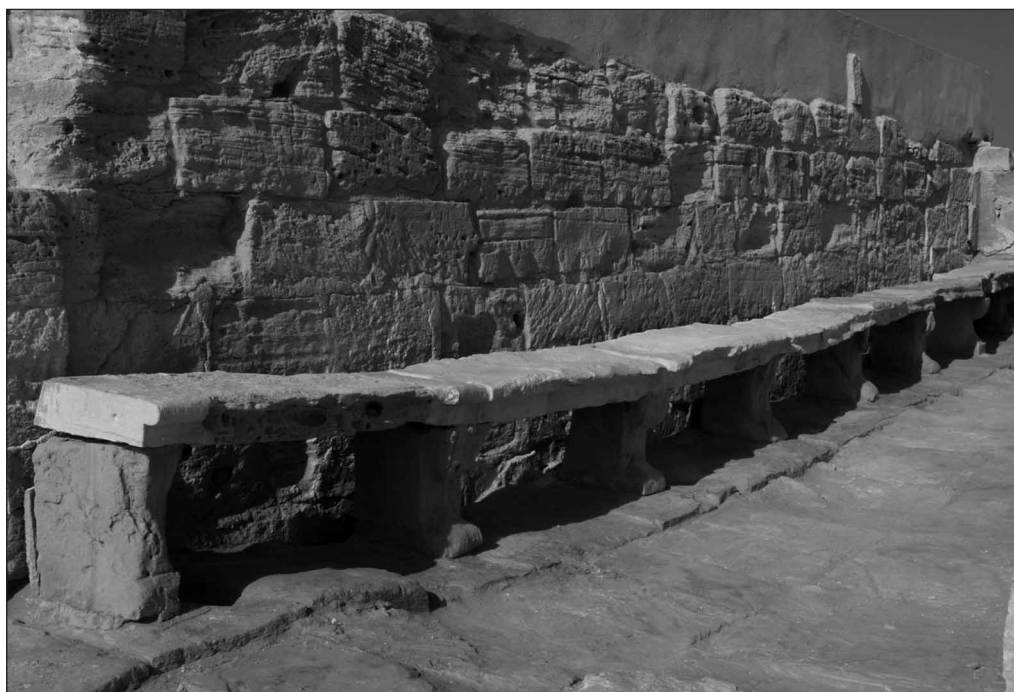
In 2006, the state of preservation of the elements in question was recorded in preparation for planned restoration in 2007. All of the seats were found to be broken as a result of mechanical impact. Since the collapsed fragments were supported on undisturbed ancient fill, it should be assumed that the damage occurred in antiquity. Documentation in April 2007 revealed new damages, presumably connected with the building works being carried out on the south wall of the South Portico, which is the back wall of the benches. The cracked seating slabs had been dismantled and the bench legs were used as provisional supports for scaffolding needed in the building works. Fragments of the benches were displaced with regard to their original position, preventing the restoration of fragments in their original position.

*Fig. 8. Benches in the South Portico, state after full restoration in 2007  
(Photo S. Medeksza)*

The bench legs displaced by the movement of the substructure were mounted on the floor in their original position. The natural dilatation at the joining with the south wall was not refilled intentionally in order to reduce the amount of rainfall flowing from the high wall onto the surface of the bench. (A historical joint was left in place by the extreme leg as proof of its existence).

The damage to one of the legs was considerable, necessitating the making of a limestone replica. The ancient piece was recomposed and stored for display in the future museum exhibition.

Bigger losses of the stone were filled in with stone patches following appropriate technical parameters. For structural reasons

all bench restoration was also made of material with appropriate technical parameters. The adhesive used was a modified mass based on epoxy resin KEMAPOXY 150 by C.M.B. The structure was reinforced with stainless steel rods ( $\varnothing$  12 mm).

Small losses and cracks were filled with lime-cement putty with lime filler. The seating slabs were mounted on the legs, and the joints were only partly filled [*Fig. 8*] (in anticipation of the need to dismantle the benches for conducting further building work on the back walls).
