Title: **Marina el-Alamein. Conservation work in the 2009 season**

Journal: *Polish Archaeology in the Mediterranean* 21 (Research 2009)

**Abstract:** In 2009 the Polish–Egyptian Restoration Mission to Marina el-Alamein proceeded with another season of conservation work in heavily constrained circumstances. Architectural studies preceding building conservation work were carried out in House H1, where the Mission has been active over the past few seasons. It was established that the house had an inner peristyle consisting of two tiers corresponding to building floors: pseudo-Corinthian of the Marina type on the ground floor and pseudo-Corinthian or pseudo-Ionic of the Marina type on the upper floor. A similar tiered architectural decoration was noted in the incomplete peristyle (unit 4) of the Southern Baths just off the presumed Main Town Square. Work continued on clearing the chambers of the baths and accomplishing preservation, conservation and subsequently building restoration works. A marble plaque with an inscription, found previously, was subjected to conservation treatment once standard condition monitoring demonstrated progressive deterioration of the state of this object

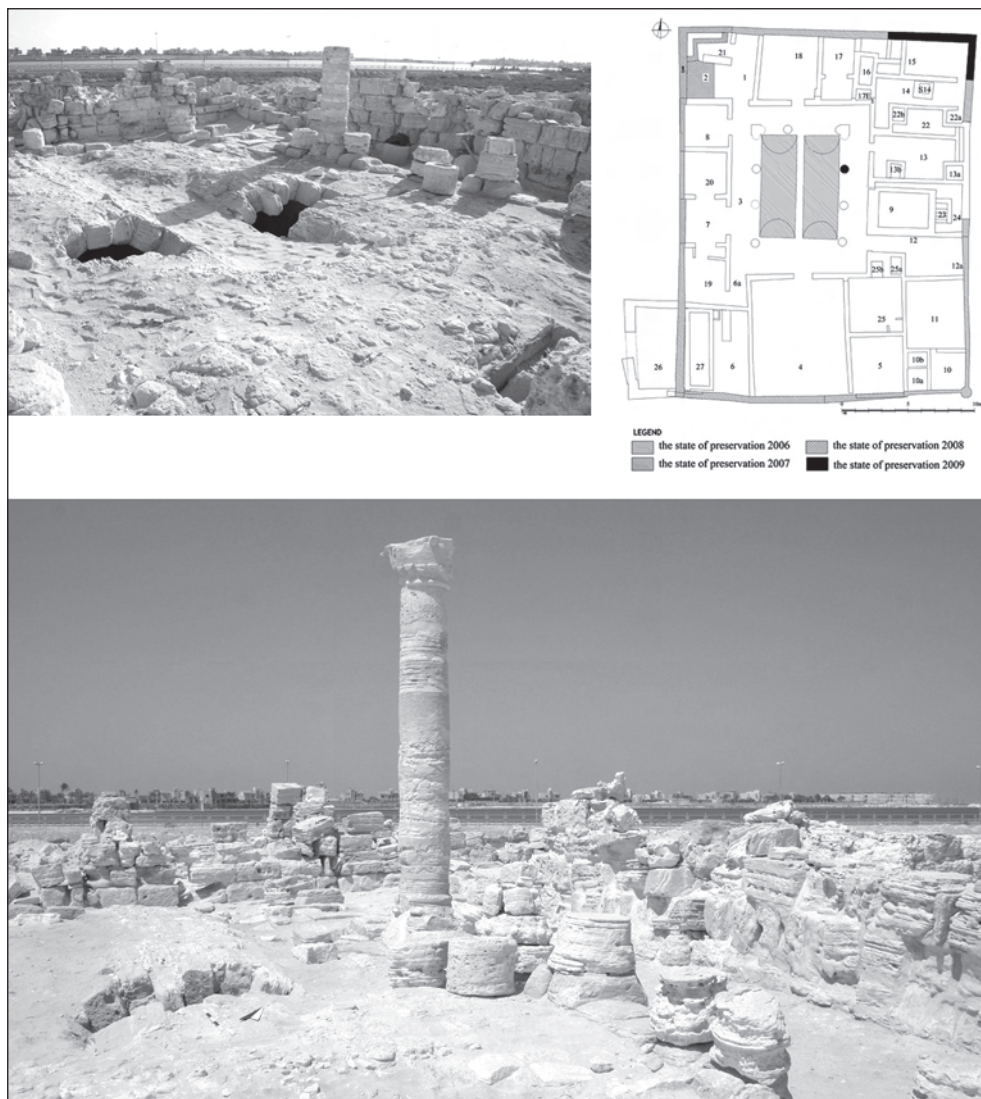
Fig. 2. House H1, central peristyle before (top left) and after conservation; top right, amended plan (Photos R. Czerner; plan A. Brzozowska)

The foundations and upper parts of the outer walls were completed this season. Another course was added to the foundation in the northwestern corner of the building. One column was raised to its full height following architectural studies on the proportions of the portico columns [Fig. 2]. The parts done in 2005 and 2006 were now raised with four more drums and topped with a capital, achieving a height of 3.45 m which is close to the theoretically reconstructed one. One of the drums had to be made anew, while more extensive

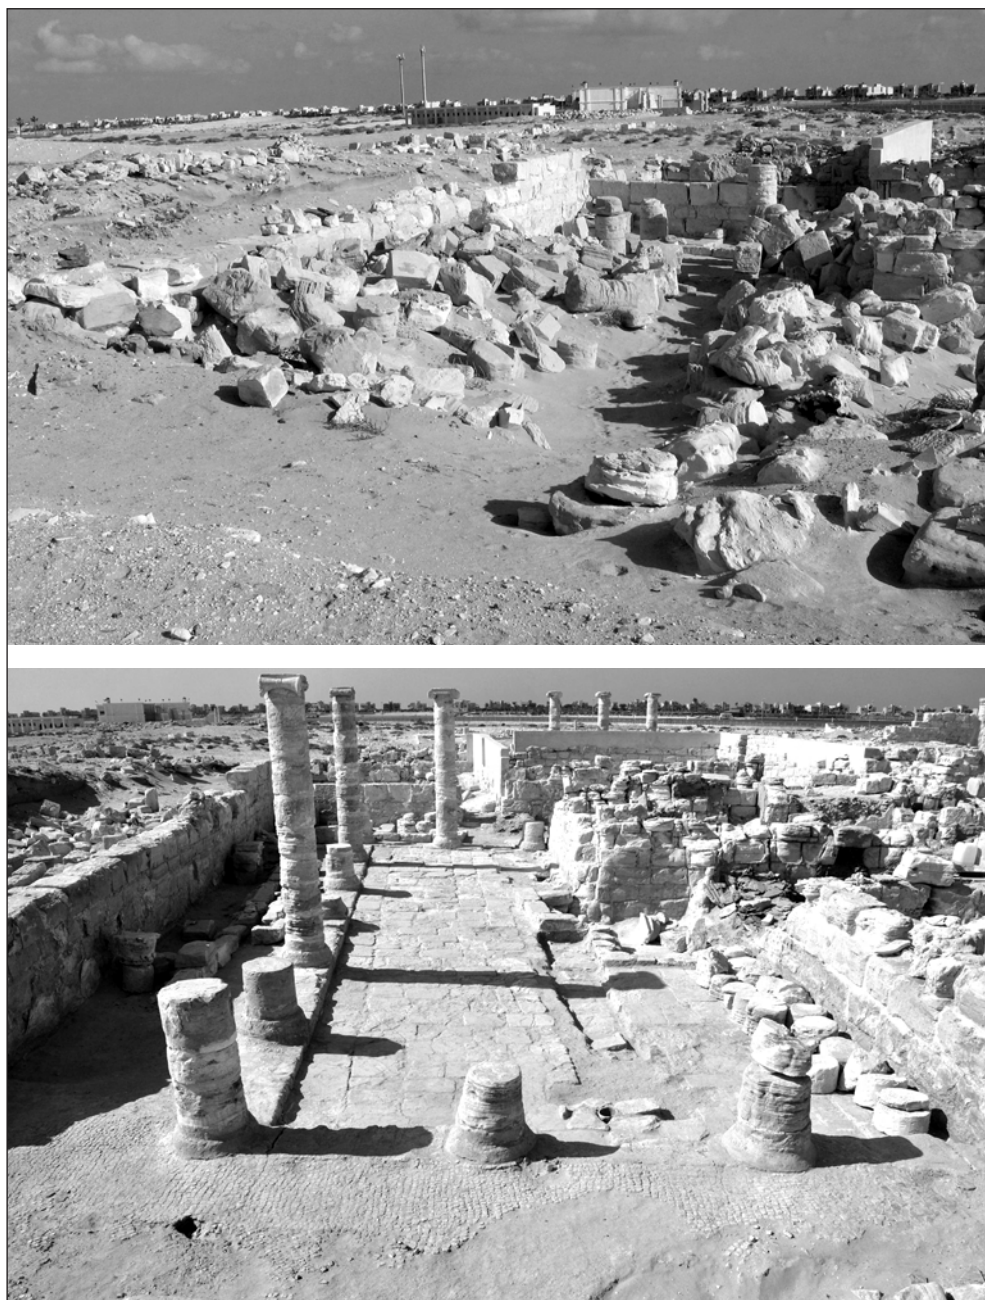
*Fig. 4. Unit 4 of the Southern Baths, before (top) and after clearing and conservation, view from the south (Photos G. Bąkowska-Czerner, P. Zambrzycki)*

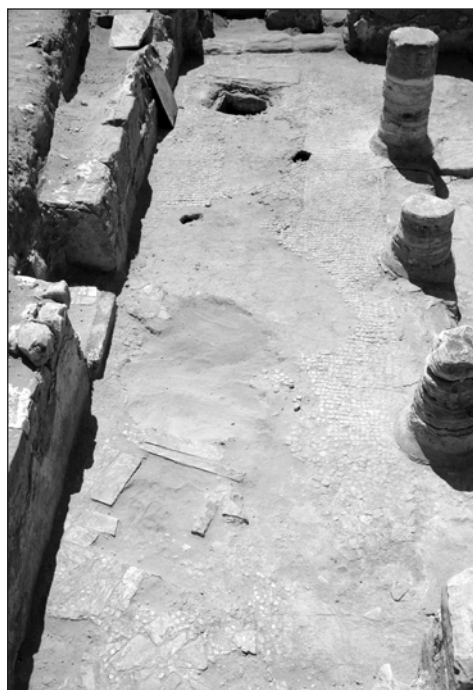
*Fig. 9. Mosaic floor preserved in the southern portico in unit 4, view from the east (Photo R. Czerner)*

In the eastern end of the southern portico, the floor had been damaged by a falling column drum, which broke through it. Tumbled architectural elements and

Considering the evidence of the multi-layered polychromy on wall plaster fragments and the repairs evidenced on the mosaic floor in the southern portico, unit 4 must have remained in extended use for a long time. It appears to have been rebuilt at the end of the 2nd or the beginning of the 3rd century; the eastern end of the paved courtyard was reduced at this time. Destruction came in the 3rd century, the collapsing architectural elements destroying the floor in the eastern part, but also apparently sealing the part of the porticoes where the mosaic floor has been preserved. In the central and northern parts, where stone blocks and elements of architectural decoration had collapsed onto a layer of drifted sand approximately 0.15 to 0.20 m thick, several hearths installed in the porticoes damaged the floors.

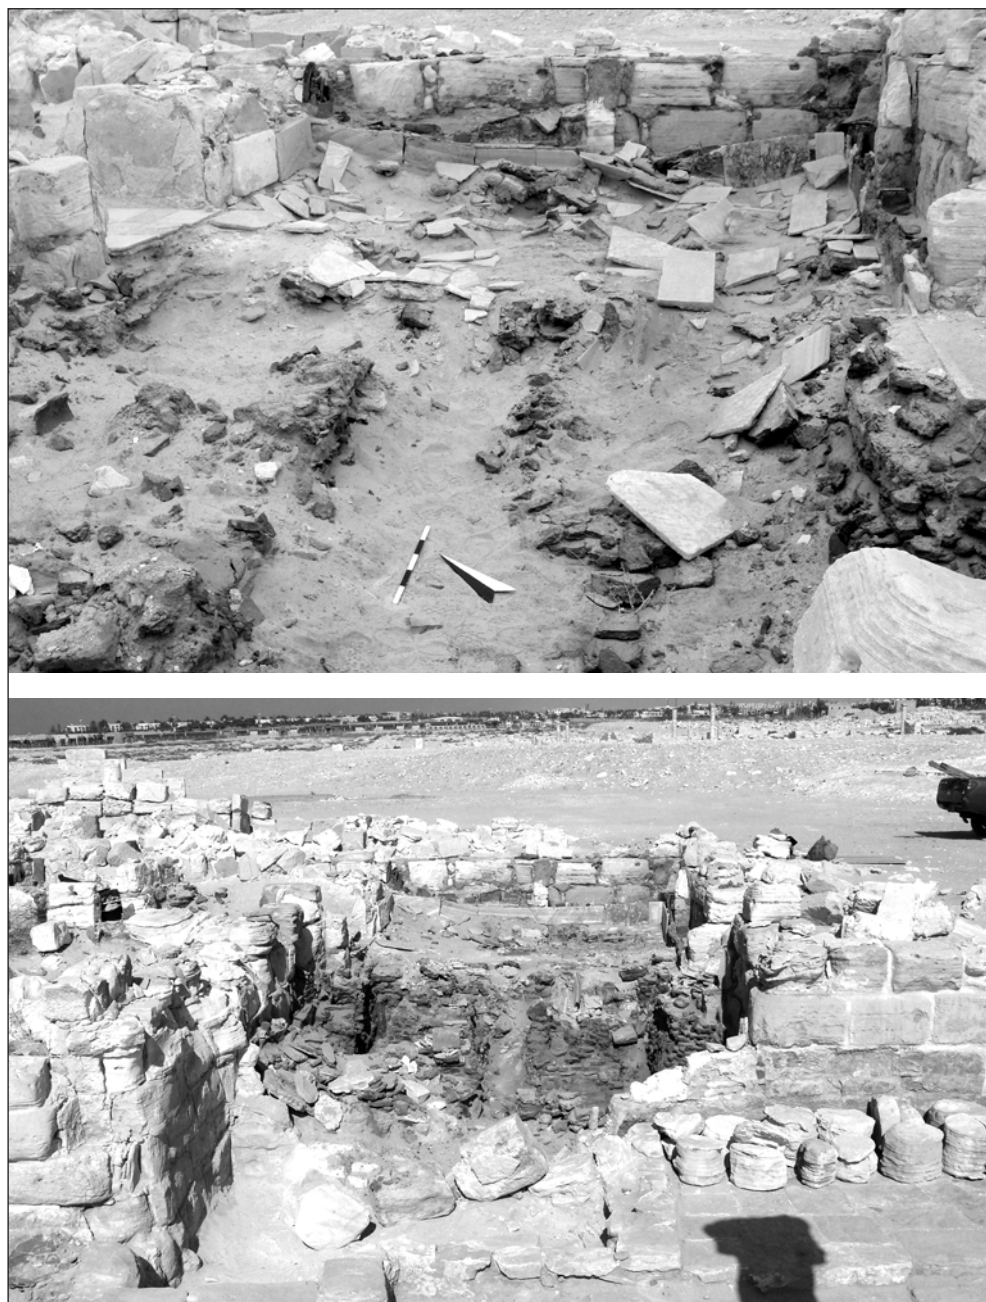
an apparent inner recreational courtyard, and reconstruction of the porticos [Fig. 3]. Emergency measures were needed in unit 6, where the hypocaust and tubuli heating installation relics were rapidly deteriorating — the ceramic tiles powdering, the tubuli shattered and hypocaust cellar vaults collapsed — and the marble floor slabs and wall revetment were in no better shape.

*Fig. 11. General view of unit 6 of the Southern Baths at the beginning of the season (2009) and after emergency conservation of the remains (Photos M. Mrozek-Wysocka)*

The preserved parts of columns in the Western Portico of unit 4 had small losses of the substance in the form of old lime joints and fragments of bases and drums. After clearing of the feature parts of the hypocaust structure in unit 6 of the Southern Baths were also found to be detached and powdering.

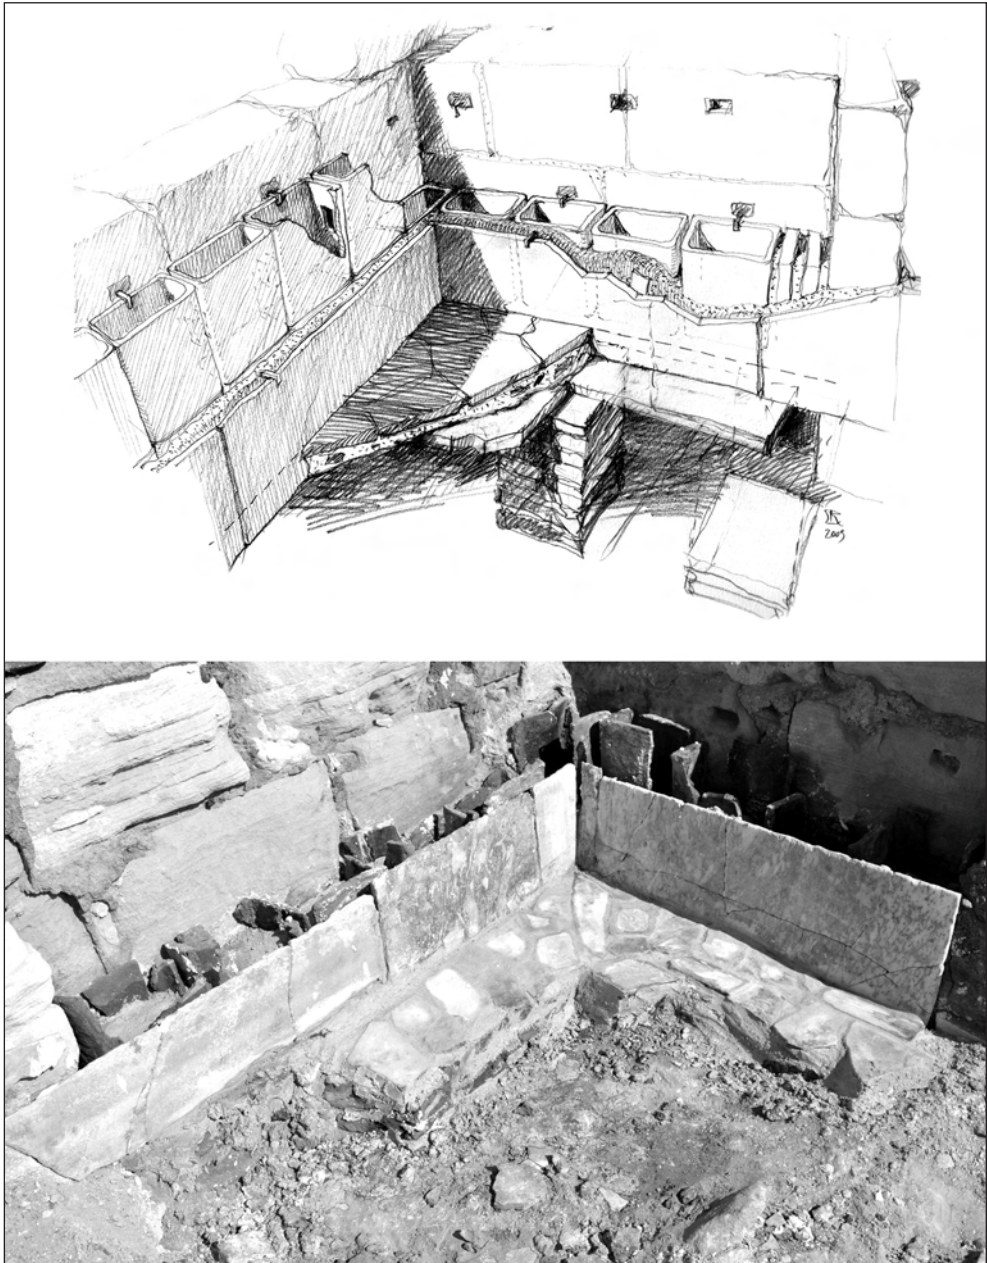
Fig. 13. The tubuli system in the southeastern corner of unit 6 of the Southern Baths: theoretical reconstruction (top) and state after conservation (Reconstruction drawing R. Czerner; photo P. Zambrzycki)

a reconstruction of the *tubuli* system preserved in the southeastern corner of the room. This led to a theoretical reconstruction prior to the actual restoration [Fig. 13].

The condition of the revetment and tubuli was assessed and steps were undertaken toward a partial anastylosis of this installation [see Fig. 10]. Cracked fragments of the revetment were removed for consolidation and reassembly before remounting. Excavated elements of ceramic tubuli were cleaned and partly reinforced

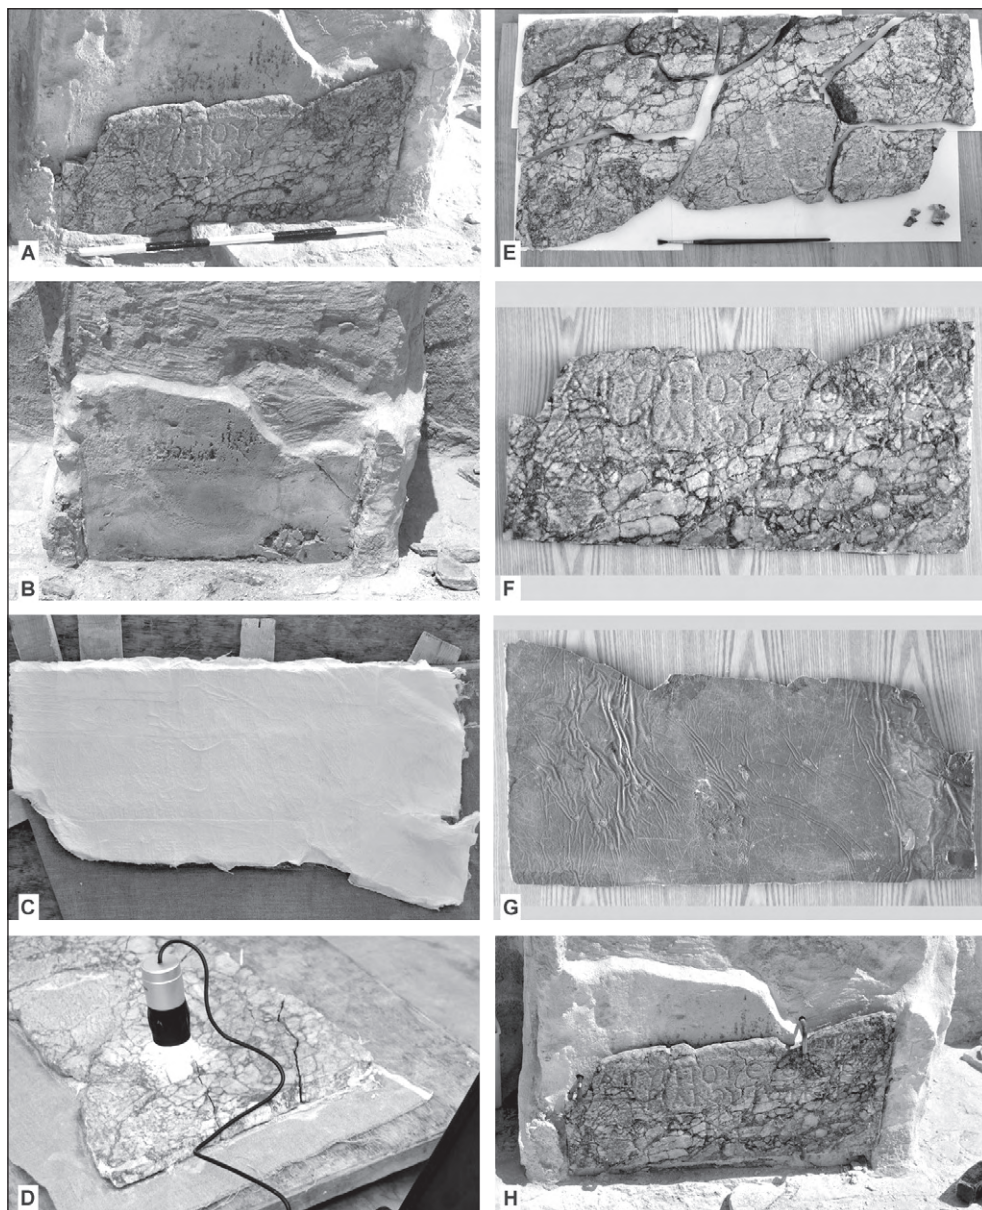
of peeling and detached plaster were filled with loose accumulations, parts of the plaster sticking as much as 2 cm away from the wall face. The marble inscription plaque, which had been protected after its original discovery, had come away from the pedestal; its deformation created a deep pocket filled with loose saline sand. The preserved fragment of the plaque was cracked heavily, the cracks radiating along the veining of the marble. Conservation *in situ* was no longer possible, hence it was dismantled and transferred to the field lab for further treatment.

*Fig. 14. Conservation of a marble inscription plaque: a – current state before conservation; b – the pedestal during conservation after the plaque had been dismantled; c – desalination of the plaque with compresses; d – recording of damages; e – after removing of the “facing”; f – gluing of pieces; g – consolidation of the back side of the plaque; h – after reassembly (Photos G. Bąkowska-Czerner, M. Mrozek-Wysocka, P. Zambrzycki)*

Annual monitoring of the condition of a marble inscription plaque discovered in 2005 in the passage by the basilica (for the archaeological context of this object, see Daszewski 2007: 83) [location marked with a dot on the inset plan of the Southern Baths in *Fig. 3*], preserved out in the open on the site, recorded extensive damages to the structure of the stone of this plaque, caused by unfavorable exposition and natural erosion processes.

First the plaque was cleaned of loose deposits and delicately washed with water. The pocket behind the plaque was cleaned. Joints around the plaque were also cleaned, uncovering the bronze anchors used to mount the plaque. The piece was documented and then dismantled by the transfer method. Two layers of cotton gauze were fastened to the surface of the plaque with polyvinyl alcohol (water solution). The same adhesive was used to attach linen cloth to the gauze. Once this was done, the plaque was detached mechanically with trowels onto a convenient support in the

Conservation procedures started with a desalination of the plaque using cellulose compresses [*Fig. 14*]. The protective “facing” on the face of the plaque was removed temporarily for this purpose. The state of the stone was examined and assessed, and a program of conservation treatment was developed. The complete deterioration of the stone around the cracks called for these areas to be cleaned and reinforced. Particular fragments were first separated, cleaned and protected with a 5% solution of PARALOID B-72 in toluene. The pieces were reassembled using an epoxy mass with marble filler.

The back was reinforced with a fiberglass laminate with binder KEMAPOXY 150 produced by CMB. The stone was subsequently reinforced with a silico-organic agent SILEX OH produced by Keim. The last stage was mounting the plaque back in its original position using stainless steel anchoring. Air isolation 20 mm above the floor will reduce the negative effects of ground humidity. In preparing the remounting of the plaque an effort was made to minimize the detrimental effect of climatic conditions in its surroundings, hence the anchors which do not transfer pressure and which maintain horizontal and vertical air isolation.

Should erosion processes continue, the plaque will have to be replaced with a copy and the original prepared for museum display.
