### Title: The Mosque Building in Old Dongola. Conservation and revitalization project

Author(s): Artur Obłuski, Włodzimierz Godlewski, Wojciech Kołątaj, Stanisław Medeksza, Cristobal Calaforra-Rzepka

Journal: Polish Archaeology in the Mediterranean 22 (Research 2010)

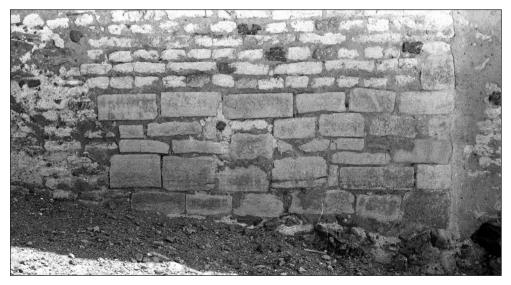
Fig. 9. Stone blocks reinforcing the northwestern corner of the Mosque Building (Photo W. Jerke)

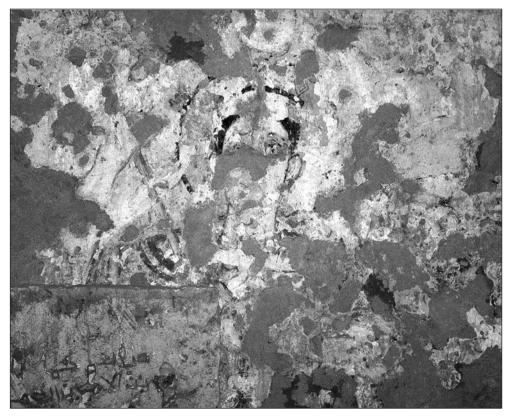
Fig. 10. Mural of a warrior saint on the south wall of the staircase (Photo W. Godlewski)

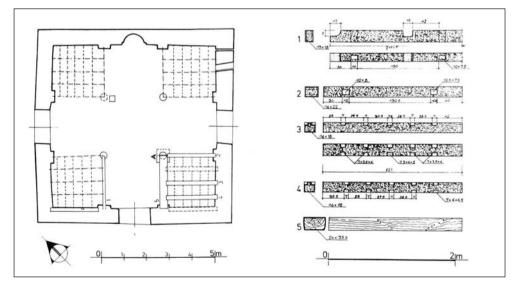
Fig. 11. Ceiling of the central room on the first floor (Archival documentation S. Medeksza)

It is indispensable to replace various elements of the ceiling above the central room; however, a guiding conservation principle is to preserve historically justified ceiling elements wherever possible. Replacement shall be considered solely in case of elements which undoubtedly were not introduced in the 20th century reconstructions or as protective means. At least a fragment of the coffer ceiling (in the southwestern corner) will have to be reconstructed. Construction of a flat ceiling is posited, independent of the ceiling, above the central room, thus achieving independent operation of the ceiling and roof structure and proper natural ventilation.

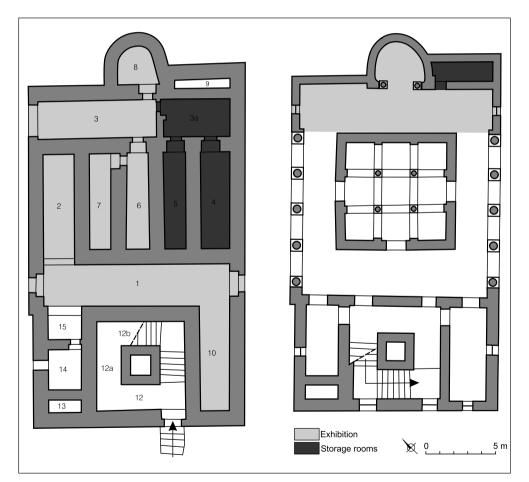
Fig. 15. The Mosque, concept of interior adaptation, ground floor and first floor (Design W. Kołątaj, S. Medeksza)

The current project is intended to prepare the grounds for an adaptation of the building that will meet all the requirements of conservation of historical heritage, while making the structure significant again for the local Dongolan community. Growing tourist interest in the site of Dongola and a rising local pride in the town's and region's history have created the proper circumstances for a meaningful restoration and adaptation of the structure [Fig. 15].
