WALL-PAINTING TRANSFER AND CONSERVATION AT NAQLUN

PART 2

Cristobal Calaforra-Rzepka

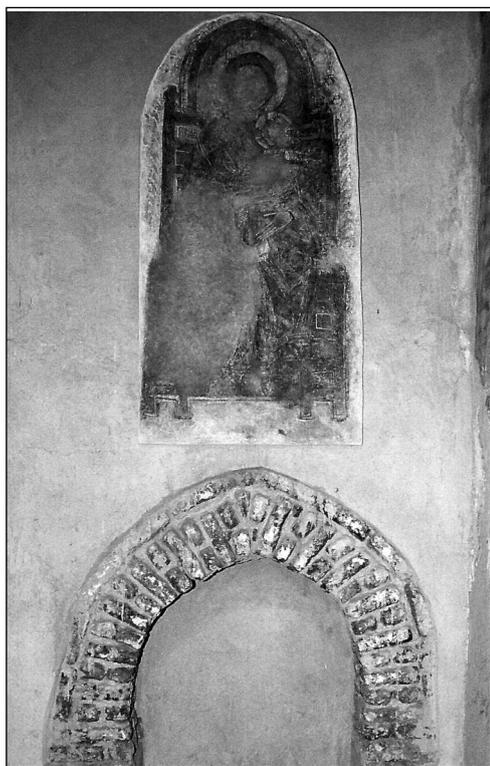
Fig. 1. *The Virgin-and-Child painting reinstalled in the church narthex (Photo C. Calaforra-Rzepka)*

As a final step, the transferred picture was screwed onto the south wall of the narthex, beside other paintings from the

same period (*Fig. 1*). This will prevent any further damage due to accidental transport of the object, while putting the painting

high enough to be out of reach of visitors. The mounting holes were then filled with plaster and retouched.

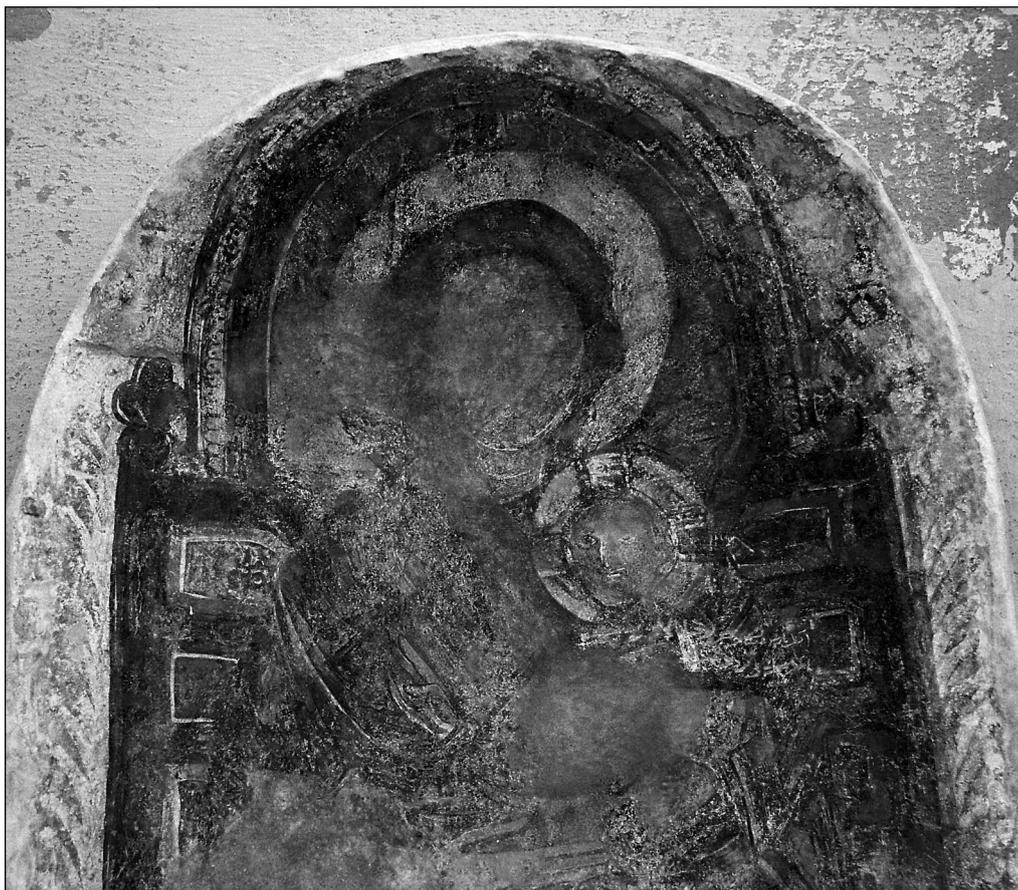
Fig. 2. The upper part of the composition of the Virgin and Child from the central niche of the church apse, after retouching (Photo C. Calaforra-Rzepka)

The final aesthetical arrangement of the transferred representation of the Virgin and Child, which had been postponed from the last season, was now the chief objective. The procedure of retouching was done in the same watercolor technique as in the case of the earlier layer of painting. In view of the fact that the church continues to be in use and is heavily visited by pilgrims, not to mention scholars, it was deemed appropriate to reconstruct parts of the missing composition in order to make the whole entirely more legible.

The smaller gaps were first filled with local color lighter than the original, tracing lines and shapes that had not been legible at the beginning of the work. This was followed by a partial reconstruction of the basic shapes, such as ovals of heads and haloes, hands, and the outline of the throne. The reconstructed lines were blurred to suggest the shape, but without any details, which can be discerned only on the original parts (Fig. 2).
