MOSAIC CONSERVATION AT KOM EL-DIKKA IN ALEXANDRIA IN 2002

Joanna Lis

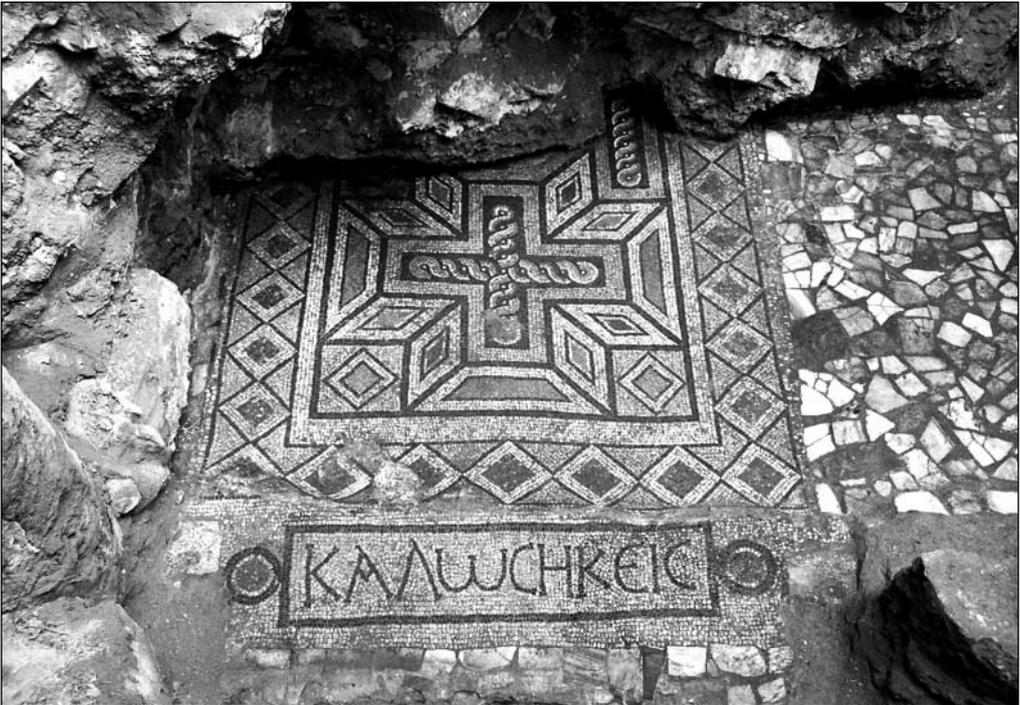
Fig. 1. Mosaic floor after preliminary cleaning of the surface
(Photo J. Lis)

The first step in the conservation process was to remove the protective layers of earth, sand and cloth that had been applied upon discovery (*Fig. 1*). Photo-

graphic documentation of the condition of the floor before and during conservation was regularly made. The surface was cleared of loose dirt and salt efflorescence. Wet sponges were then used to clean the surface and the losses were filled with lime mortar. Water with ammonia and acetone was then used to clean and degrease the surface. Following some testing of adhesives for the layer protecting the top face of the mosaic, PVA (WINAVIL) of Egyptian production was used. Cotton gauze was applied on the edges of the cracking.

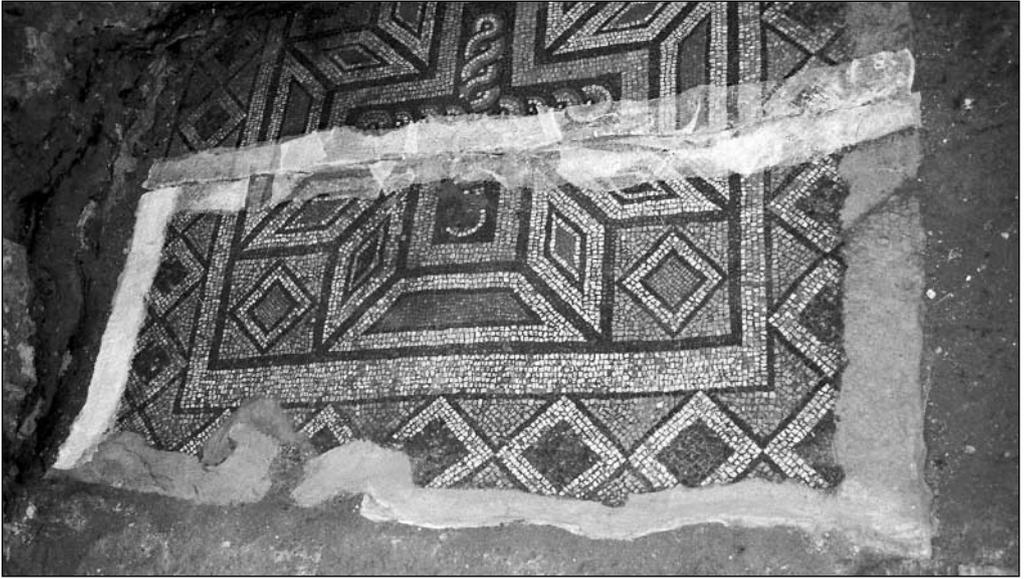
Fig. 2. Mosaic floor divided into sections in preparation for lifting
(Photo J. Lis)

For the transfer the pavement was divided into three major sections, two smaller ones and the tondo (*Fig. 2*). The natural crack was taken advantage of as one of the division lines, while the others were traced across the floor. The three major sections measured 210-212 cm in length by from 56 to 90 in width. The smaller ones around the tondo were 54 by 37 cm and 46 by 15 cm respectively. The tondo was 64 cm in diameter. The *opus sectile* border frame was left in place. The face of the mosaic was protected with two layers of cotton gauze and a layer of thicker cloth. The next step was to cut away the surface layer of the mosaic section by section,

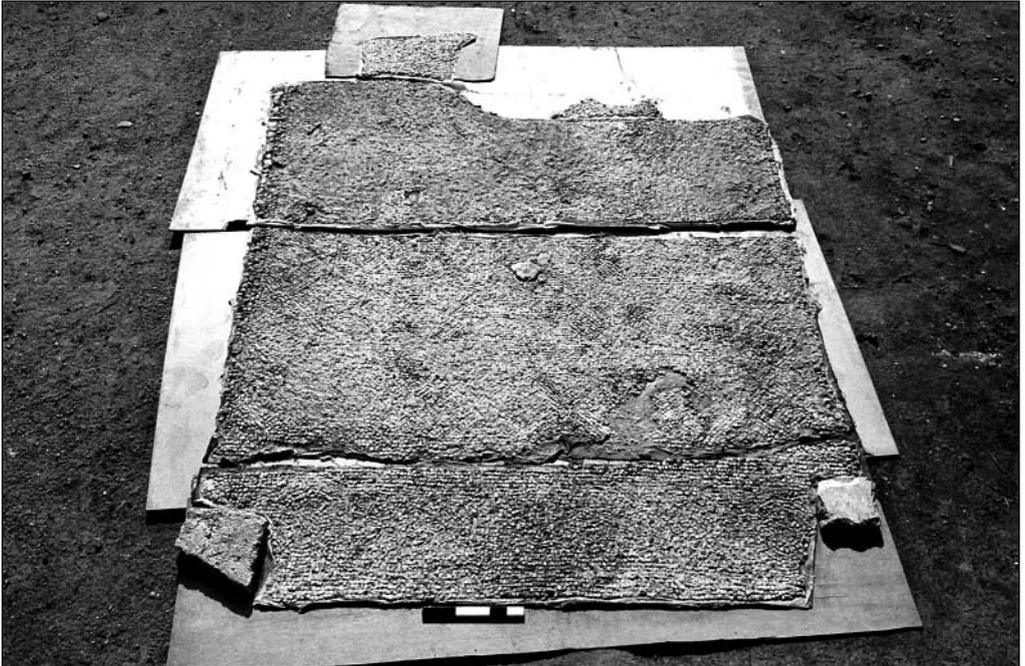
Fig. 3. Back of the mosaic floor after cleaning
(Photo J. Lis)

In an on-site field conservation lab, the mosaic sections were laid face down and the remnants of the bedding, consisting of lime mortar and original floor substructure, were removed (Fig. 3). Cubes that had stuck loosely and had been displaced along the line of the crack were removed, cleaned and secured back in place. The cleaned back of the mosaic sections was then sprayed with an impregnating 7% solution of PRIMAL AC 33 of Italian manufacture. Everything was prepared for introducing a new lime bedding, consol-
