MAREA

EXCAVATIONS 2004

Hanna Szymańska, Krzysztof Babraj

The fifth season of Polish excavations at Marea lasted from August 14 to September 27, 2004.¹ Excavation in four separate areas of the basilican church, the exploration of which commenced in 2003, led to the clearing of the north wing of the transept together with collateral chapel, the tracing of the main church entrance in the west wall of the complex, and the investigation of lateral rooms beyond the southwestern corner of the church. Further work was also done on the kiln discovered last year under the apse.

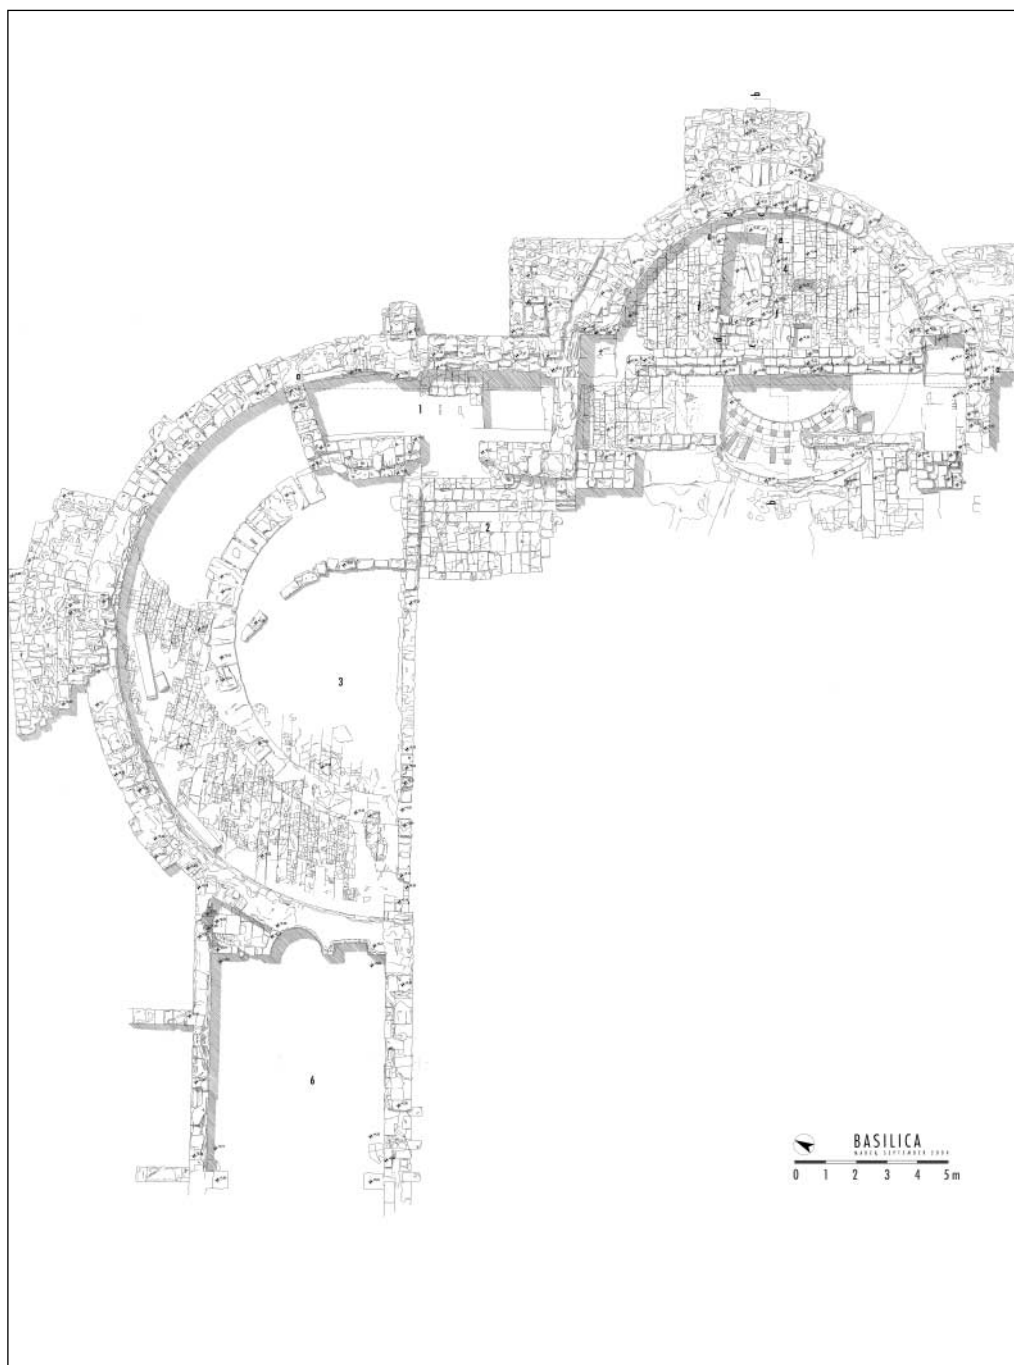
*Fig. 1. Plan of the apse, northern wing of the transept and north chapel of the basilica
(Drawing D. Tarara)*

Work commenced last year in the north wing of the basilica transept was now continued with more limestone blocks from the collapsed walls being cleared from further sections of the building [Figs. 1,2]. The stylobate, which was revealed in the north transept, was made of blocks of nummulithic limestone averaging 1.00 by 0.75 m. Of the marble columns that had stood on the stylobate, three shafts of 0.35 m diameter were found on the floor of the transept in this area.

The room adjoining the basilica on the north proved 6 m wide [cf. *Fig. 1*; *Fig. 4*]. A third of it was cleared in the course of this campaign. Meriting attention is the difference in the thickness of the walls between the apse, the outer wall of the basilica and the side room: 1.20 m, 0.80 m and 0.50 m respectively.

and the other a little further away [cf. *Fig. 1*]. They are suggestive of yet another chamber being located behind the wall here. Ledges for steps, possibly leading to the emporas in the aisle, were noted in the wall between the two walls [*Fig. 6*]. The fill behind the wall yielded a sherd from a Coptic plate featuring a wavy edge and painted scene from the Dionysiac repertoire [*Fig. 7*].

At a distance 1.25 m to the west, a semi-circular brick structure was uncovered (room 10) [cf. Fig. 1]; it appears to have protected a latrine (?) found 2.21 m below it. Further explorations should provide an explanation of the function of this feature. Investigations in room 8 brought the most

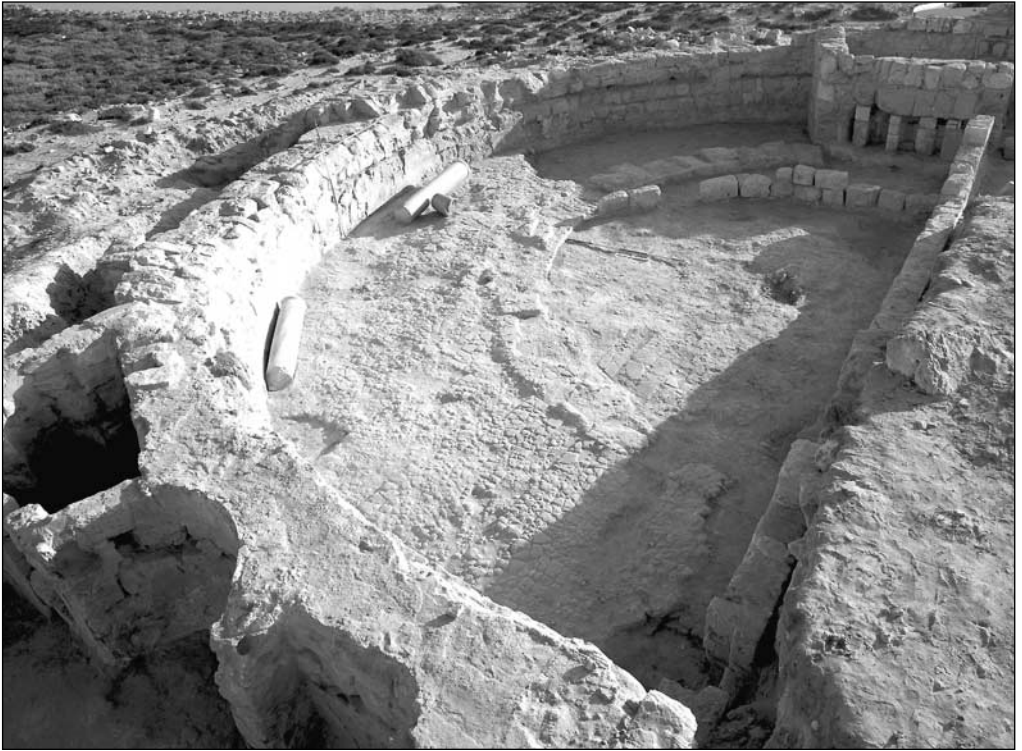
Fig. 2. North wing of the transept with stylobate under the columns, view from the west. Note the circle of stones protecting a late fireplace (Photo J. Kucy)

One complete shaft was 2.21 m long; the other two were fragmentary. Furthermore, Grossmann's presumed intercolumnar space of c. 2.40 m has now been confirmed.⁴ Consequently, the number of columns in the transept should be reconstructed as twelve. Four of these columns were later incorporated into the wall of the northern pastophorium (prothesis?) during a rebuilding of the church, as indicated by the negative impressions in lime mortar of three of these columns, recorded during

last year's work. The fifth column (third counting from the intersection of the transversal colonnade with that of the nave) must have been removed presumably because the wall of the pastophorium and the north wall of the basilica were joined to a narrow (0.30 m thick) stone wall. The width of the ambulatory between the colonnade and the transept wall was 2.80 m. The evidence points to the intentional removing of three column shafts to a place by the outer wall; this was done by people who occupied the building once it had been abandoned as a church. They erected in this part of the transept a circle of blocks taken from the collapsed walls and meant to protect a fire, traces of which are still evident today.

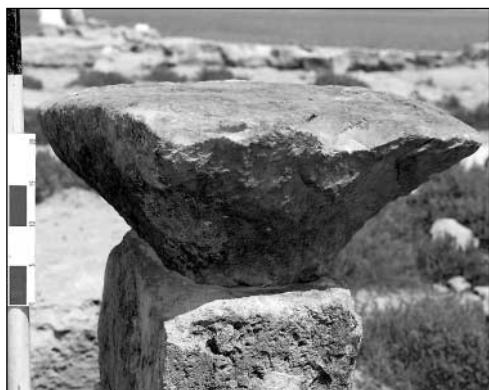
Fig. 3. *Capital stripped of carved decoration, found in the northern wing of the transept (Photo J.M. Kucy)*

An interesting find of a capital was made in a corner between the wall of the northern aisle and the wing of the transept. The top surface of the capital measured 0.47 by 0.45 m, the bottom diameter 0.26 m [Fig. 3]. It was not ornamented. Perhaps the decoration was never executed or else the decoration was hammered away at one point in order for the element to be painted.⁵

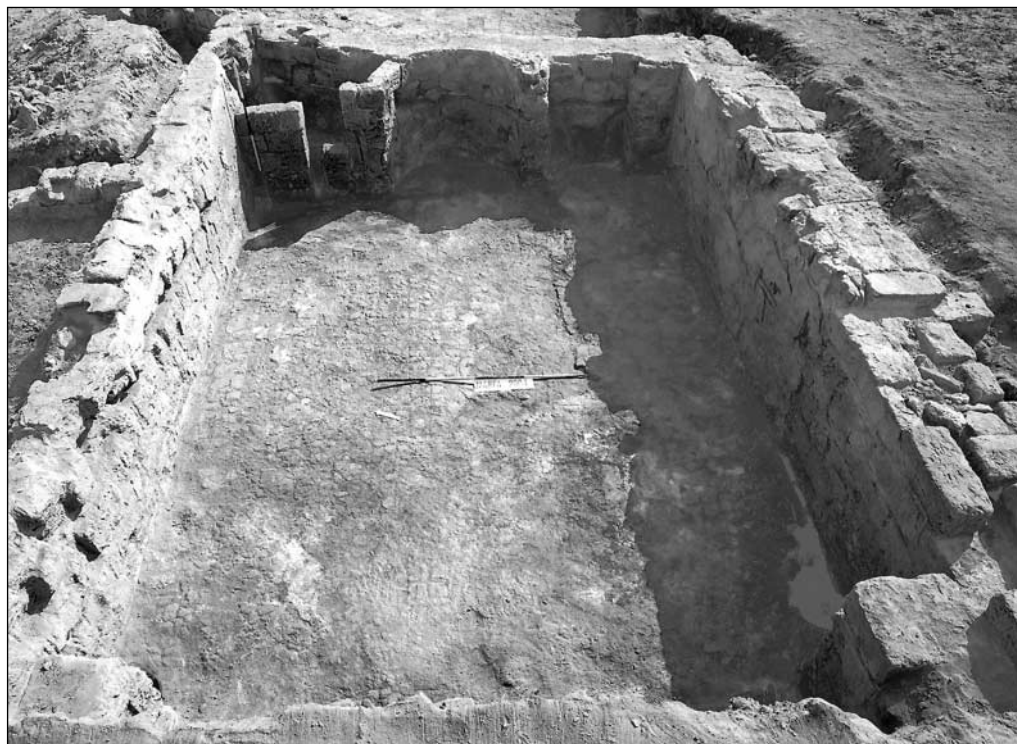
*Fig. 4. Chapel adjoining northern aisle. View from the west
(Photo J.M. Kucy)*

Much would suggest that this room was used as a chapel. Two niches were cut into the western part of the transept wall: one semicircular (0.80 m deep and 1.80 m wide), the other rectangular (0.40 m deep, 1.20 m wide). The space between them and the north wall of the chapel was occupied by

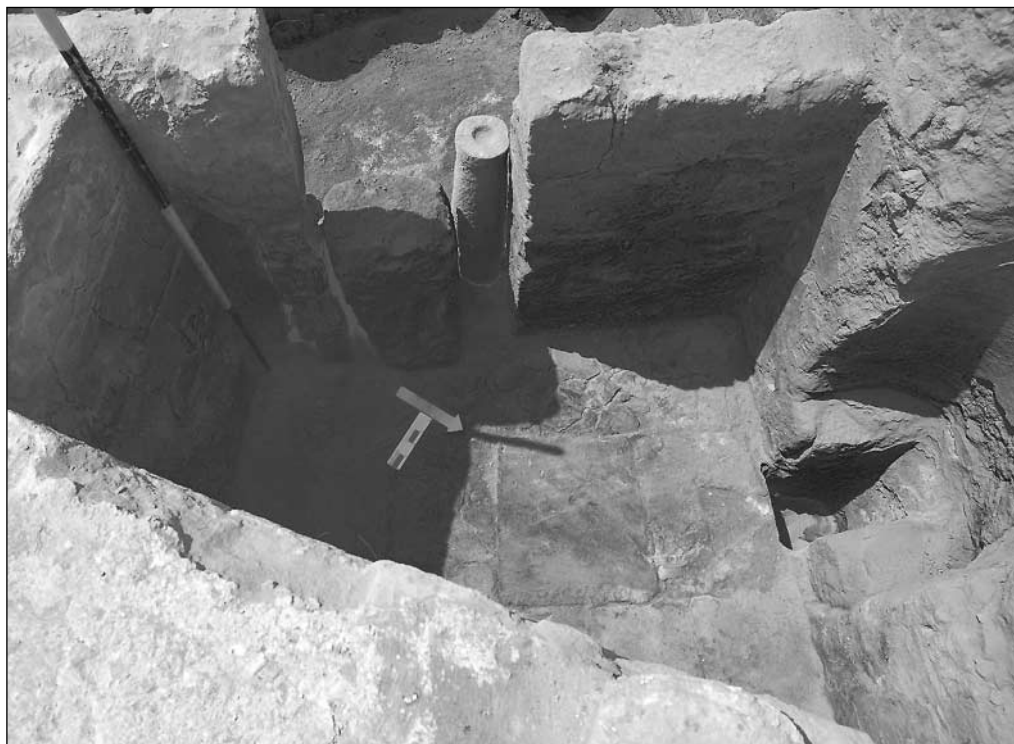
Fig. 5. Blocked passage between alleged chapel and small next-door room. Note opening of a channel in the wall of the room on the right (Photo J.M. Kucy)

a small chamber paved with limestone slabs, entered from a narrow passage leading from the west. This passage was later blocked with a piece of destroyed wall and a granite column (diameter at the base 0.22 m; height 0.85 m) incorporating a base and shaft which narrowed toward the top [*Fig. 5*]. Its shape and the depression for a bowl in the top of the shaft indicate that it had served as the foot of a washbasin. Nearby, by the north wall of the chamber, a small channel was discovered, presumably intended as a means for discharging water from a washbasin that had once stood there and which served liturgical purposes in the chapel.

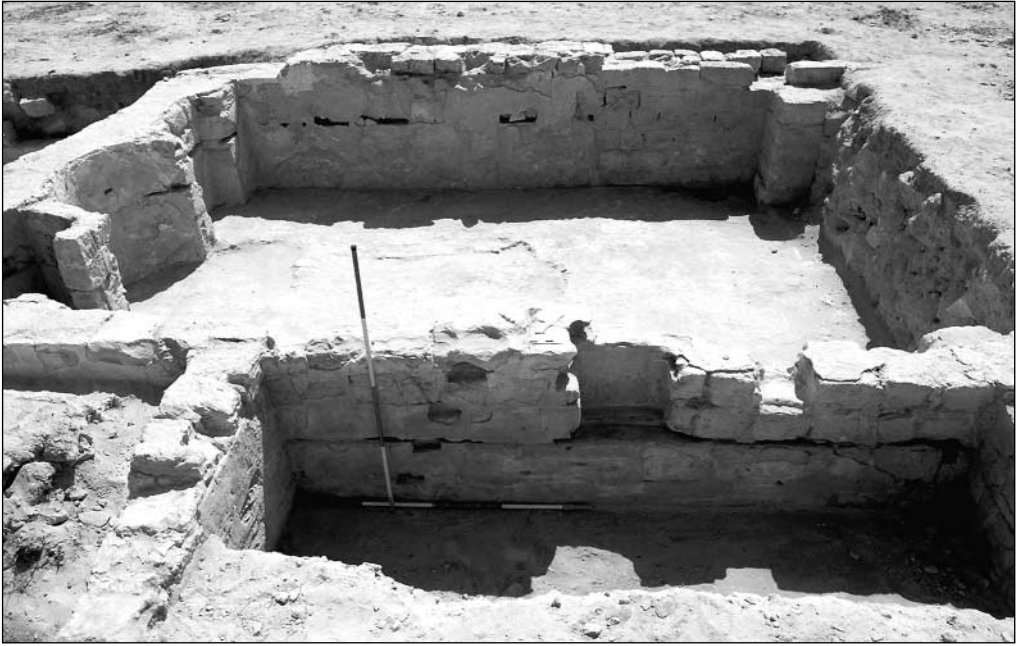
Fig. 6. Evidence of a staircase leading to the gallery in the northern aisle. View from the north (Photo J.M. Kucy)

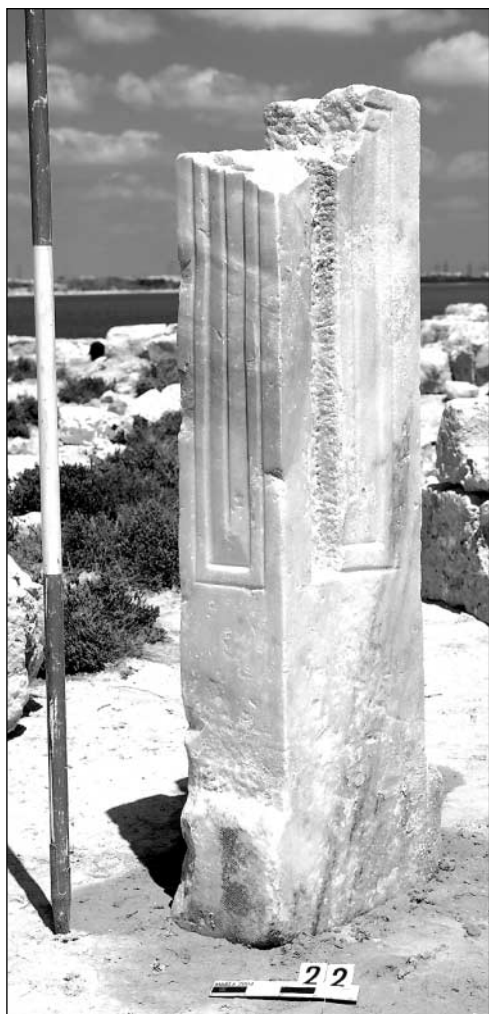
Fig. 8. *Chancel post from the altar, recovered from underlying rubble*
(Photo J.M. Kucy)

The bottom of the kiln was explored further down in order to remove another chancel post standing inside it. This element (H. 1.30 m; W. 0.21 m) differs in size from the pillar found last year; it also bears evidence of reuse [Fig. 8]. Originally, it may have flanked the entrance to the bema, but was later moved to the corner of the balustrade, as indicated by modified profiling with secondarily cut grooves for mounting screens. It adds to the list of finds testifying to alterations introduced in the interior decoration of the church.

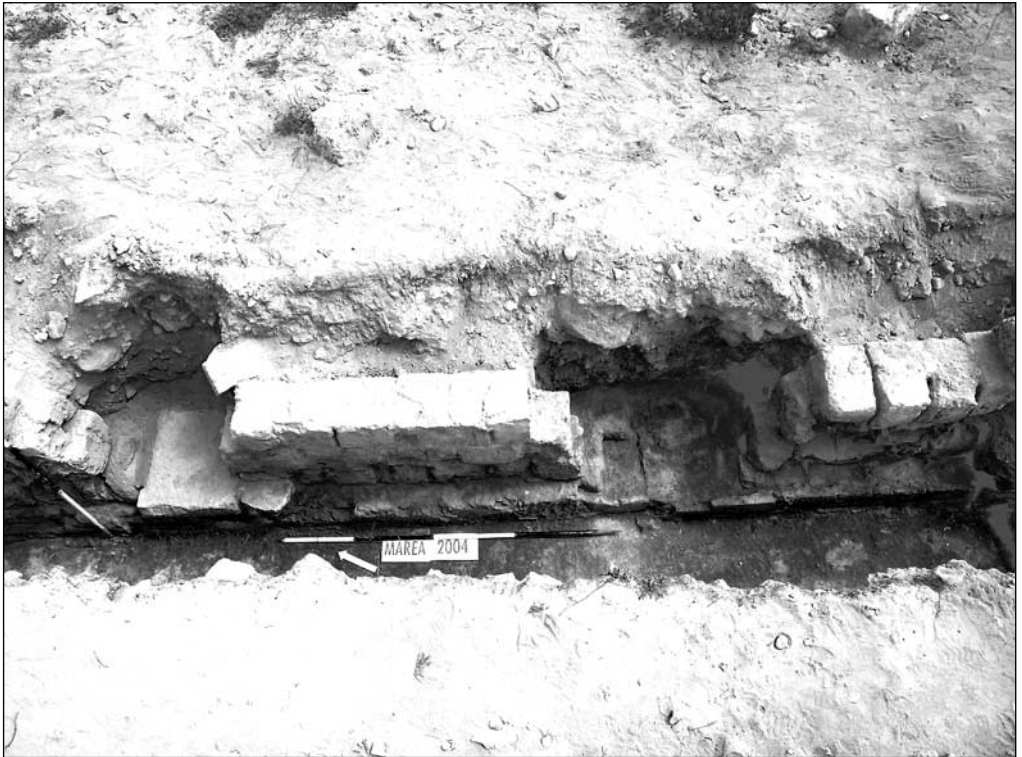
Fig. 9. Main entrance in the west wall of the basilica. View from the west (Photo J.M. Kucy)

Another objective of this year's investigations was to locate the main entrance to the basilica, believed to be in the west wall of the building. Excavations in this part of the church revealed at a depth of about 1.20 m below the preserved top of the walls, an entrance 6.40 m wide, clearly divided by two pillars (evidence of one of these pillars was preserved on the threshold). Later the space between the two pillars was blocked, thus forming two doorways of a width of c. 1.10 m each [Fig. 9]. Under the threshold, used as a support under a slab, was a small, undamaged marble Corinthian capital. The pavement

was laid 0.60 m below the threshold. Leading to the entrance from both north and south were three steps. Above the steps on the north side traces of burned ground were found – evidence of a Bedouin fire. The layer of burning yielded over 50 marble tiles coming from the decoration of the basilica, mostly square, hexagonal and triangular pieces. The fill further yielded two fragments of plaster giving an idea of what the ceiling could have been like: one with impressed bunches of reeds on the reverse and the other from a corner with impressed images in the negative of the construction supporting the roof.

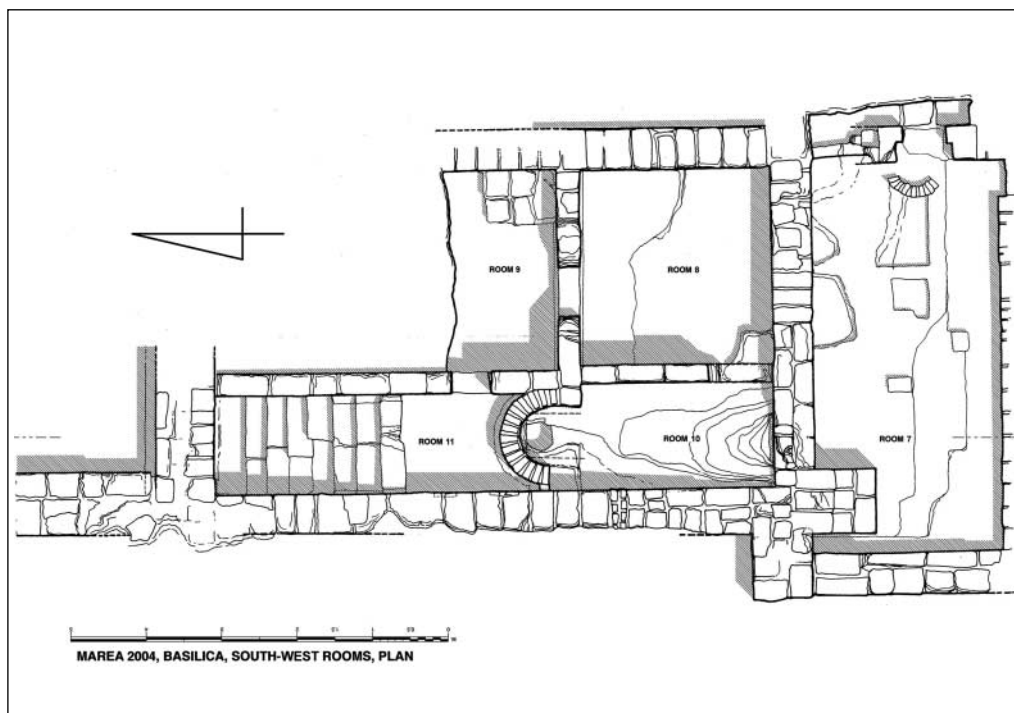
Fig. 10. Rooms beyond the southwestern corner of the basilica
(Drawing B. Wrońska-Kucy)

Explorations this year also covered the area beyond the southwestern corner of the basilica. A series of rooms adjoining the south wall of the church was cleared. On the south, they were closed off with an interlocking wall [Fig. 10].

Directly behind the aisle of the church there was a set of six steps leading to an upper level (room 11). Under the steps on the south side, at a depth of 1.50-1.60 m, a rubbish dump was discovered. It has not been fully explored yet, but already it has yielded a huge quantity of *opus sectile* tiles [Fig. 11], of differently colored marbles, as well as tiles ready to use for floor inlays. Other finds from the dump included discarded fragments of bone inlays used in

the decoration of boxes (furniture?), oil lamps and a considerable quantity of loom weights. Indeed, the latter category of finds can be found scattered all over the basilica, even in the crypts of the apse excavated last year. The pottery found in the dump is dated to the 6th-7th century. Ledges recorded in the west wall of room 11 corresponded to another set of steps, parallel to the first one described above.

interesting finds of the season. The chamber is 2.70 by 2.50 m and had two floors: a paved floor of limestone blocks c. 1 m below the preserved top of the walls and another floor, this time of lime mortar, underneath it. On the partly preserved upper pavement, more than a hundred bronze coins were found,⁷ as well as more than 30 handles of lamps from a *polycandelon*.⁸ This last pavement may have been stabi-

lized on a stone sub-structure: the surviving fragment was found to have an underlying slab of marble (which turned out to be decorated with a wreath in relief). Directly adjoining the chamber on the north is a backroom (room 9), still to be explored, apparently connected with the first room via a passage that was later blocked. Finds from this backroom: two bronze pieces, used for weighing coins

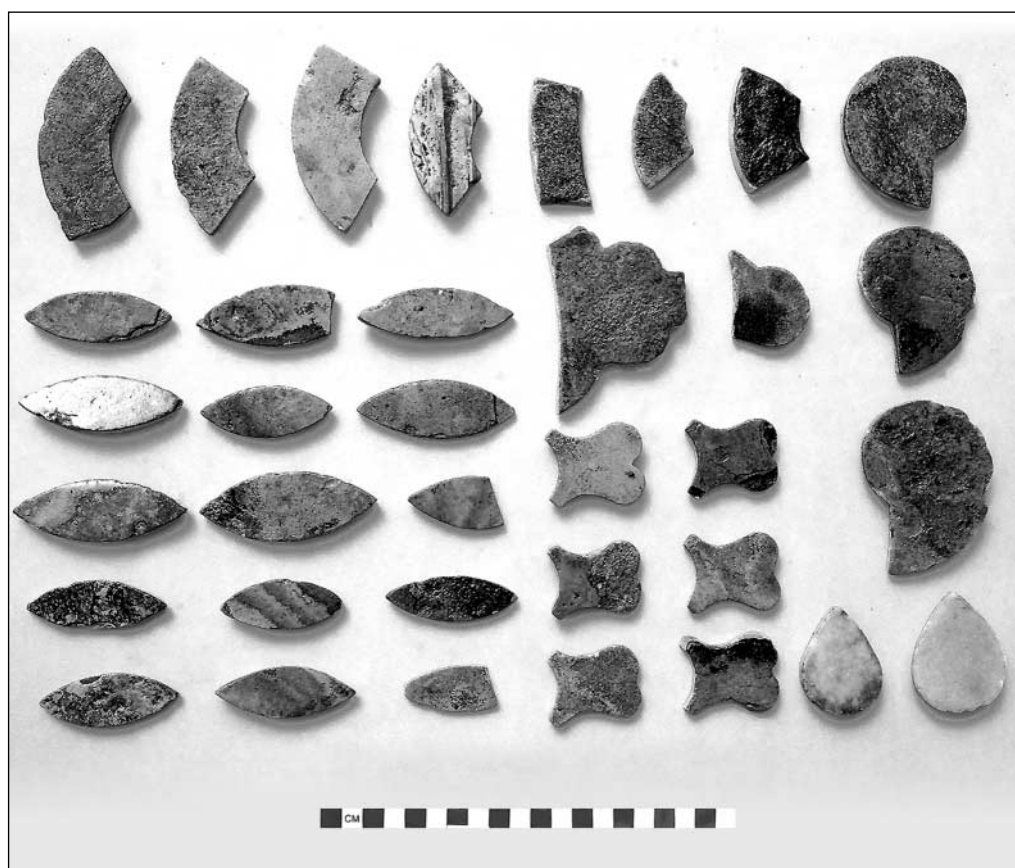
Fig. 11. Collection of marble opus sectile tiles from the basilica area
(Photo J.M. Kucy)

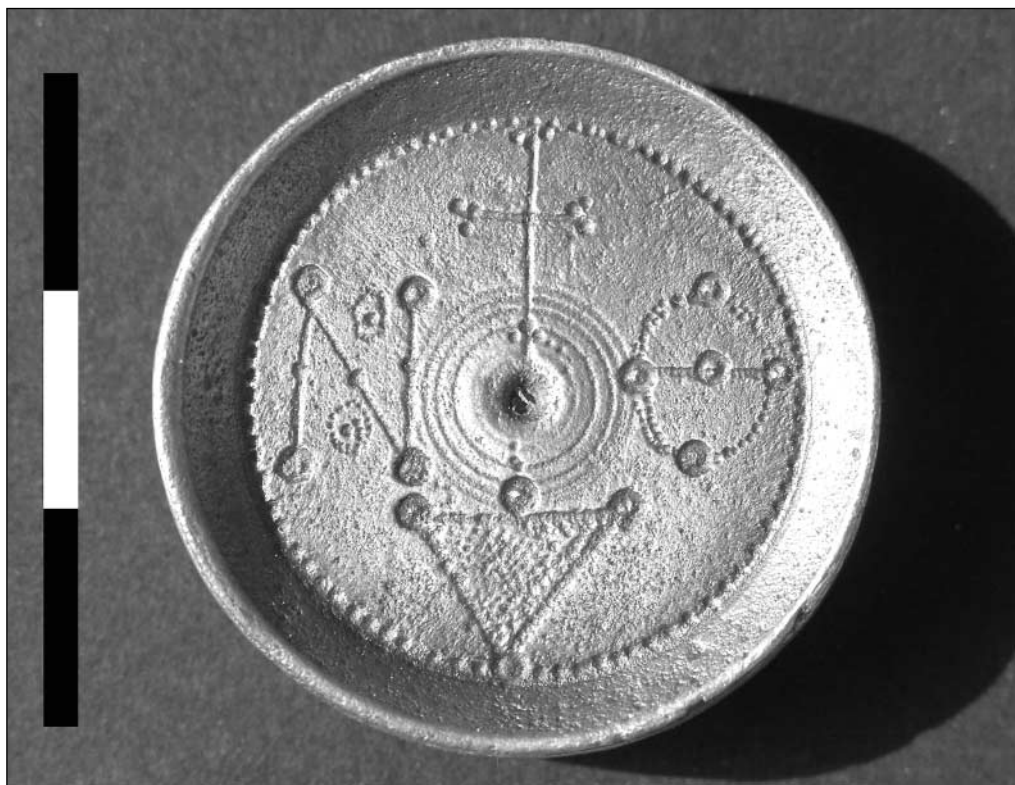
Fig. 12. Coin weight
(Photo J.M. Kucy)

[Fig. 12], found on the floor, suggest the potential function of this complex as a sort of exchange office for various foreign monies brought by the pilgrims arriving through the port here from all over the Mediterranean. This would also explain why so far no coins of other than Alexandrian issue have been found in our excavations.⁹
