# THE LION OF ALLAT IN PALMYRA NEW MUSEUM DISPLAY PROJECT

Bartosz Markowski

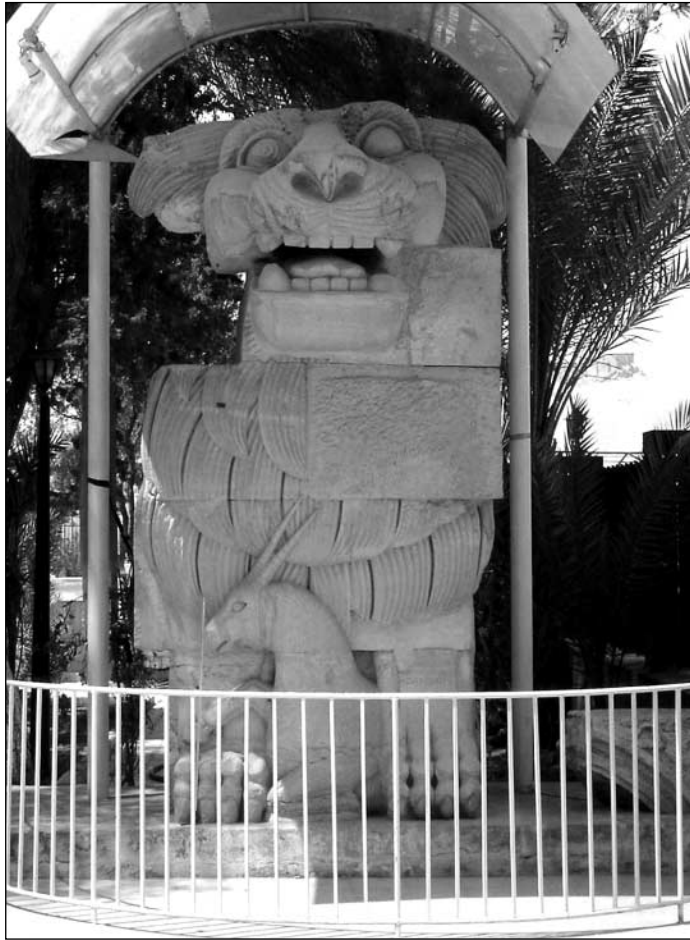
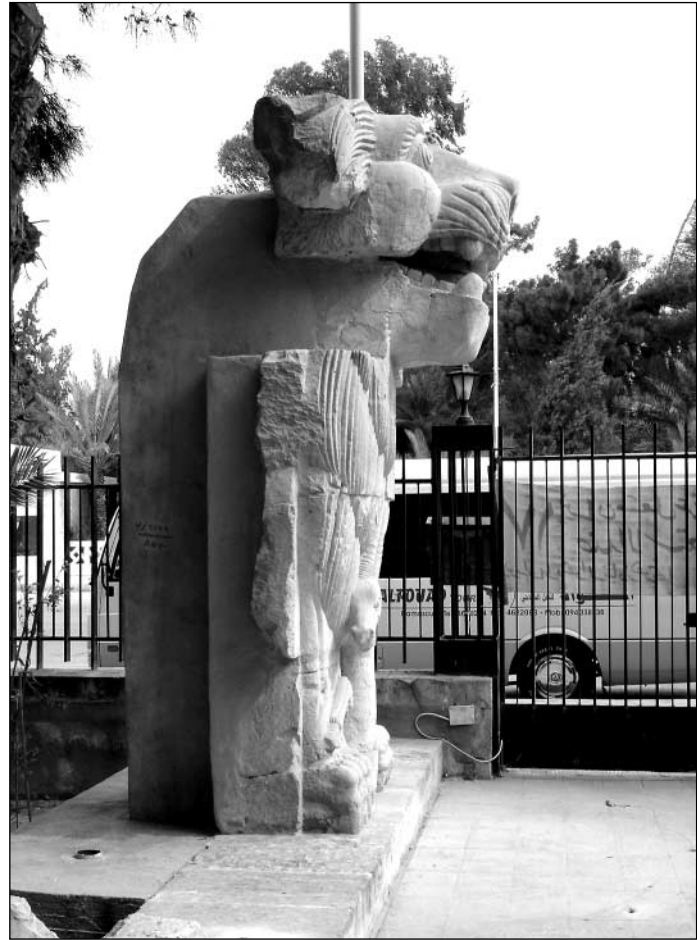
After 25 years, the display of the statue was found to be inadequate [*Fig. 1*]. Indeed, problems had appeared already during the remounting when the lion tilted forward dangerously, threatening to collapse. A concrete counterweight was added at the back of the statue to counter the tilt, giving the lion an unbecoming hump in effect. Recently, monitoring of the stone surface noted considerable cracking and disconnection of fragments, resulting from the statue's shaken equilibrium. The scaly cracking of the blocks under the lion's jaws seemed to be the most serious problem, suggesting that the head was pressing too heavily on the edges of the blocks.

Fig. 1. Lion statue from the Allat temple now in the Museum of Palmyra, before conservation in 2005, front and lateral view (Photo B. Markowski)

In 2000, a project was presented for a new display of the statue. It addressed two issues, one of which was to recreate the ori-

ginal form of the lion as a relief representation. The other question was to design a supporting construction that would ensure proper statue balance, while satisfying accepted aesthetic standards of reconstruction. The statue had to be dismantled and remounted on a new foundation connected to a reinforced concrete wall backing the sculptured fragments and acting as a counterbalance for the forward tilting tendency. Stone blocks on either side of the lion were supposed to imitate the wall, against which the statue must have been displayed originally. The new restoration project also called for a reconstruction of the missing curls of the mane in order to improve the overall aesthetic effect. Two of these missing elements with carved curls had been replaced in the past with unworked blocks and the third had not been restored at all.

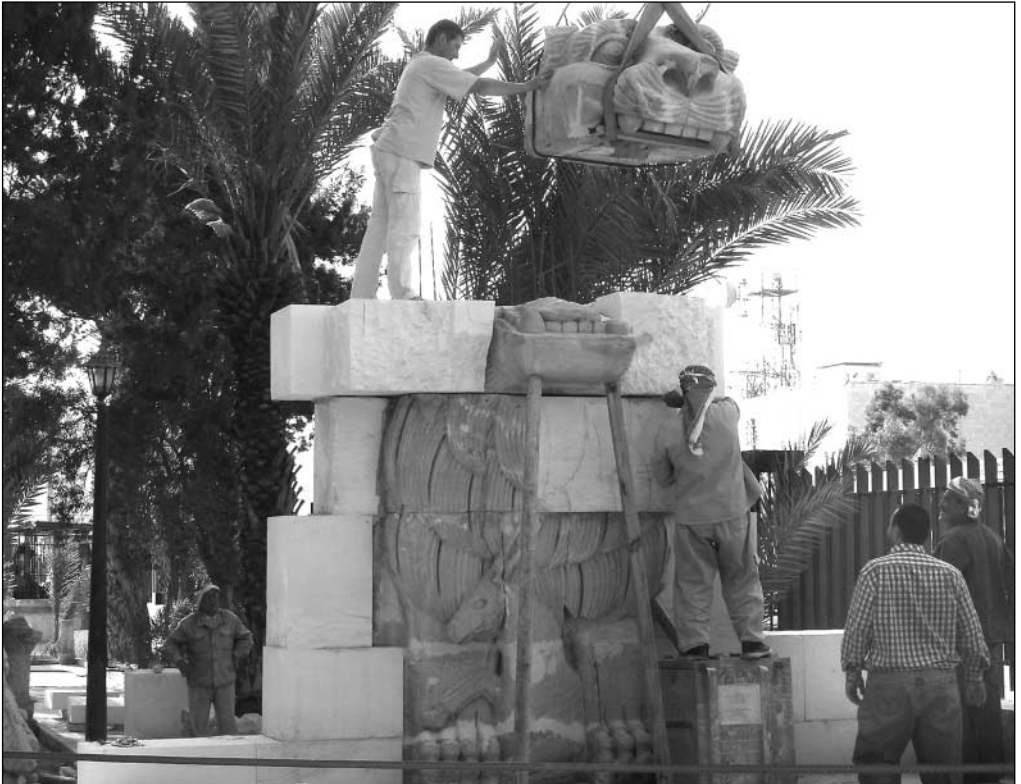
Once all the elements of the statue had been refitted [Fig. 2], sculptural work on the front progressed simultaneously with building the bearing construction at the back. Each block was fitted with from one to three stainless steel rods ( $\phi$  14 mm), inserted at an angle of  $45^{\circ}$  downward, which should reduce the thrust on particular joints. Each of the 24 rods was bent in copy of the 13 pieces of ribbed steel reinforcement in the wall ( $\phi$  12 mm). Wood scaffolding was then put up and the reinforcement poured with concrete. The contacting surface of the

Fig. 2. *Lion statue from the Allat temple during refitting of the elements*  
(Photo D. Wielgosz)

limestone blocks was first impregnated with c. 10 l of 5% PARALOID B72 in toluene. The concrete wall was 1.30 m long, 3.10 m high and had an average thickness of 0.25 m. Wooden beams shored up the statue from the front until the concrete had set. Once the concrete had dried, the scaffolding was removed and the surface floated with a sand-and-white-cement mortar.

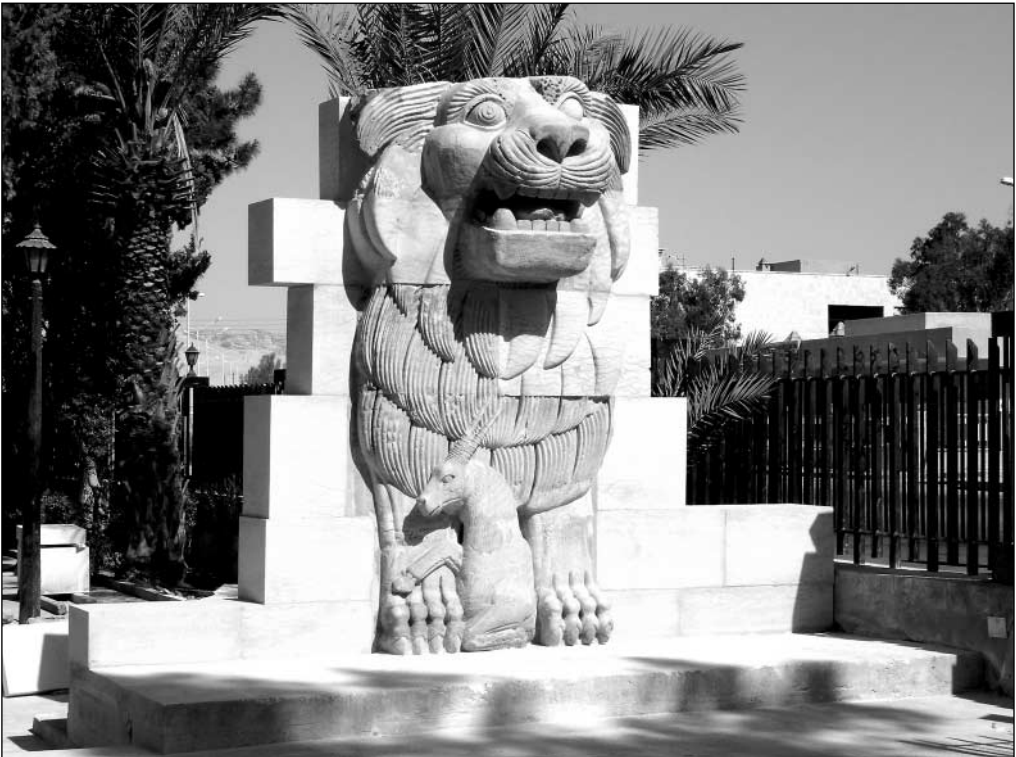
In the effect of the work, the Lion of Allat was restored in imitation of its original appearance [Fig. 3]. It is no longer a statue in the round removed from its building context, but fulfils the design of the ancient artist who wanted it to be a relief representation jumping out from a wall. Its

*Fig. 3. The Lion of Allat after conservation  
(Photo B. Markowski)*

appearance in past years with the huge mass of concrete at back must have been misleading to visitors and clearly had nothing to do with the original lion. The new bearing construction of the statue fits into the thickness of a wall made of new limestone blocks, forming a uniform surface at back. The concrete wall to which all the stone blocks were anchored is connected integrally with stainless steel reinforcement with the foundation, thus

guaranteeing full and permanent stability of the structure. After color merging with the patinated yellow color of original blocks, this bearing wall attracts virtually no attention. The improvised wall, erected of new blocks, and the reconstruction of the missing curls of the mane ensure viewers' capability to appreciate the integrated and harmonious composition of an ancient sculpture and leave no doubt as to which elements were original.
