# MAREA

## SIXTH SEASON OF EXCAVATIONS

Hanna Szymańska, Krzysztof Babraj

*The sixth season of Polish excavations at Marea lasted from August 9 to September 28, 2005.<sup>1</sup> The objective was to continue the excavations in the basilical church, started in the previous two campaigns (2003 and 2004). These were completed in three areas of the church:*

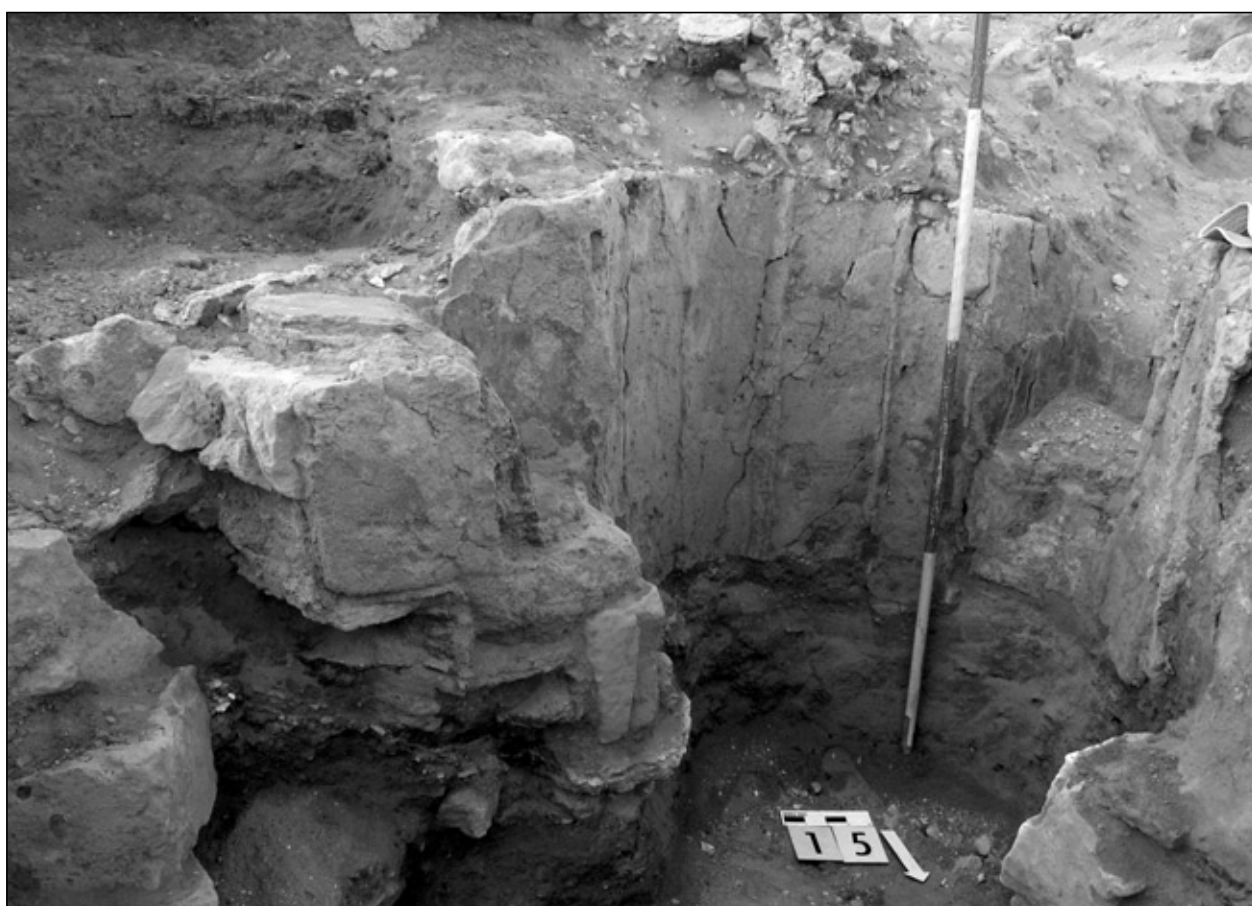
Fig. 4. Baptistery. View from the north  
(Photo J. Babraj)

deterioration, its shape is clearly discernible [Fig. 4]. It belongs to the round *piscina* type (1.08 m in diameter and 1.00 m in depth), with descending flights of steps situated facing each other on the eastern and western sides, two steps on each side.<sup>4</sup> The wall of the basin, preserved only on the south side, and the steps, were made of lime mortar and covered with red, waterproof plaster (*opus signinum*). Vertical imprints are proof of marble revetment on facing the walls. The location of the baptistery below the floor and under or in the vicinity of the altar points to a dating earlier than the

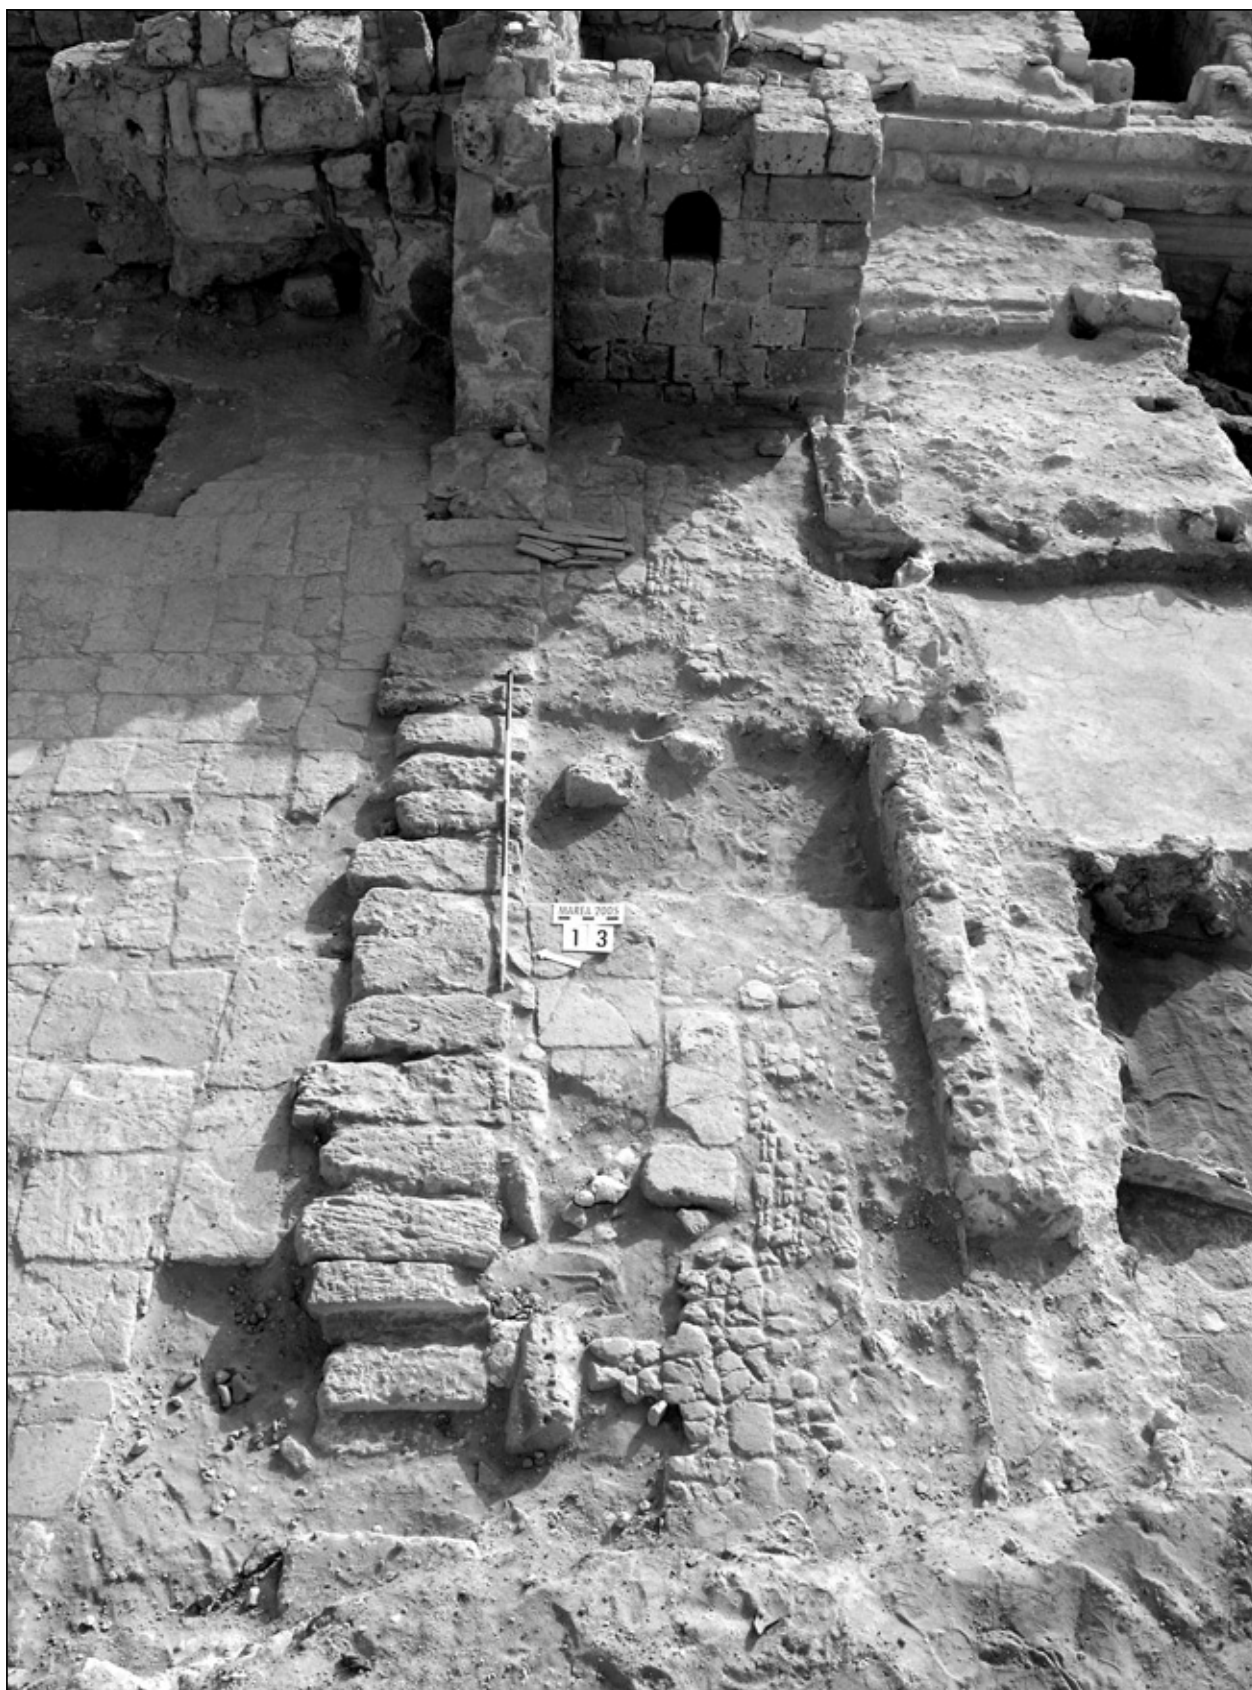
*Fig. 6. Stylobate under a colonnade separating the nave from the northern aisle of the basilica  
(Photo J. Babraj)*

In the northern aisle, yet another part of a floor with tile imprints was uncovered, as well as a stylobate under columns separating it from the nave [*Fig. 6*].

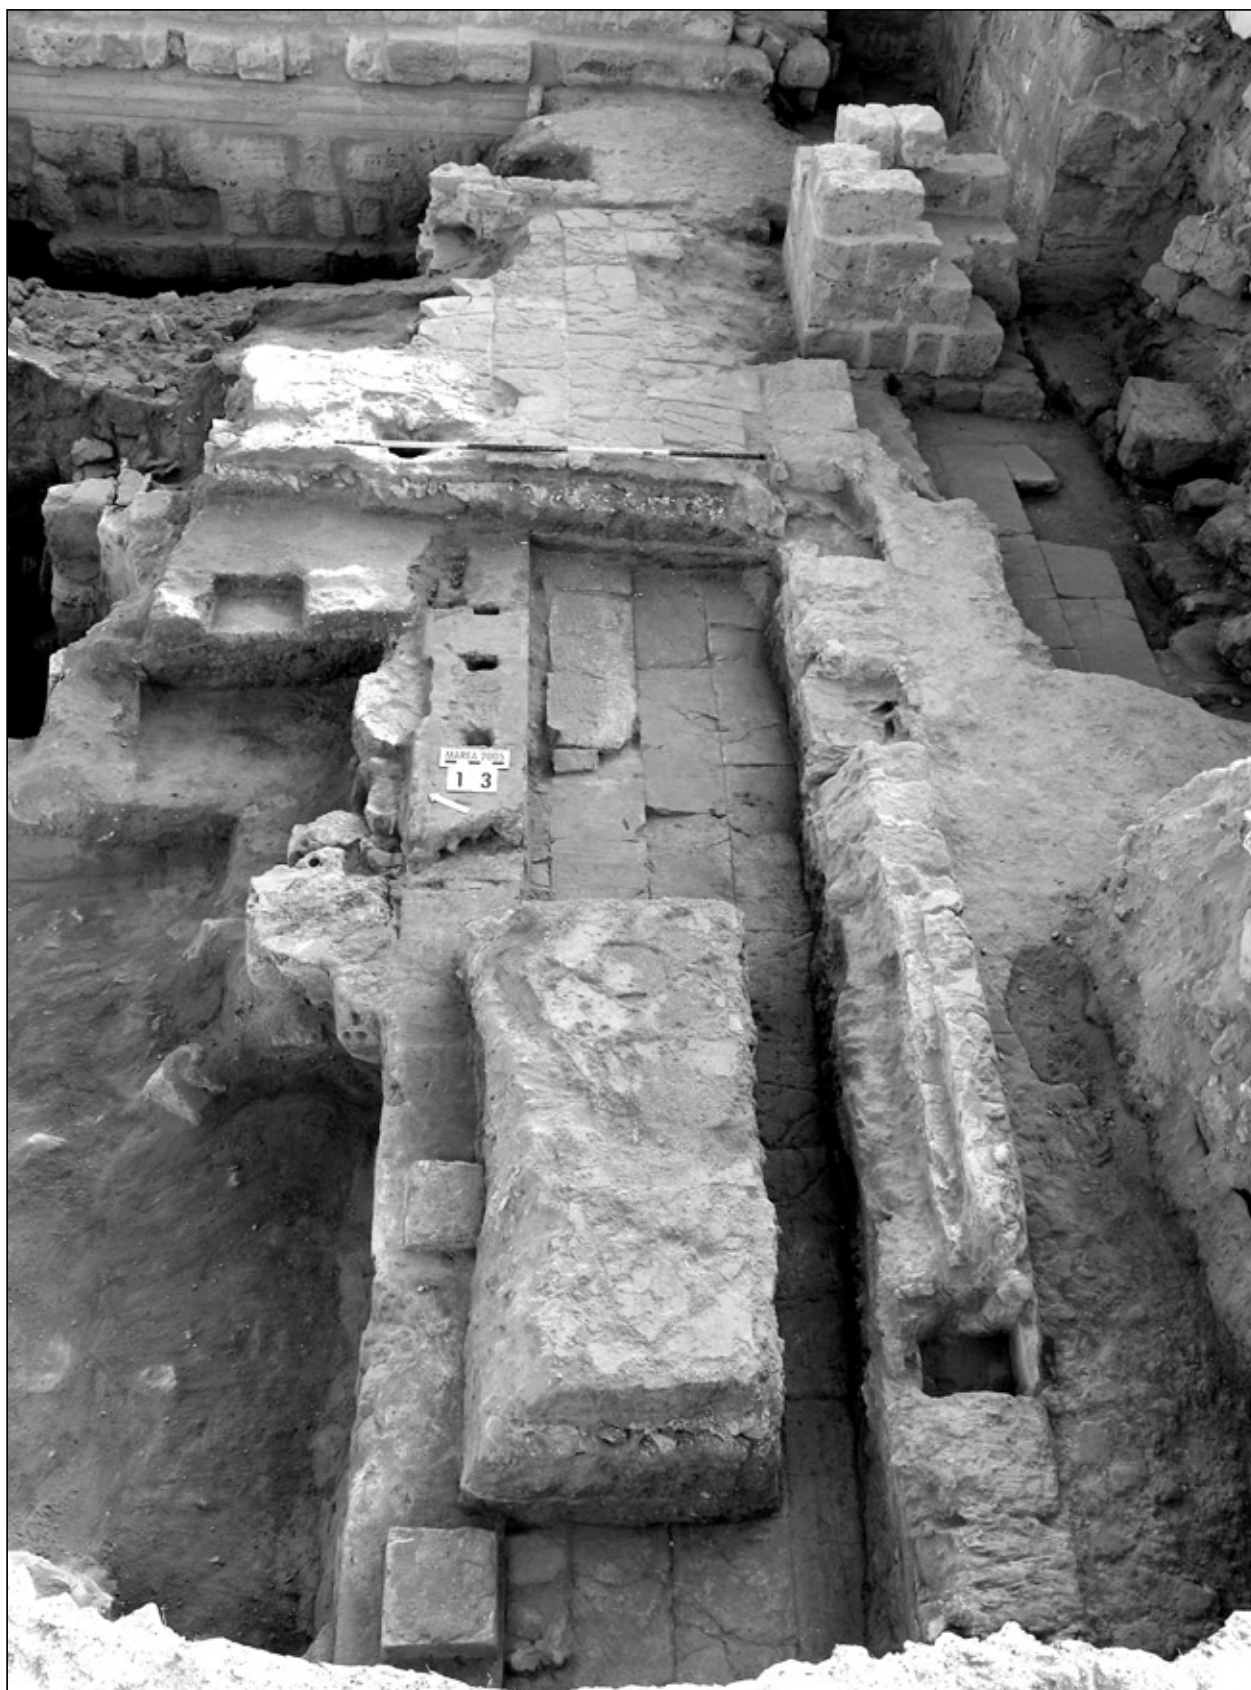
*Fig. 7. Southwestern part of the nave showing remains of two floor levels. View from the west (Photo J. Babraj)*

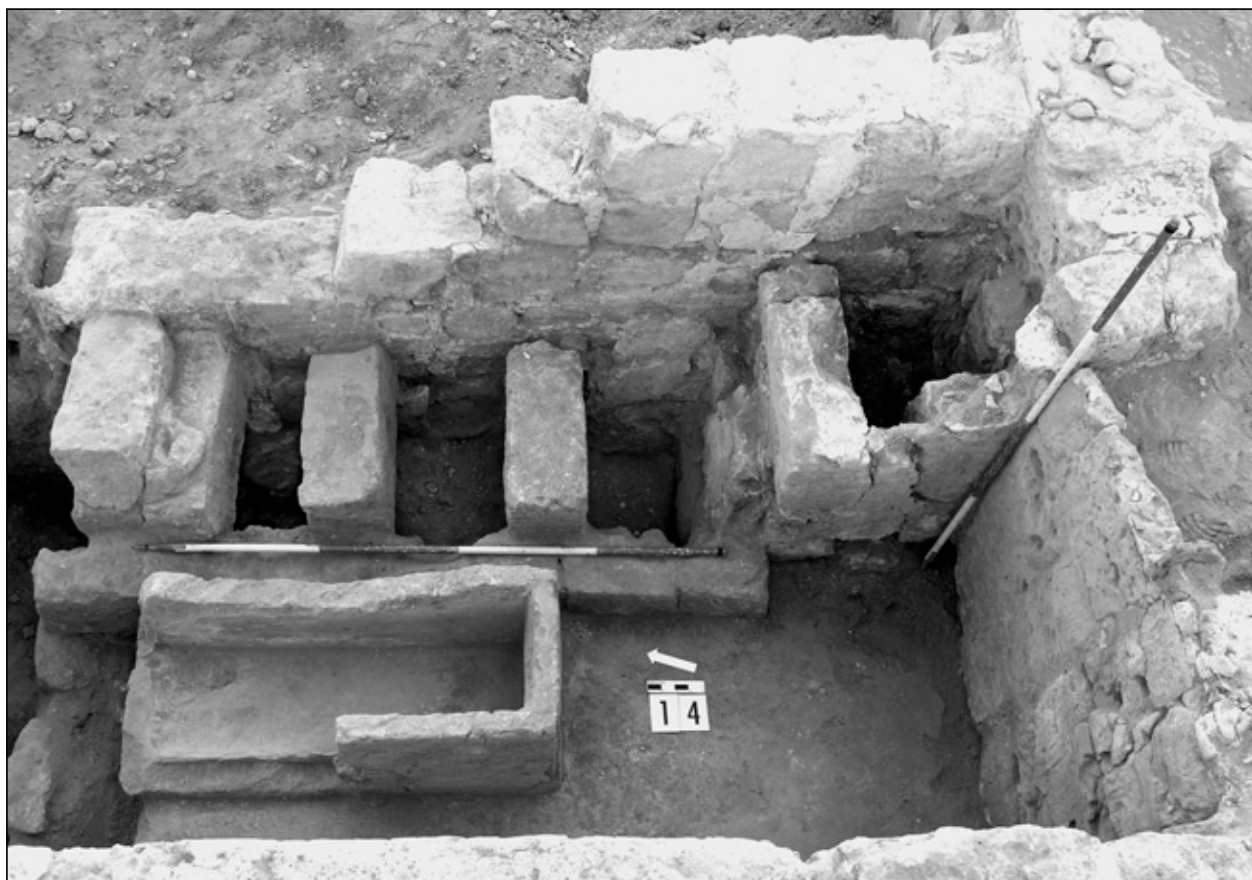
*Fig. 8. Latrine uncovered behind the northern wall of the chapel*  
(Photo D. Dziedzic)

First from the west was a rectangular latrine (4.00 x 2.20 m) [cf. *Fig. 2*, no. 14]. Three toilet seats were aligned along the eastern wall [*Fig. 8*], preserving *in situ* only the blocks supporting the seating, the latter being found in the debris. Two of the

seats measured 0.75 by 0.46 m and 0.40 by 0.20 m. In the southeastern corner, there was a fourth toilet, which was converted into a water tank (?) at a later time. Alongside the toilets there is a stone foot rest, and in front of it a deep and well preserved basin made of stone slabs, measuring 1.40 x 0.80 m, presumably for washing hands and rinsing sponges. Both the inner and the outer walls of the basin were coated with waterproof plaster that bears traces of water stains. A thick layer of *opus signinum* is also visible in the north-eastern corner of the latrine. Originally, the latrine was accessible from the church, specifically from a room situated behind the western entrance to the chapel (to be excavated next year). The second entrance was in the western wall of the latrine. Both doorways were later blocked. The exploration of the latrine, which will also be continued in the upcoming season, yielded many finds, including fragments of a painted Coptic plate with motifs of birds and fish [Fig. 9], two terracotta figurines

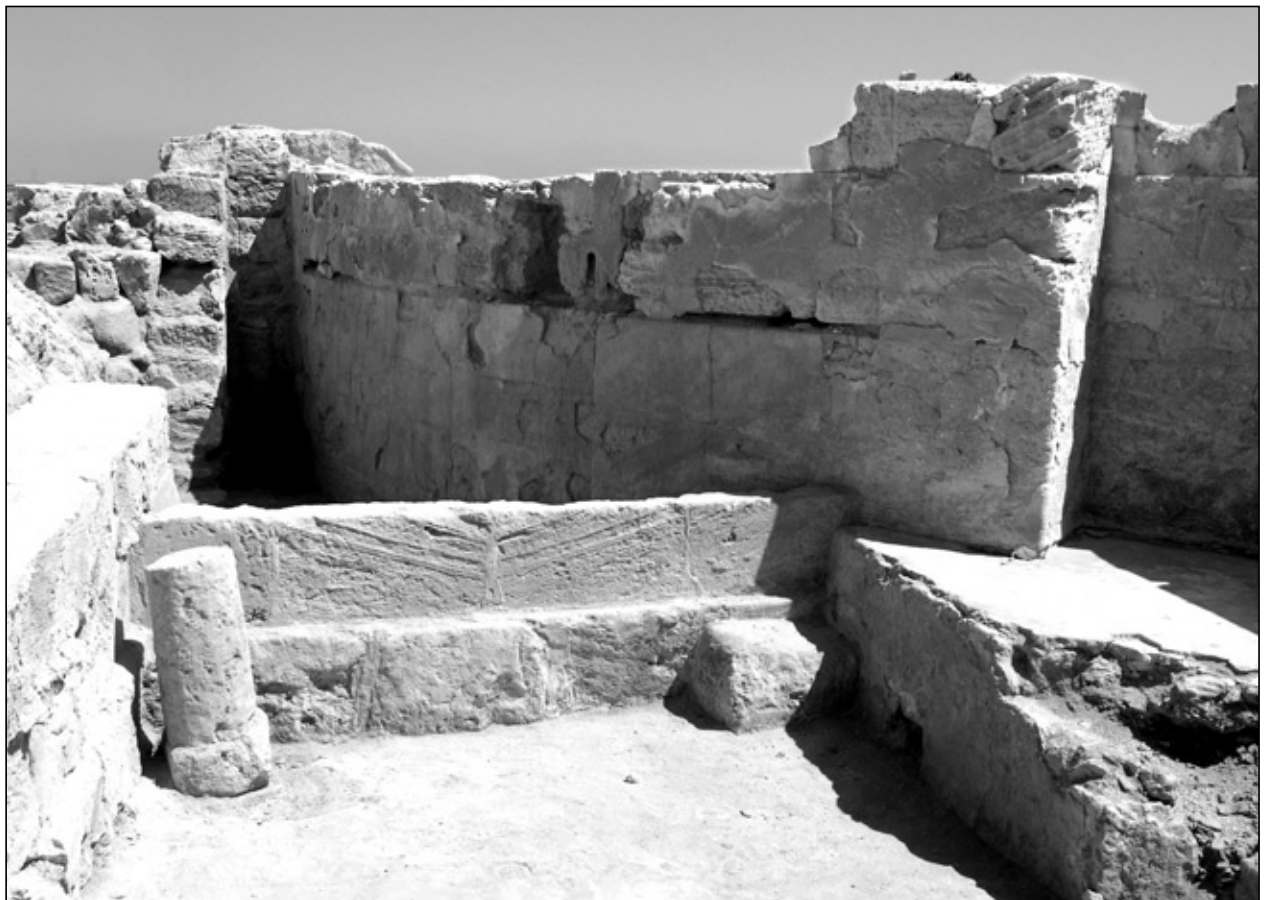
*Fig. 12. Washbasin stand in room 17. View from the west  
(Photo J. Babraj)*

covered with a thick layer of lime mortar sealed with *opus signinum*. Inside they were filled with tiny potsherds, the rounded edges of which suggest water erosion. In the wall between the counters, there are three round openings for wooden beams that probably supported another counter or table (?). In the northeastern corner, there stood a limestone washbasin stand [*Fig. 12*], confirming the utilitarian purpose of the room. The floor was covered with limestone slabs that reached up to the part of the northern buttress added in the second phase, for the building of which another washbasin stand was used.
