DEIR EL-BAHARI

THE TEMPLE OF HATSHEPSUT

SEASON 2004/2005

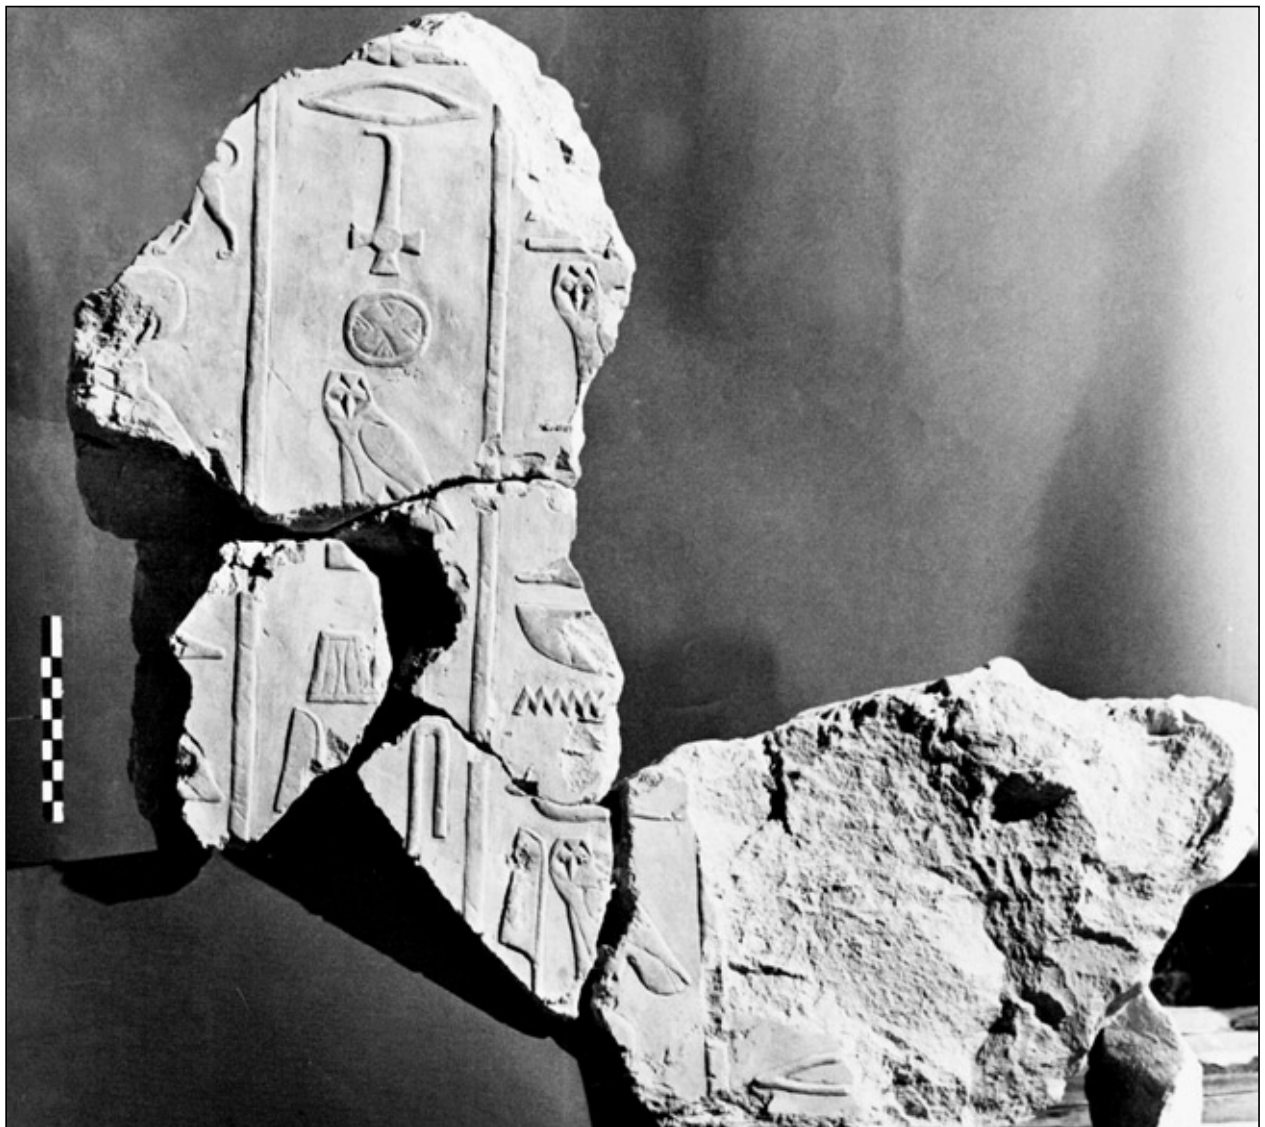
Fig. 4. Royal Mortuary Cult Complex. Chapel of Hatshepsut. Blocks bearing the "Night hours" text (Photo M. Jawornicki)

reconstruction of the so-called "Night hours" decorating the northern part of the ceiling [Fig. 4].

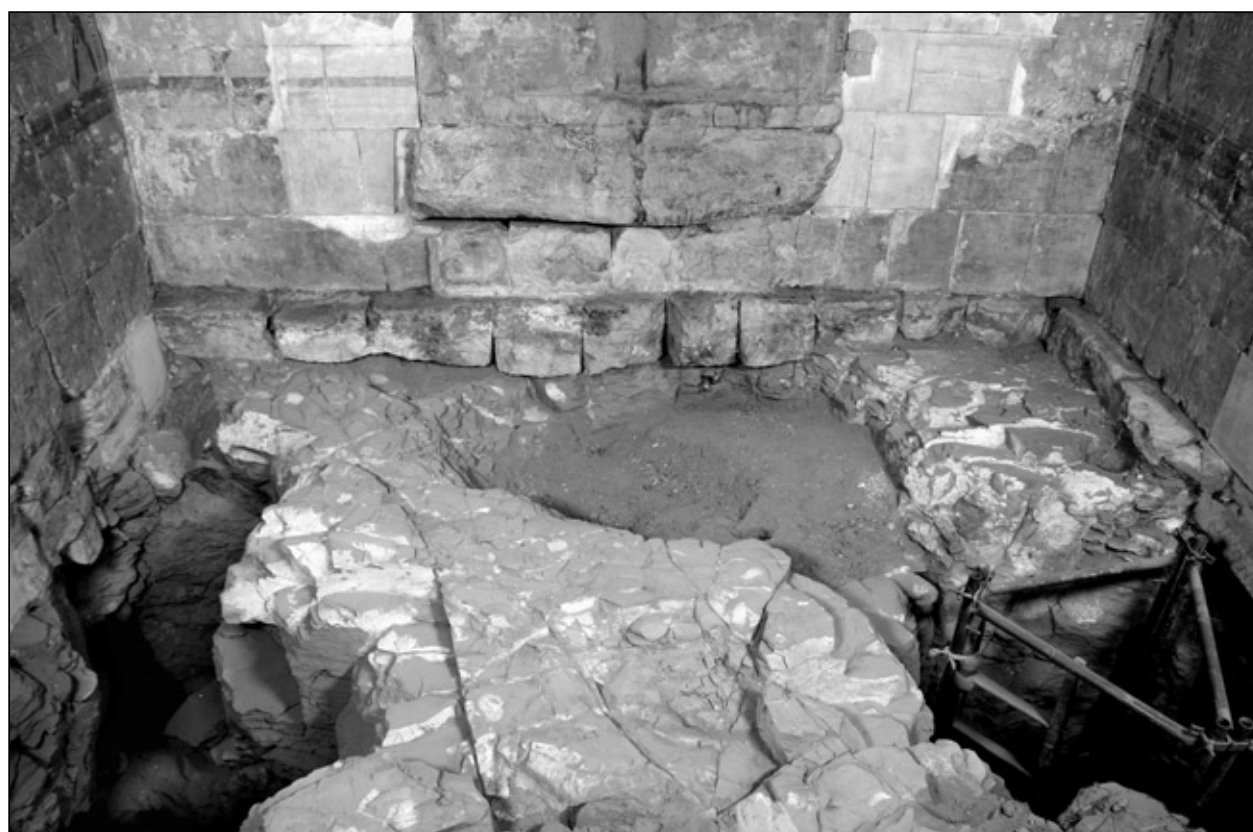
Fig. 6. Chapel of Hatshepsut. Western end with shaft tombs S.7A/82 (right) and S.7B/82 (left); the depression between shafts is proof of the presence of yet another shaft (Photo M. Jawornicki)

Meanwhile excavations were carried out along the entire length of the bottom of the wall. Shaft tomb S.7B/82 of the Third Intermediate Period, located earlier but not excavated,⁷ was now explored [Figs 5, 6]. Following the two seasons of digging in the shaft tombs, it has been confirmed that the tombs had been plundered in modern times. Fragments of several coffins, pottery vessels and cartonnages, found in the two tombs, have been found to match. Therefore, the archaeological material from these two shaft tombs has been documented as one unit.

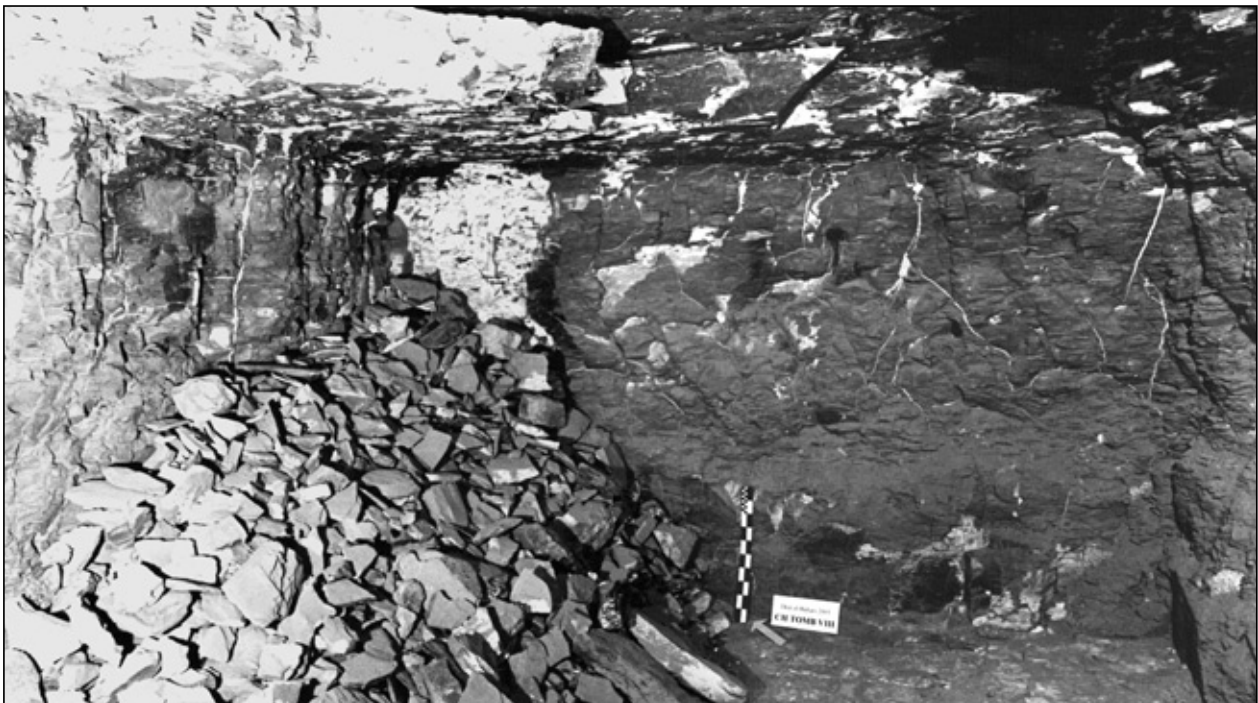
Fig. 7. Chapel of Hatshepsut. Burial chamber of shaft tomb S.7A/82
(Photo M. Jawornicki)

Chapel, deepest of all the shafts explored so far, and led to a burial chamber with a northward sloping floor (maximum depth 6.40 m). The undecorated burial chamber, located on the north side, was 3.80 m long, 2.90 m wide and 1.70-1.80 m high [Fig. 7].

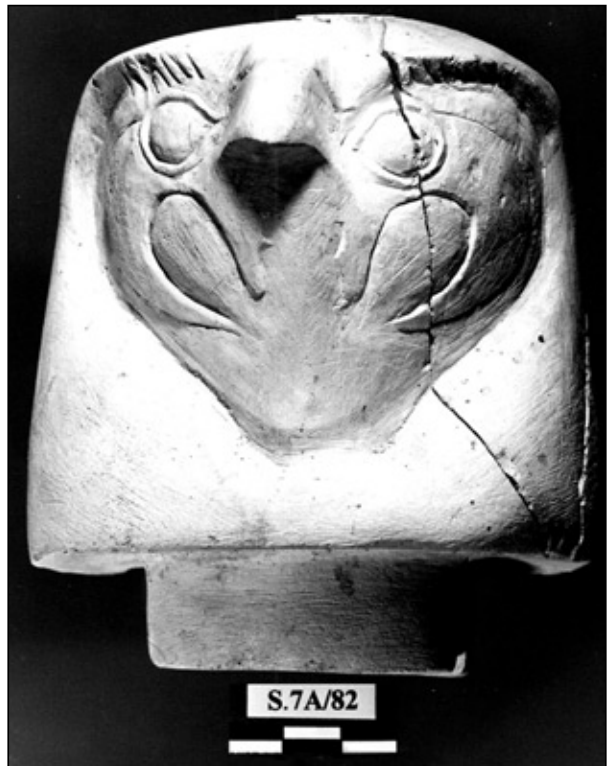
Fig. 10. Top of Canopic jar in the form of a hawk, from the filling of shaft tomb S.7A/82 (Photo M. Jawornicki)

bearing the name of Hatshepsut [Fig. 9], fragments of ushebti and stone Canopic jars [Fig. 10], parts of wooden funerary equipment [Fig. 11], hieratic and Coptic ostraca, very small fragments of hieroglyphic and Coptic papyri, fragments of wooden coffins and linen cartonnages, including small pieces of excellent artistic quality.
