MARINA EL-ALAMEIN

SITE PRESENTATION PROJECT (ARCE/EAP)

PRELIMINARY ARCHAEOLOGICAL REPORT

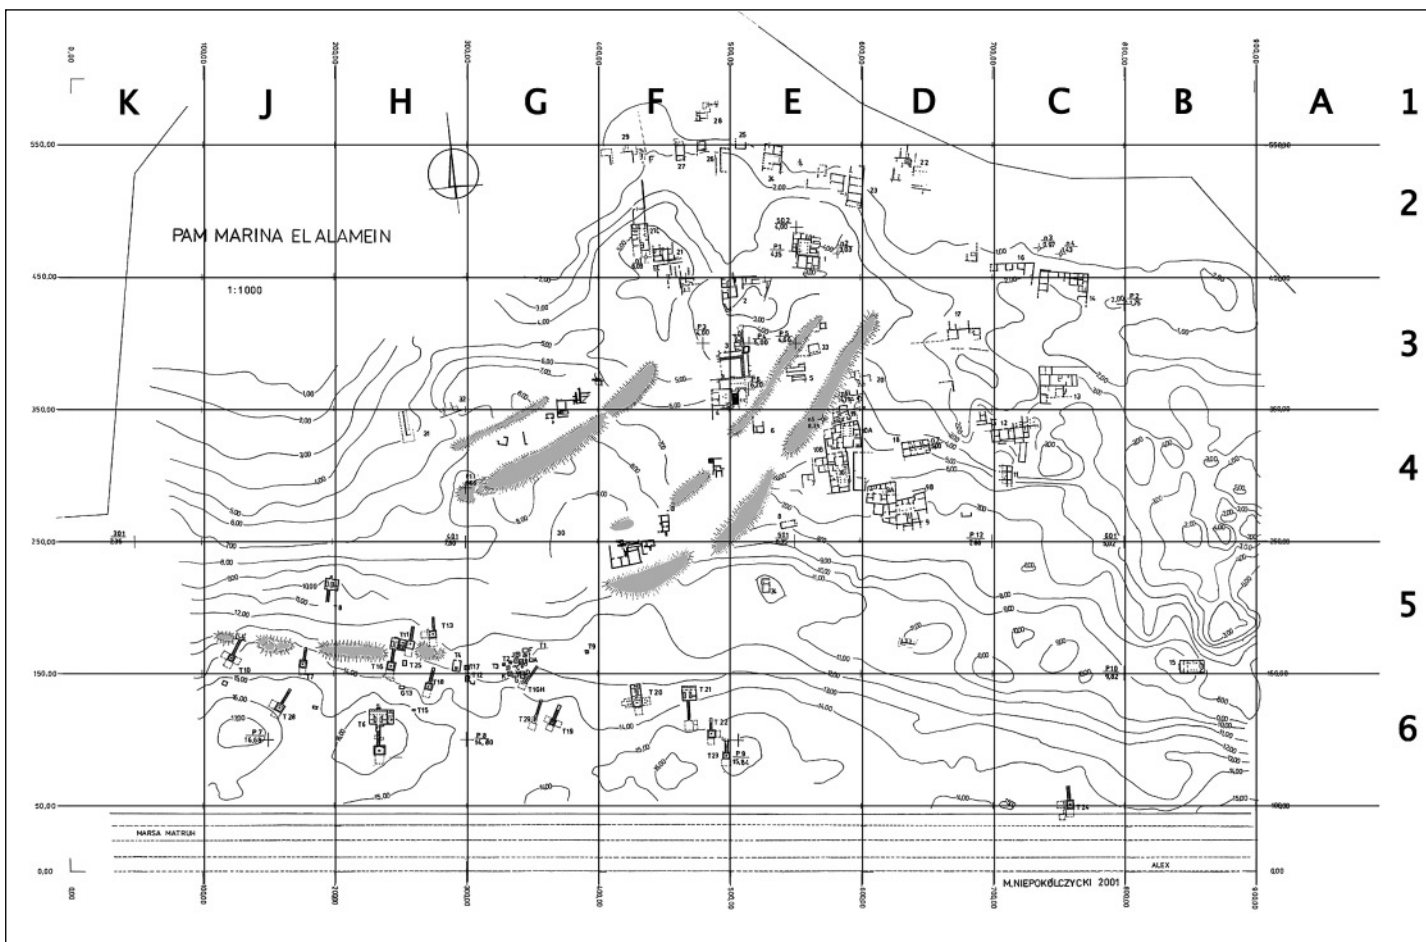
Fig. 1. Plan of the site of Marina el-Alamein introducing a grid of squares and including the results of the MASP survey in 2006; building dumps of the mid-1980s shaded in gray (PCMA archives, updated for MASP by A. Obtuski, U. Wicenciak)

Given the logistics of the undertaking and budgetary constraints, as well as the overall aesthetic objectives of the site presentation plan, the project director ultimately decided to landscape the area [Fig. 1], removing as much of the volume of the dumps as possible and partly backfilling the deep artificial wadis in an effort to render the unexcavated parts of the site more natural to the eye. This decision required full-scale archaeological recording of the bottom of these two cuts prior to their backfilling.

The dumps in question, shaded gray in Fig. 1, appear on either side of two 'cuts', both some 25 m wide, traced under the future streets. They run parallel to one another, a few dozen meters apart. The eastern sides of the cuts were more heavily covered by sand and rubble excavated from the bottom. These mounds were from 10-12 m to 28.50 m wide at the base, rising to a height of from 2 to 3 m. The western-side dumps were smaller and less extensive and actually nonexistent over long stretches, the edges of the cuts being actually in undisturbed ground. All of the dumps presented a characteristic crescent-shaped pattern of ridges, resulting from loaders pushing particular scoops of material before them without any further leveling.

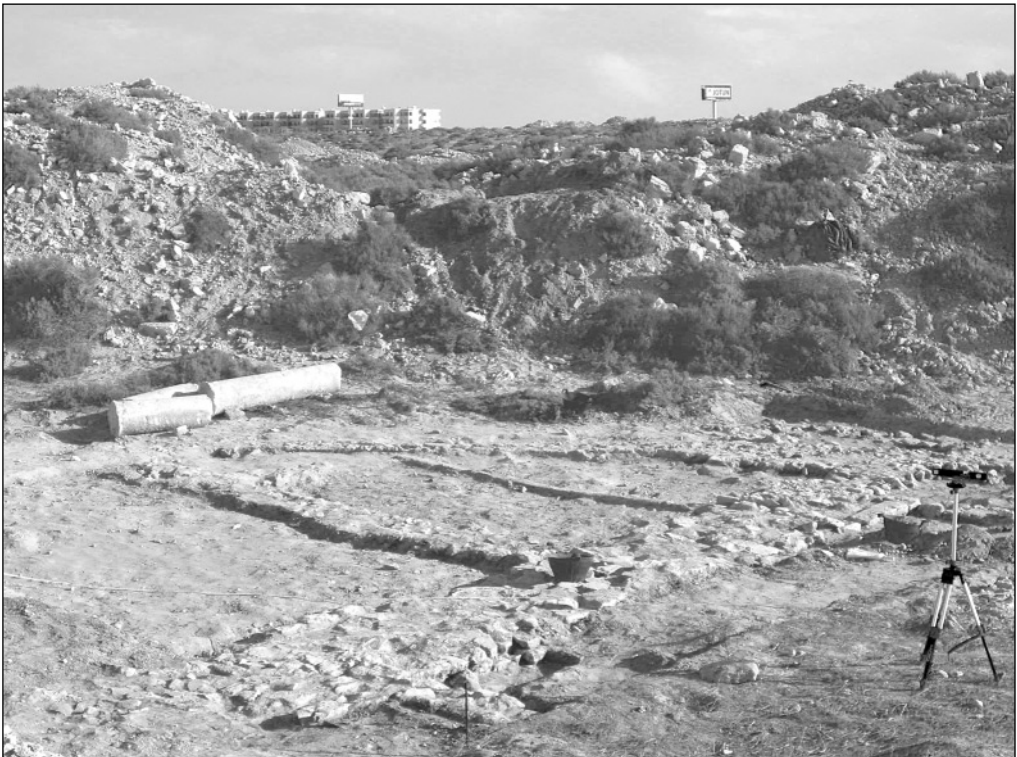
Fig. 2. One of the building dumps and the uncovered archaeological features in the western part of the bulldozed cuts (Tr05+07) (Photo A. Obłuski, courtesy MASP ARCE/EAP)

Tests on a part of one dump demonstrated a classic case of inverted stratigraphy. Ancient remains were dumped at the very top and lying in the open for the past twenty years. Everything underneath was drifted sand, which had previously buried the ruins under a layer one to two meters thick. Loaders had lifted this natural layer (destroying in the process ancient walls and carrying with it modern debris), stopping for whatever reason at what proved to be Roman-age floor levels

[Fig. 2]. The occupational levels from the bottom of the 'cuts' ended up on top of the mounds. Moreover, with the length of the traced streets being between 130 and 180 m, it is only logical to assume that particular sections of the mounds contents corresponded to archaeological features found at the bottom of the cut in the immediate vicinity. Fieldwalking of the mounds largely bore out this assumption. Most obviously, there was a World War II bottle coming from the whereabouts of military trenches in the western of the cuts and a piece of water spout, which proved to fit a pipe in the wall of a structure uncovered in the eastern cut.

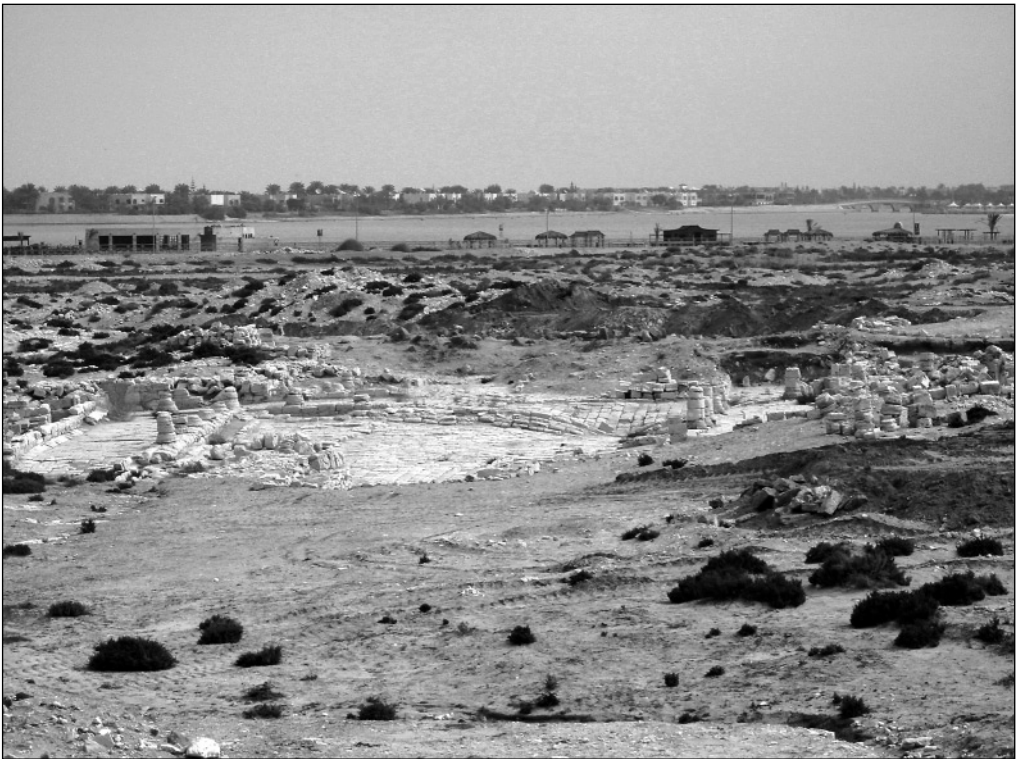
Fig. 3. *The eastern side of the main town square following removal of the dump, view from the west (Photo I. Zych, courtesy MASP ARCE/EAP)*

equipment. Once the tumbled debris of the underlying building started to appear on the surface, work in this area desisted [Fig. 3].² Finds from the disturbed surface layer in this area included sizable quantities of broken marble tiles and slabs, possibly from wall revetment and floor paving, a lion's leg of limestone which could have been a bench support (in analogy to the supports found in the South Portico), and several pieces of architectural cornice decoration matching pieces found earlier in the area by the archaeological mission and obviously belonging to the

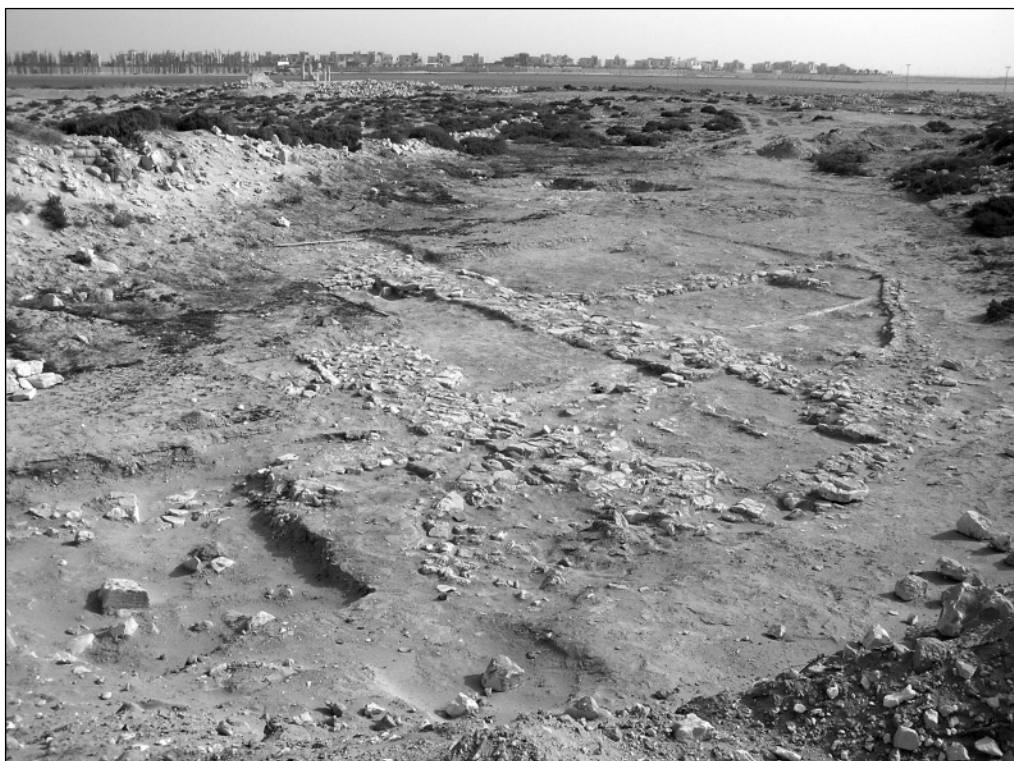
Fig. 5. View of the western cut looking north – ancient walls bulldozed at floor level; the pit at center back marks the position of a sunk exedra (Photo A. Obtuski, courtesy MASP ARCE/EAP)

The backfilling and landscaping operation took into account the results of the survey. In the case of the western of the 'cuts', the presence of a large exedra of unknown function and attribution, its location on the main E-W axis of the town, and the nearby presence of marble columns and bases – on the dump but logically

originating from this structure or close to it – prompted a decision not to cover the entire northernmost end of the cut [Fig. 5]. The exedra was connected with a double set of very thick walls, unlike anything discovered in Marina so far, and for this reason it was decided to leave the area open for regular excavations in the future. Also at the northernmost end of the eastern of the cuts the line of the landscaped slope was receded south beyond the trench, leaving the architecture here open for future excavations should such a project be considered. The backfill where it was accomplished measures from barely a few centimeters to over a meter of sand and

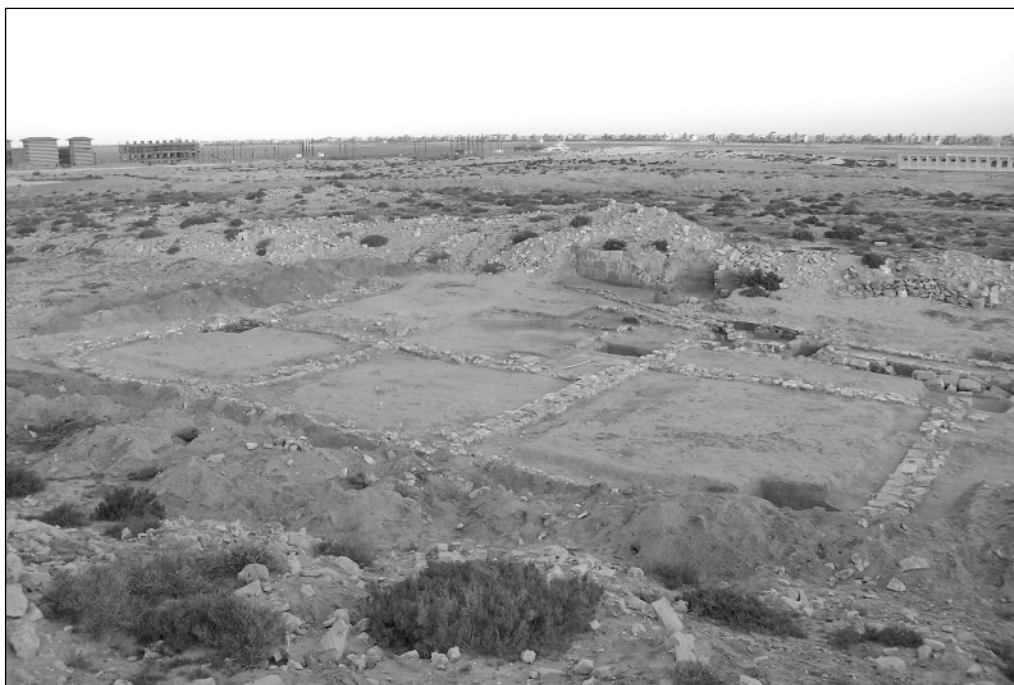
Fig. 6. General view of the cluster of rooms in Tr04 looking west; note wall of ashlar blocks in the west side of the cut (Photo A. Obluski, courtesy MASP ARCE/EAP)

The southernmost cluster of rooms (Tr04), separated by a presumed alley from a structure already outside the survey area, consisted of four units and a small paved area in the center [*Fig. 6*]. Thresholds to at least two of the units were observed. Evidence of destruction in a violent conflagration was present everywhere, including a deposit of objects evidently in use at the time of the catastrophe, composed of a small iron adze mounted on a wooden handle, iron fittings (of a box?) wrapped in plain cloth,³ bronze pyxis lid with hoop handle, terracotta fragment, a varied set of complete bowls, plates and jugs of plain and table wares, a faience bowl [cf. *Fig. 11*], and last but hardly the least, a fine example of a Cretan ivy-leaf lamp [cf. *Fig. 10*]. The combined evidence of this material places the catastrophic event in the second half of the 2nd century AD.

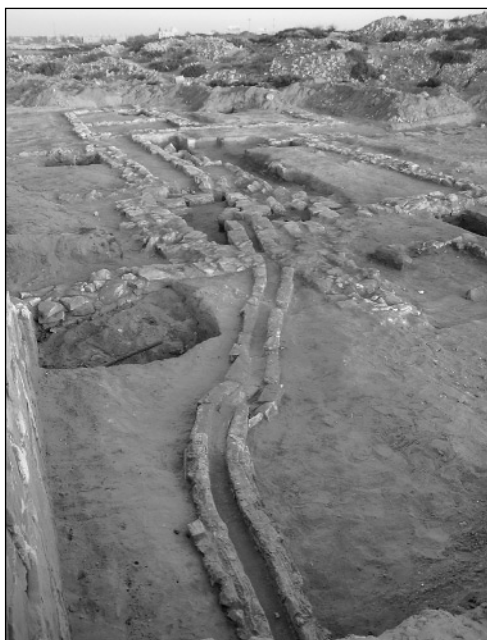
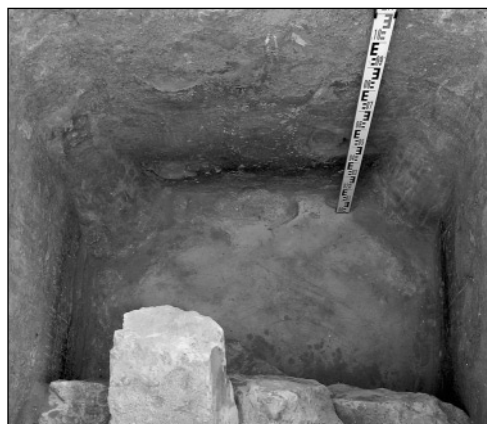
Fig. 7. Channel feeding a cistern in Tr04, view looking northeast (left) and detail of one end of the cistern with water-proofed plastering on the walls and characteristic corner projections (Photo A. Obluski, courtesy MASP ARCE/EAP)

rectangular cistern with a curious sideways projecting extension was introduced, destroying a few house walls in the process. The cistern was probably fed through a channel that meandered somewhere from the southwest. The architecture north of the cistern feature fails to be easily identified for the moment [Fig. 7].

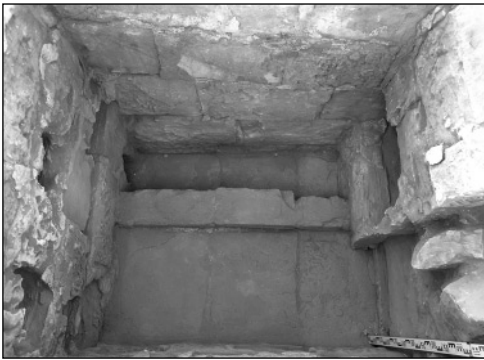
Fig. 8. *Latrine(?) compartment in a building in Tr03, top view. The entrance to the room was from the west (to the right in the photo) and the channel emptied into a street outside through a triangular hole in the east wall. Some kind of permanent seating had been installed above the channel (Photo A. Obłuski, courtesy MASP ARCE/EAP)*

east of this structure) there stood yet another complex (Tr03), of which only the southeastern corner with well preserved latrine(?) was preserved [Fig. 8]. This building or at least the part of it that was recorded within the limits of the surveyed area was built entirely of slabs. Standing walls measured some 1.70 m. With the 3 m or so of tumbled wall slabs that were found lying practically in order immediately to the south of this structure, it gives us a height of at least 4.50 m for the building. Considering the small size of the latrine(?) unit in the southwestern compartment of this structure, one cannot but think of there being an upper floor to this building. The latrine had a paved floor and a waterproofed channel that emptied through a triangular opening in the wall into the open (?) space located to the south. The unit next to it was paved but with no other features to identify its function. A coin found fortuitously in the blocks from the collapsed upper parts of walls inside the presumed latrine suggest that the destruction occurred not earlier than in the earthquake of AD 164.

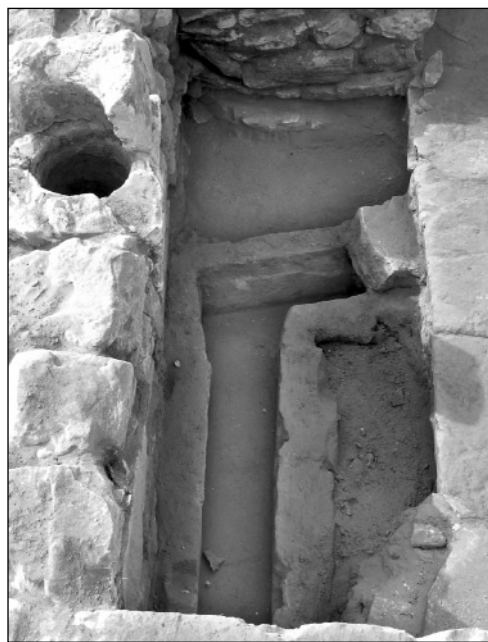
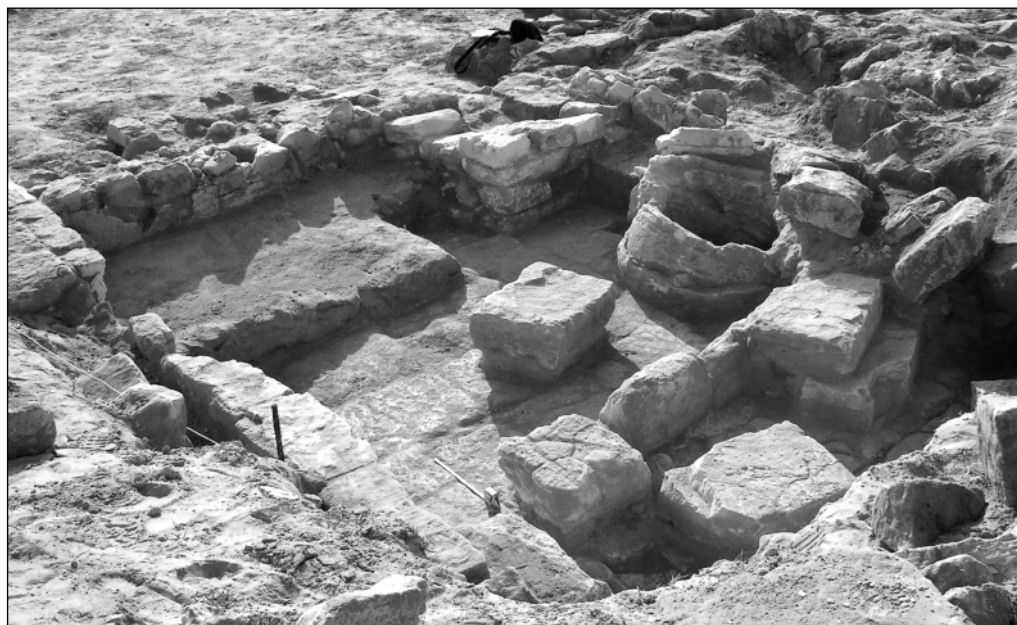
Fig. 9. Paved unit with well (to right), fireplace and bin in Tr01, looking northeast; the channel under the platform (photo at top right) was fed from a drain in the corner of the room and emptied into the well structure; the vertical drain in the wall above the channel was not connected with it (Photo U. Wicenciak, courtesy MASP ARCE/EAP)

corners [Fig. 9]. A masonry drain pipe was pierced through one of the walls (its outlet was not discovered unfortunately) [cf. Fig. 9, top right]. The paved area turned out to have a channel installation fitted under the earth platform in the eastern end, fed through a pottery vessel rim mortared to the floor and emptying in the general direction of the cistern in the southern part of the unit (the connection could not be traced because of overlying flagstones).

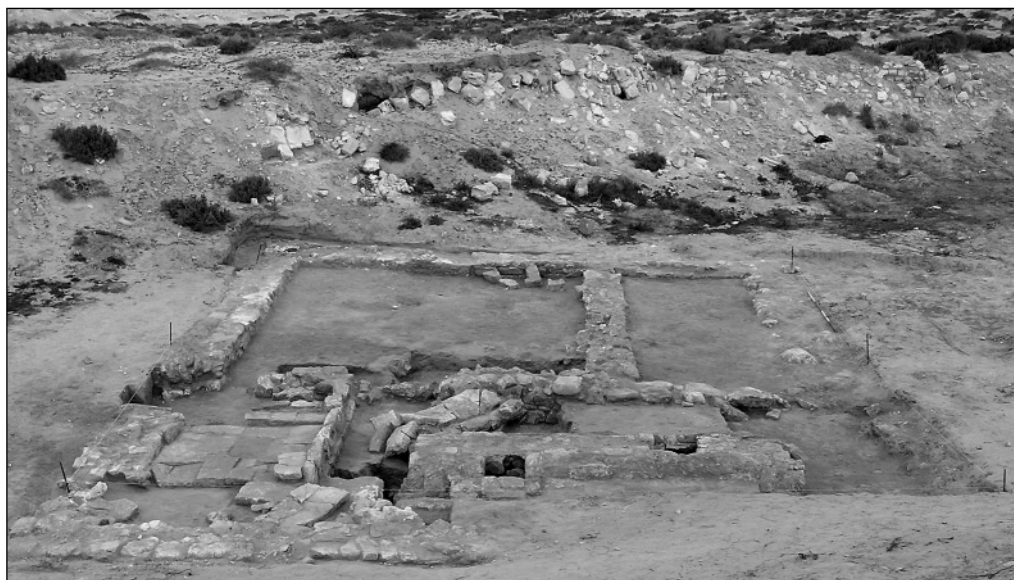
Fig. 12. General view of Tr06 with cistern in foreground, looking northwest; note remains of WWII structures in the western side of the cut (Photo A. Obłuski, courtesy MASP ARCE/EAP)

The cluster of units around a cistern in the middle of the surveyed area proved to be in effect part of a big complex that extended all the way to the north of the surveyed area. It also contained a big exedra opening to the east, the function of which cannot be ascertained at present except that it may have had some connection with water use. Further west of this feature, a double set of walls of a thickness up to 1.50 m not encountered in Marina so far (to the present author's knowledge) cut across the surveyed area, following a N-S orientation (Tr05+Tr07). These walls proved to be connected with the building, of which the

cistern was a part of in a later stage of its use (Tr06) [Fig. 12].

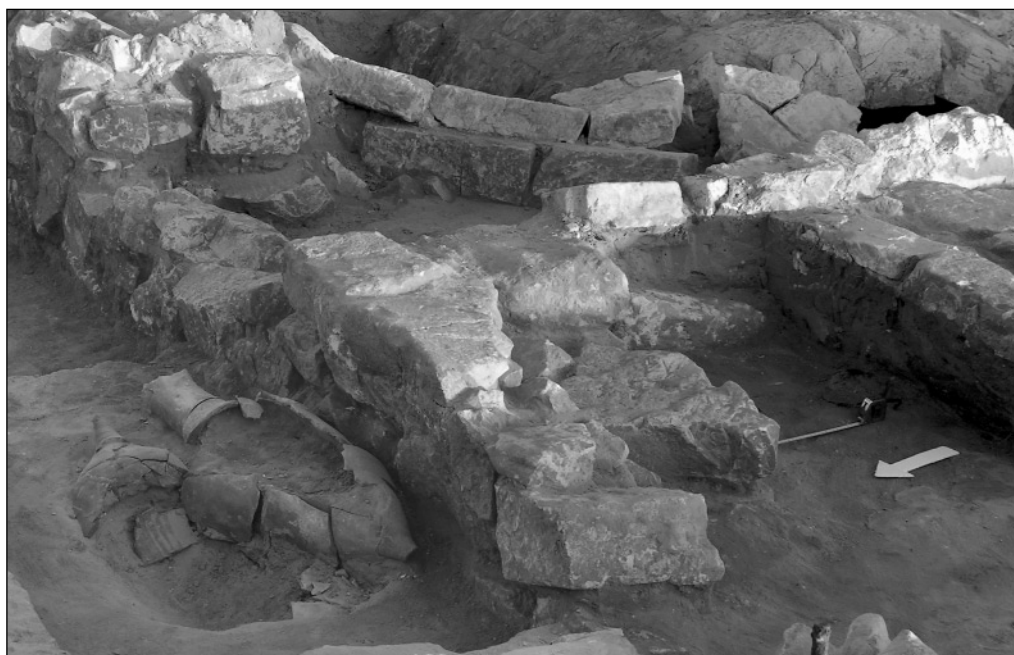
Fig. 13. Household area in Tr06 with bin containing amphorae on left and cistern with feeding channel for rainwater collected from the roof at center back and right, looking east (Photo A. Obłuski, courtesy MASP ARCE/EAP)

The cistern functioned in association with a paved area used for some household activities, a small kitchen area perhaps and storage space (perhaps open courtyard) where a bin containing three amphorae, one with *dipinti* and another one a typical Rhodian import of the 1st century AD, was discovered [Fig. 13]. A small limestone altar was also discovered here. The building obviously extended to the north, into the side of the 'cut', where an ancient wall was found to touch a World War II trench built practically on top of it [Fig. 14]. (Indeed,

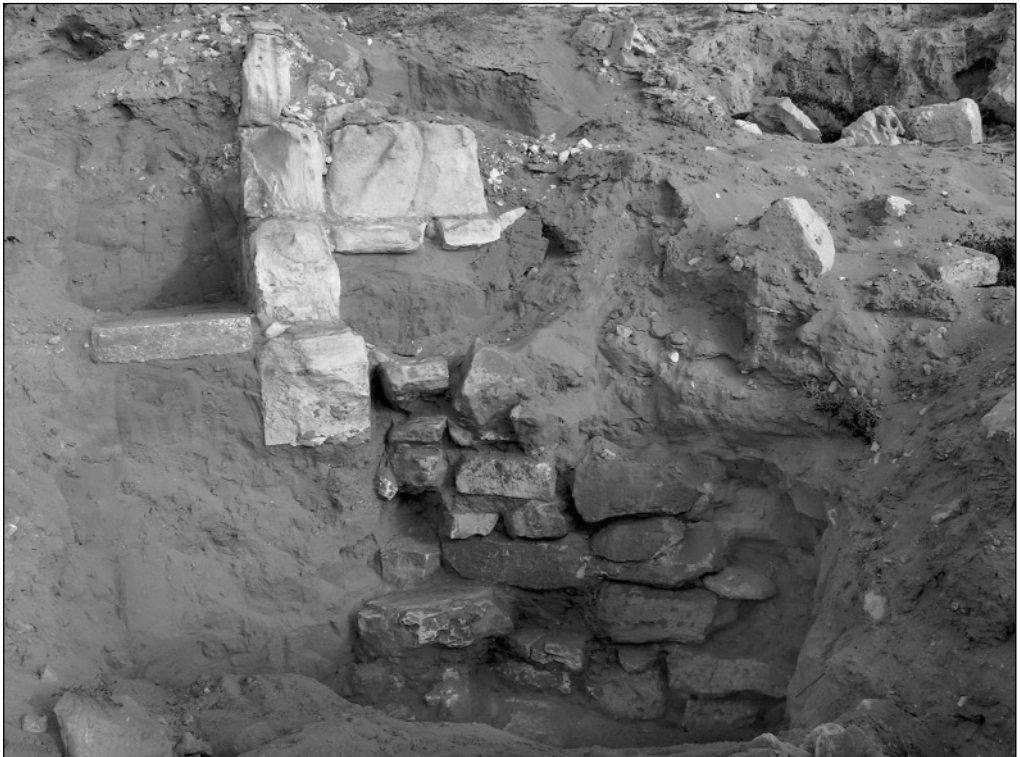
Fig. 14. World War II structure resting on top of ruined walls from the Roman age
(Photo I. Zych, courtesy MASP ARCE/EAP)

the center part of this area must have been drilled full of pits by the World War II structures,⁴ several of which were found alongside it and on the opposite side and which evidently destroyed much of this last-phase architecture in and west of Tr06).
