# NAQLUN (NEKLONI) PRELIMINARY REPORT, 2006

# Włodzimierz Godlewski

# MEDIEVAL MONASTIC ARCHITECTURE

# HERMITAGE 85

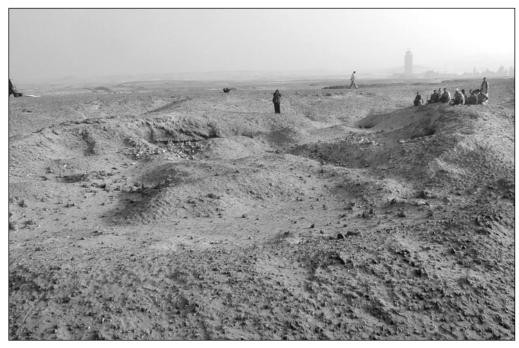
Fig. 5. Hermitage 85 before the beginning of explorations (Photo W. Godlewski)

Several rock-hewn hermitages were found during a survey conducted by the Mission in 1987 in the western part of the Nekloni monastic complex, located today between the enclosure wall of the modern-day monastery and the canal, to the west of cemetery C [Fig. 5]. Contemporary economic activity in this area: excavation of stone for building purposes and the expansion of agriculture, constitute a real danger to the ancient remains. Salvage excavations of one of the hermitages (no. 85 on the site map), undertaken this year, revealed that it had apparently been cleared illicitly some time in the 1970s.
