HERMITAGE 85 IN NAQLUN: MATERIALS AND CONSTRUCTION

Szymon Maślak

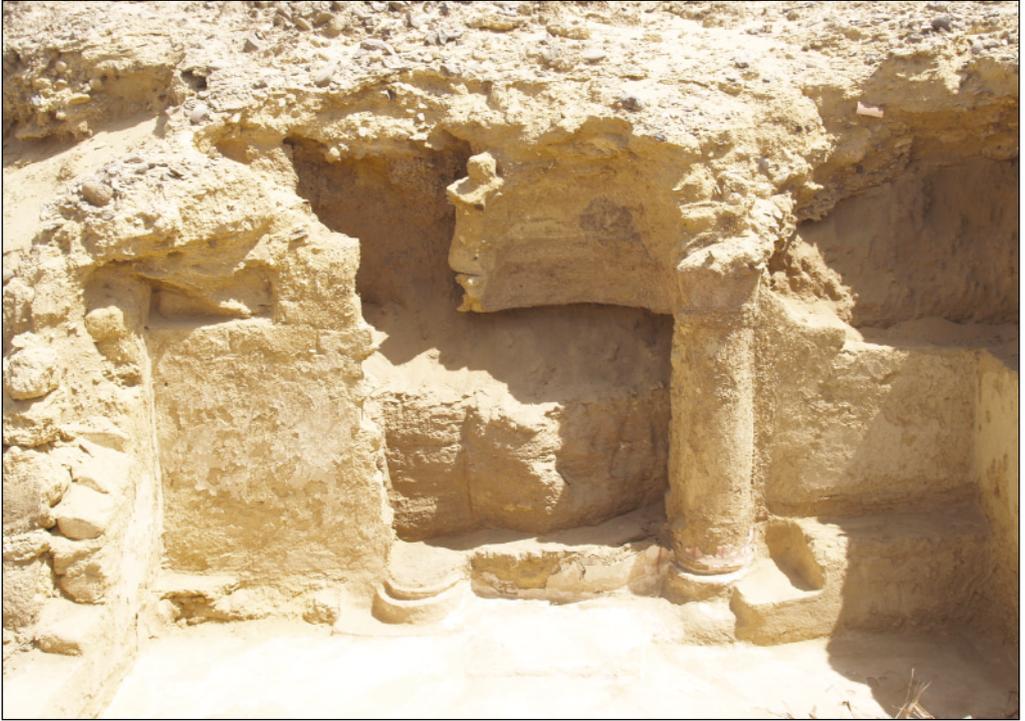
*Fig. 1. Prayer niche in the oratory of Hermitage 85
(Photo W. Godlewski)*

walls of the oratory were covered first with a thin coating (2-3 mm thick) of pale gray-beige plaster with chaff and then with an even thinner layer (1 mm or less) of almost cream plaster, produced from raw material of desert origin with chaff as well. The engaged columns and *mensa* in the niche between them had a coating of lime plaster (up to 2 mm thick) painted with a red ornament, laid on an underground of pale gray-beige and partly dark gray mud plaster.

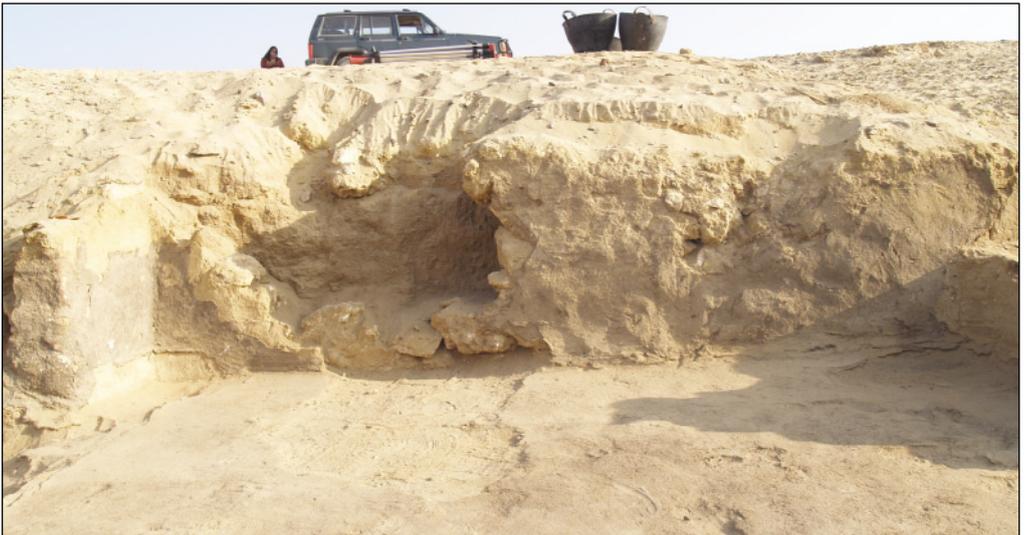
*Fig. 2. Remains of a mud floor and mud plaster on the walls of Room 5, view looking north
(Photo W. Godlewski)*

In other units, more of a domestic or living character, the walls were plastered in a different way. Preserved fragments show that at least the lower parts were covered with a thin coating (2-6 mm) of dark gray mud plaster containing fine chaff, smoothly passing into a floor made of the same plaster. Plasters of this kind are laid usually on a relatively thick underground (up to 2 cm) of grayish or pale-gray-beige plaster, both produced from raw material of desert origin.

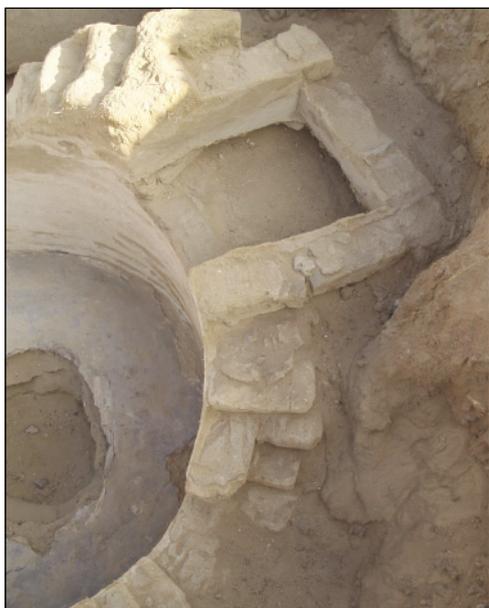
Fig. 3. Pit for storage jar and step down faced with brick in the southern pastophory (Room 6) (Photo W. Godlewski)

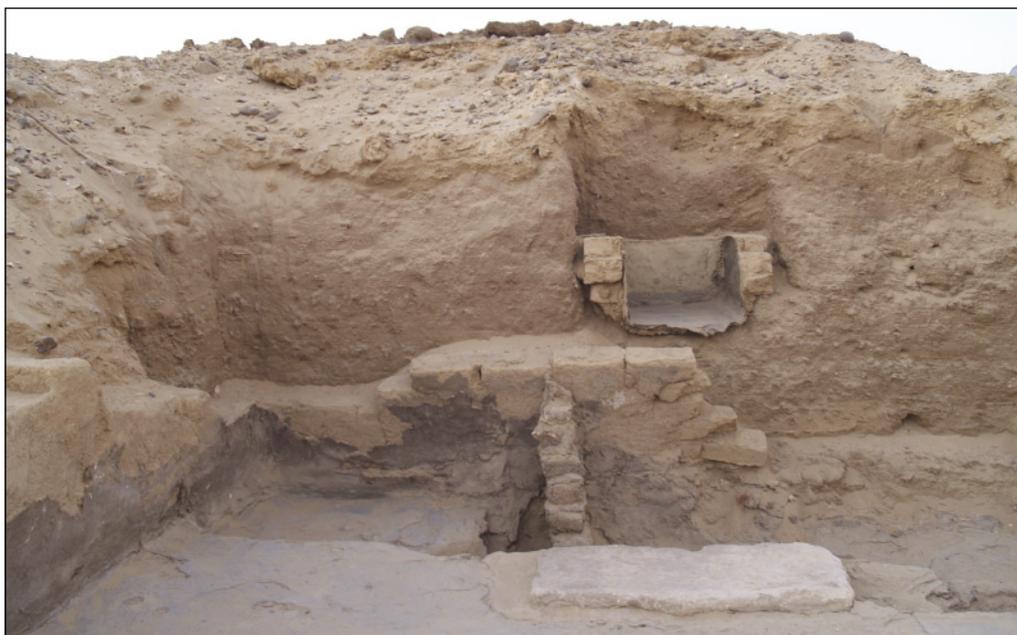
Fig. 4. The installations in Room 3, view looking north (Photo W. Godlewski)
