Title: **Dongola 2008–2009**

With appendix: **Conservation of wall paintings inside the former Throne Hall of the Makurian kings in Dongola (2009 season)**

Journal: *Polish Archaeology in the Mediterranean* 21 (Research 2009)

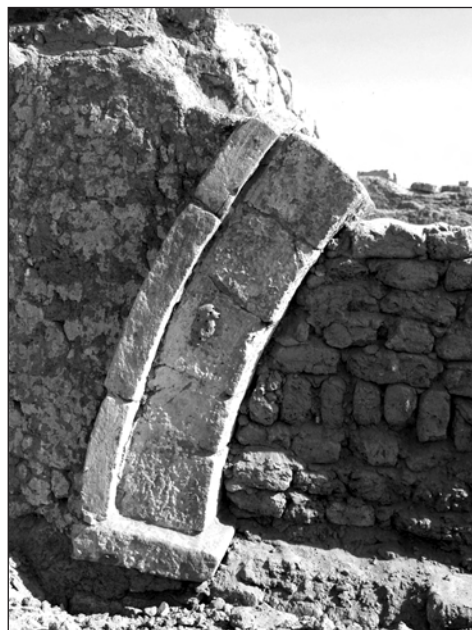
Fig. 6. Doorway to corridor B.I.11, eastern side  
(Photo W. Godlewski, PCMA archives)

with rubble. An arched stone doorway in the southwestern corner of the vestibule (B.I.44), only partly preserved, opened into a corridor (B.I.11) which traversed the entire building from north to south, separating the eastern part of the palace from the rooms on the western side (B.I.15, 36–37, 41–42) which evidently served economic functions. The entrance to B.I.11 from vestibule B.I.44 was 2.20 m wide and was topped by an arch of sandstone voussoirs resting on imposts. Only the lower stones have survived in place. This doorway was also blocked when the ground floor was filled up with rubble [Fig. 6]

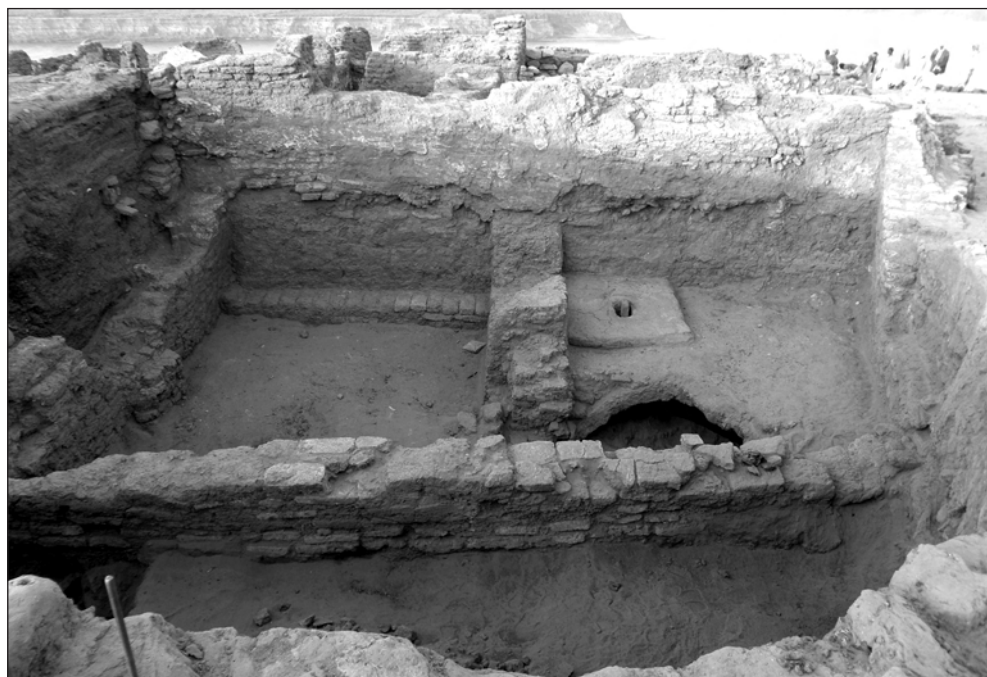
Fig. 7. Building B.I. Northeastern corner, B.I.46 and B.I.47, view from the east (Photo W. Godlewski, PCMA archives)

Excavations in unit B.I.46, which measured 4.96 x 2.70 m, uncovered a low square structure in the southwestern corner, erected on a floor resting on the vaulting of the unit. The structure had a conduit pierced through the center, going also through the said vaulting [Fig. 7]. A trace

impression in mortar on the top surface of this structure suggested the presence of a ceramic toilet seat.<sup>2</sup> A fragmentary seat of this kind was identified in the assemblage filling unit B.I.46. This evidence suggests a toilet function for this unit. The floor of B.I.46 at 26.61 m. a.s.l., compared with the walking level in B.I.20 at 26.51 m a.s.l., indicates beyond doubt that this part of the building is preserved to the height of the first floor.

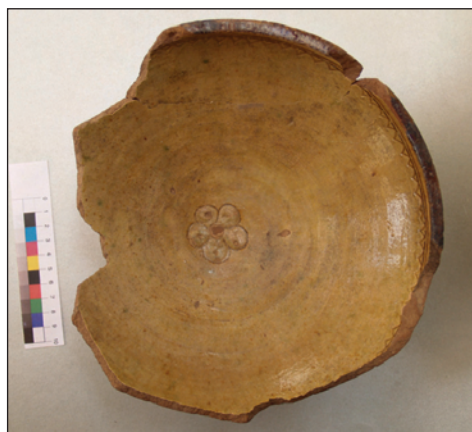
Fig. 8. Pottery of 13th century date: left, local vase (ADd.09.082; H. 18.8 cm Dia. 18.4 cm) and top, glazed bowl produced in Egypt (ADd.09.080; H. 12.0 cm Dia. 23.0 cm Dia. base 8.5 cm) (Photo W. Godlewski, PCMA archives)

The upper parts of the fill in units B.I.46–B.I.47 yielded pottery from the 13th century, identified as being either of local production or imported from Egypt [Fig. 8]. An ostrakon from the same layer, written in Greek on an amphora sherd, is a kind of payer on behalf of a woman named Ariñji (Łajtar, Van der Vliet 2011), possibly one of the residents of the building [Fig. 9]

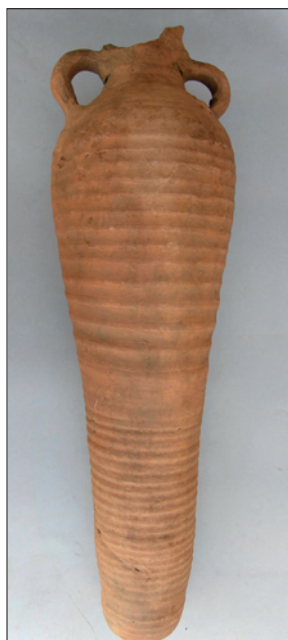
Fig. 11. Aswan-made amphora (ADd.09.355), end of the 6th century; H. +67 cm; Dia. rim 8 cm (Photo W. Godlewski, PCMA archives)

to be located inside an ancient pit dug before the north wall of the room was erected. A deposit of shattered pottery, mainly amphorae imported from Aswan [Fig. 11], was found in the original trench, which was 0.95 m deep and had partly destroyed the foundation of the citadel wall. Among the other finds, which would have originated from the palace interiors, were fragments of a broken stone tub of considerable size (Godlewski 2010: 76–78, Pls 7–8) [Fig. 12]. The front and the left side of the basin with part of the bottom have been preserved, enabling a reconstruction of both form and size. Apparently, the basin must have been broken elsewhere and only these fragments entered the rubbish pit. The rest must have been discarded elsewhere, perhaps somewhere nearby.

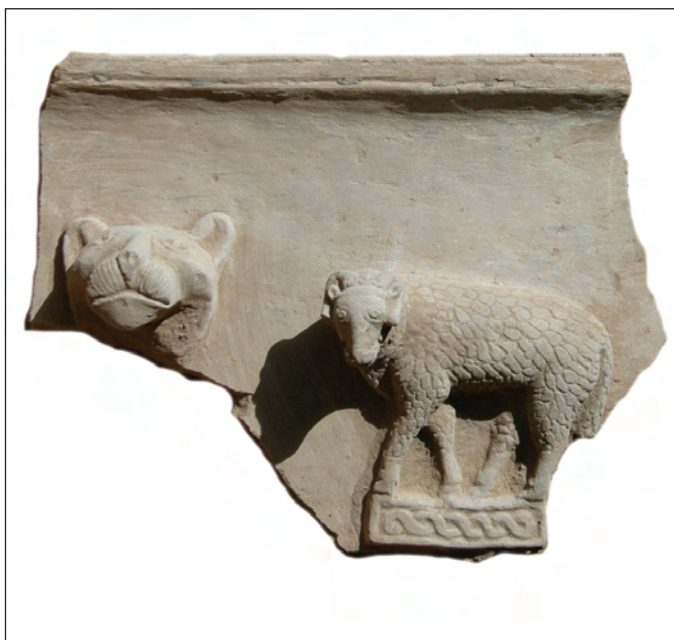
Fig. 12. Fragments of a stone washtub (Photo W. Godlewski, PCMA archives)

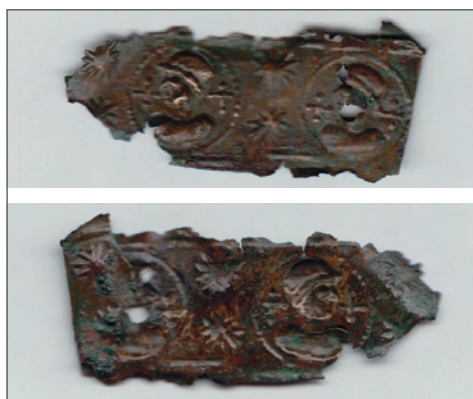
Fig. 13. Fragment of impressed sheet metal decoration, 6th century (ADd.09.320), H. 17 mm L. +52 mm, front and back view (Photo W. Godlewski, PCMA archives)

A few fragments of metal objects [Fig. 13] of unidentified function and place of production indicate the high class of the objects (codex covers? furniture?) decorated with these metal appliques that were part of the furnishings of Building B.I in the 6th century.<sup>4</sup>

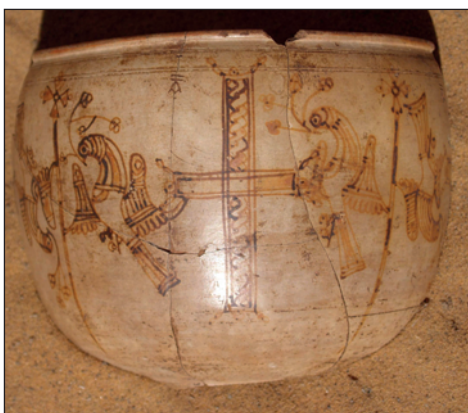
Fig. 14. Locally made White Ware vase, 7th/8th century (ADd.08.159); H. +12 cm, Dia. 17 cm (Photo W. Godlewski, PCMA archives)

Meriting special attention is a locally made vase found in the fill of unit B.I.42 [Fig. 14], decorated with crosses adored by birds (doves) carrying branches in their beaks. This fine product of the Early Christian White Ware 9 polished ware can be dated to the 7th/8th century (Adams 1986: 484–485).

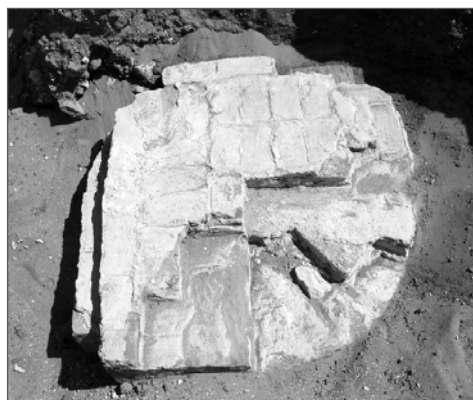
Fig. 16. *Top of the northwestern pillar in Building B.V., revealing the manner of construction*  
(Photo W. Godlewski, PCMA archives)

sloping rock in the western end. The outer red-brick walls were 1.20 m thick. The building measured 15.0 m by 20.8 m and was aligned east–west. Four round pillars made of a special format of brick stood in the center of the complex, corresponding to engaged round piers in the side walls, built of similar wedge- and quarter-shaped bricks bonded with lime mortar [Fig. 16]. Consequently, the building can be reconstructed as a rectangular complex on a central plan. The outer and inner faces of the walls and piers of the building were thickly coated with lime plaster (1.5–2.0 cm thick) featuring a polished surface. Wall paintings and inscriptions were noted in the interior, on a thin coat of flaking plaster, which detaches easily from the underlying, very smooth original plaster. The state of preservation of the wall paintings and underlying plaster put a stop to further excavations in the northeastern corner of the structure. They will be resumed once proper field preservation procedures can be ensured and implemented. Two windows, each 0.67 m wide, were cleared down to the sills,

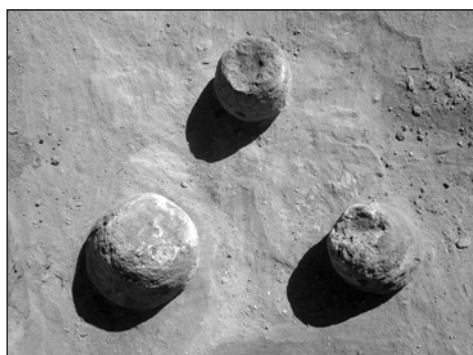
Fig. 17. Fire dogs in place in the hearth of House 2H.06 (Photo W. Godlewski, PCMA archives)

but consisted most probably of a single room measuring 3.90 m by 4.80 m. The east wall was of red brick. It was also entered from the south and had a bench, 1.65 m by 2.90 m, by the south wall and a hearth by the east wall with an irregular platform. Three fire dogs, each with a round top, were preserved in the hearth [Fig. 17].

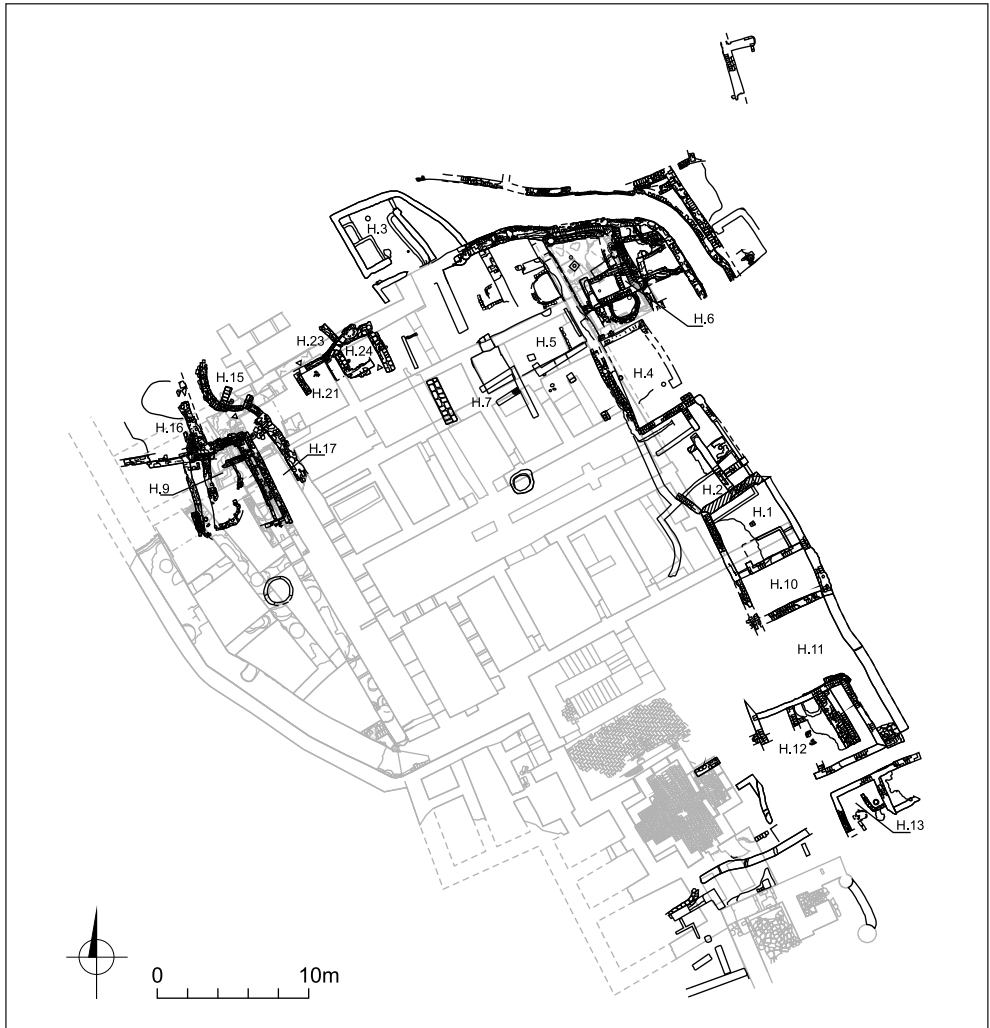
Fig. 18. Plan of 16th–17th century architecture on the citadel  
(Drawing S. Mašlak, PCMA archives)

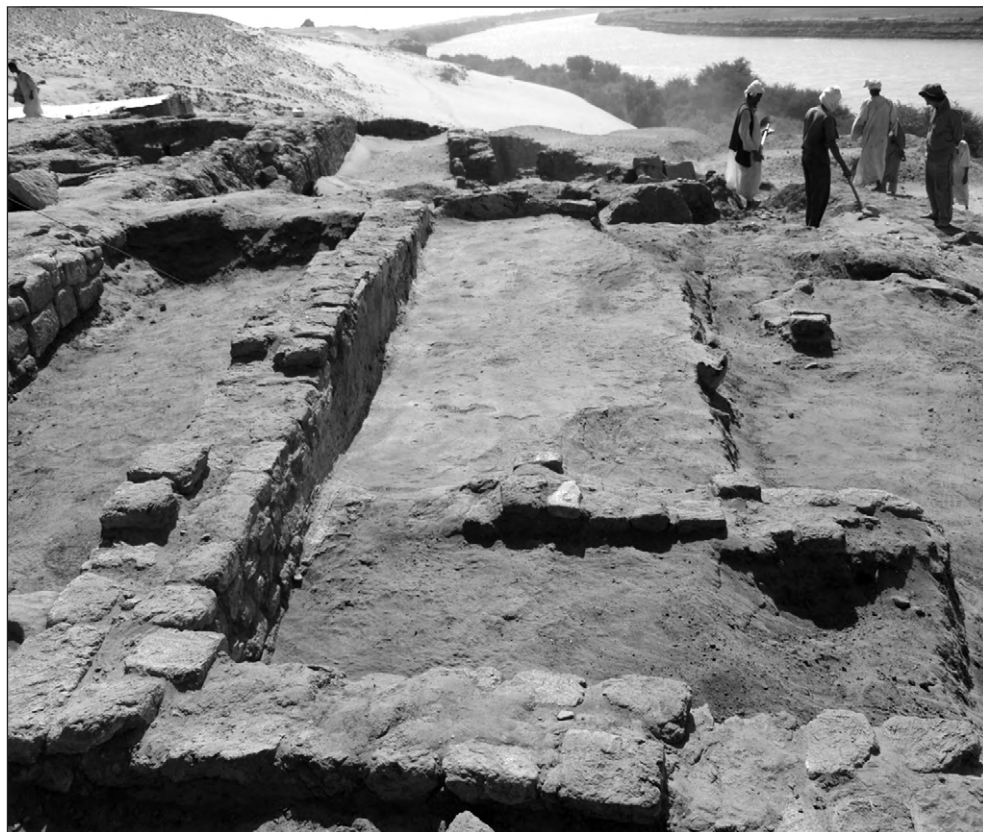
Fig. 20. House H.9, view from the north  
(Photo W. Godlewski, PCMA archives)

of house H.09 built of red brick suggests that the structure consisted of two rooms: a large one on the south, measuring 4.60 m by at least 2.00 m, with a low bench 0.54 m wide by the east wall, and a second room in the northern part, narrow at just 1.40 m, accessed from the southern room through a doorway in the east wall [Fig. 20]. A round corral for animals H.15 (probably for sheep or goats) was found to the north of it. The remains of other structures are suggestive of dense habitation architecture in this part of the citadel.

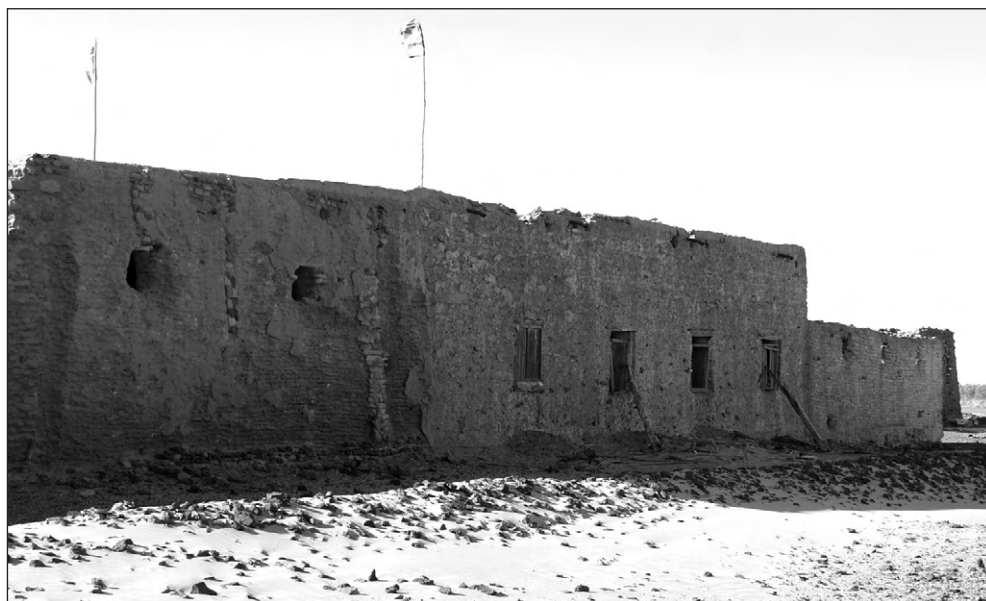
*Fig. 21. Northern facade of a 19th century mosque in the 'Abandoned Village' (SDONG.20)  
(Photo W. Godlewski, PCMA archives)*

The mosque appears to have been erected at the turn of the 19th century [*Fig. 21*]. A large rectangular hall measuring 7.25 m by 4.60 m featured six pillars in two rows supporting a flat roof and a shallow *mihrab* in the east wall [*Fig. 23*]. It was connected to a few rooms adjoining it on the east and south sides.

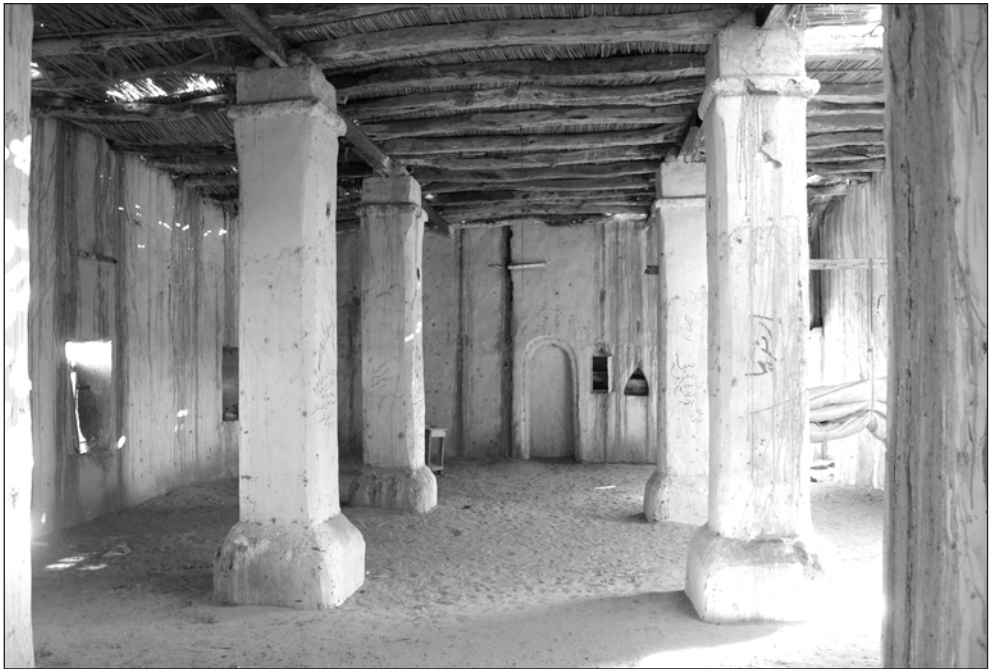
Fig. 23. Interior of a 19th century mosque in the 'Abandoned Village' (SDONG.20)  
(Photo W. Godlewski, PCMA archives)

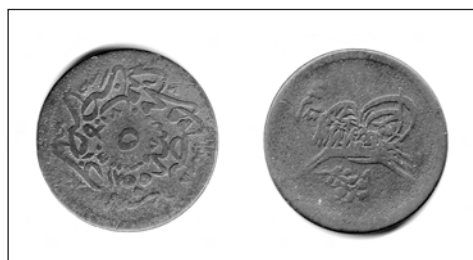
◀  
Fig. 25. Bronze coin (ADd.08.001), Dia. 22 mm (Photo W. Godlewski, PCMA archives)

in the text.<sup>7</sup> Two bronze coins were also found, one of them (ADd.08.001) dated to the fifth year of the rule of Abbas Hilmi (1848–1854) [Fig. 25], a few dozen small

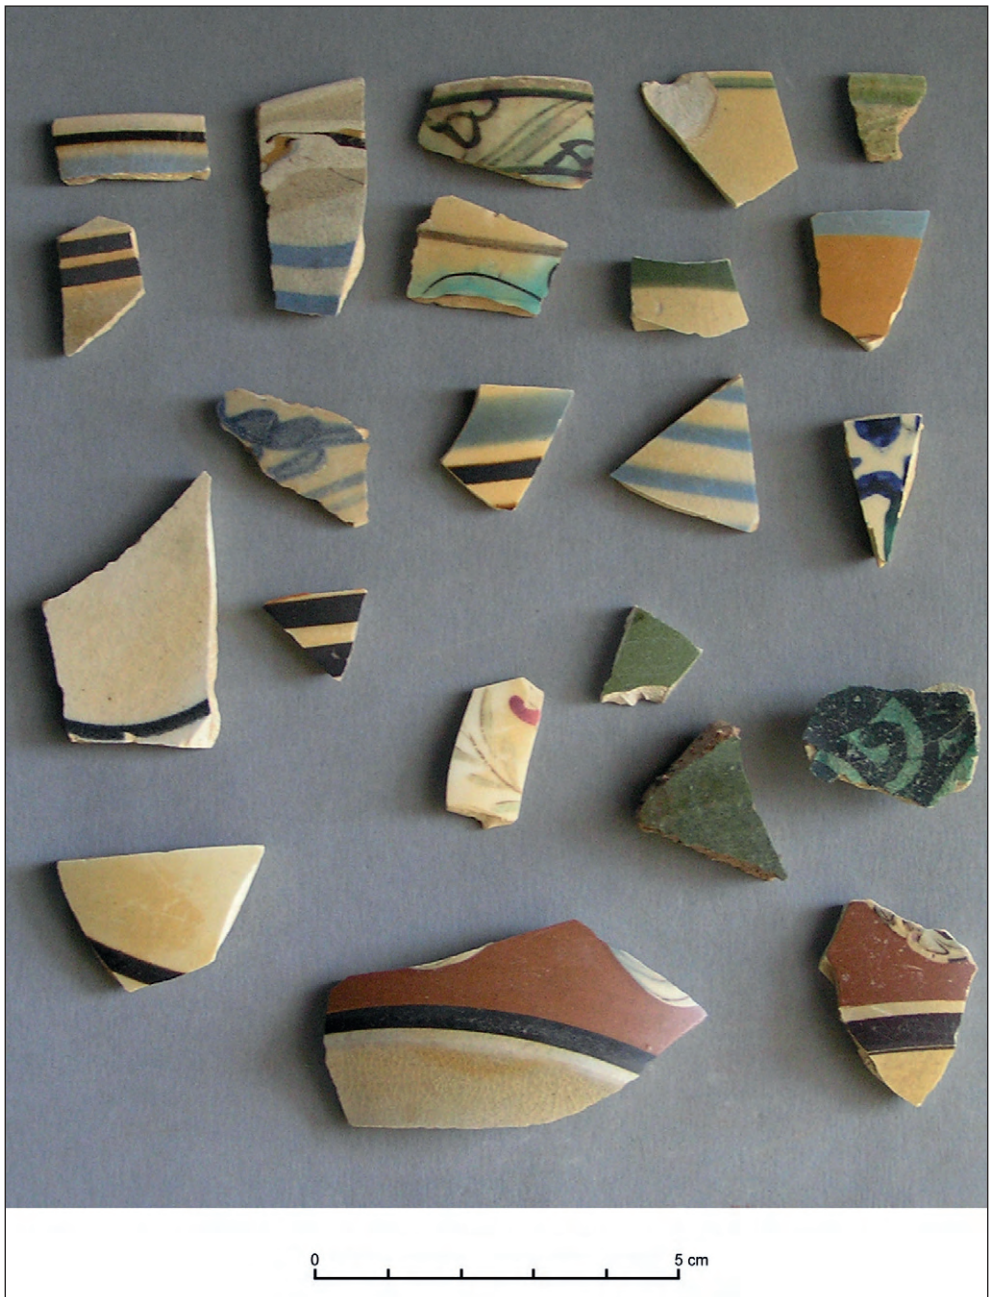
*Fig. 26. Porcelain sherds*  
(Photo W. Godlewski, PCMA archives)

fragments of porcelain bearing European and Oriental decorative motifs attest to relatively extensive trade contacts of the owner of the building [Fig. 26].

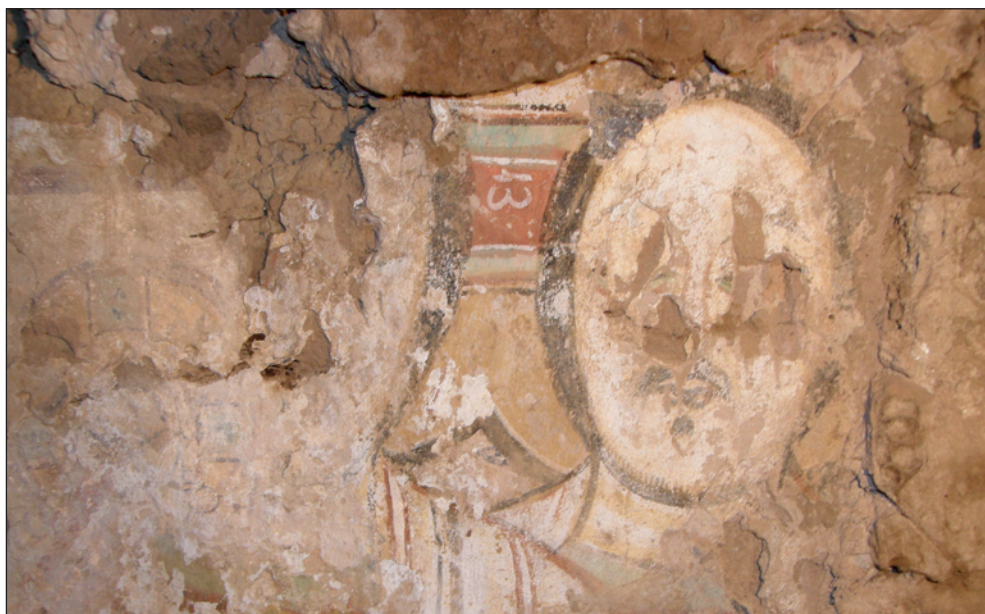
▲  
*Fig. 27. Fragment of a representation of a Makurite Holy Trinity protecting a king from the Throne Hall (Mosque) (Photo W. Godlewski, PCMA archives)*

Trinity (triple representation of Christ) protecting the king shown wearing a horned crown [Fig. 27]. One of the preserved representations on the west wall is a fragmentary image of a king holding a Byzantine-style crown in his hand [Fig. 28]. Further conservation treatment of the wall paintings is planned.

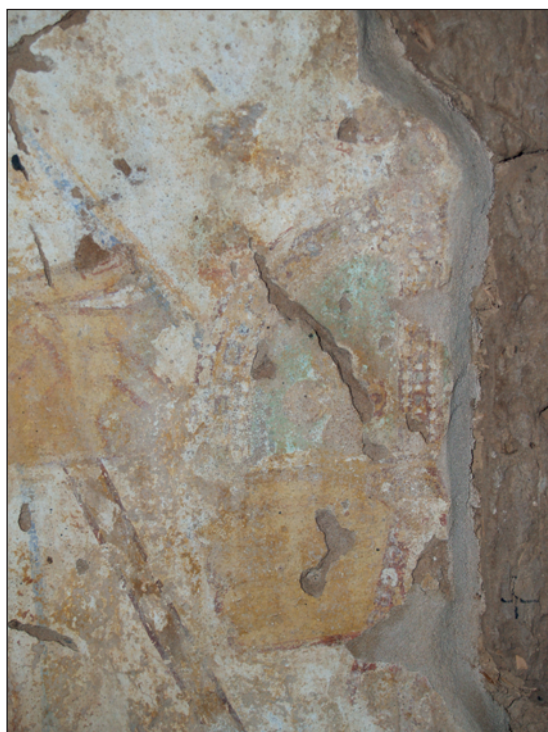
◀  
*Fig. 28. Fragment depicting a Byzantine-style crown in the hands of the king from the Throne Hall (Mosque) (Photo W. Godlewski, PCMA archives)*

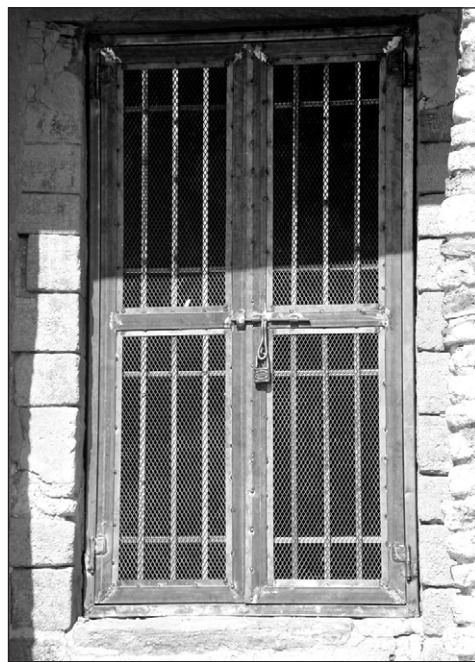
Fig. 29. Western entrance to the building of the Mosque with new mesh-net door (Photo W. Godlewski, PCMA archivess)

At the same time protection measures were taken throughout the building by staff from the National Corporation for Antiquities and Museums (NCAM). All the openings were closed with

small-mesh nets to keep out the bats [Fig. 29], fresh plaster was laid to fill gaps in the outer plaster coat and a provisional protection of the roof was carried out.
