Title: **Polish Archaeological Mission to Palmyra. Seasons 2008 and 2009**

Author(s): Grzegorz Majcherek

Journal: *Polish Archaeology in the Mediterranean* 21 (Research 2009)

Abstract: The 2008 and 2009 seasons saw a continuation of excavations in the northern Basilica (No. IV), the largest church building in Palmyra. Both the eastern part of the nave and the southern aisle, as well as a large fragment of the apse, were cleared. The most unusual feature uncovered in the church is the so-called Syrian *bema*, located in the middle of the nave. This is the first time that this liturgical installation has been evidenced in central Syria. Excavations revealed also traces of Early Islamic (9th–10th century AD) occupation of the site, when the abandoned church building was re-oriented and transformed into an official/residential structure. This new arrangement reflected the changing urban landscape of Early Islamic Palmyra.

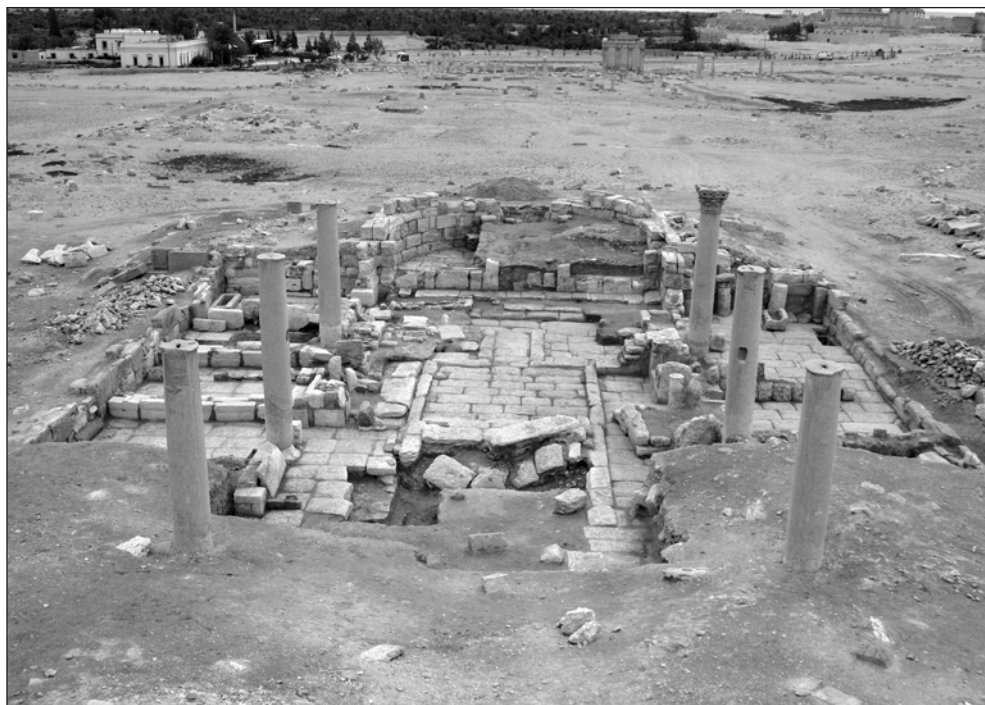
Fig. 1. Basilica IV. General view, looking east
(Photo K. Juchniewicz)

The church is a typical monoapsidal basilica with two rows of three columns dividing the interior into a nave and two aisles [*Fig. 1*]. Monolithic columns on either side of the nave are spaced at regular distances of some 8.50 m (measured between the column axes). Massive piers protruded from the walls at both ends, thus making for four arcades. Basilica IV is definitely the largest church building in Palmyra [*Fig. 2*]. Its overall size is impressive. The external measurements of the main body are 47.50 m by 27.50 m,

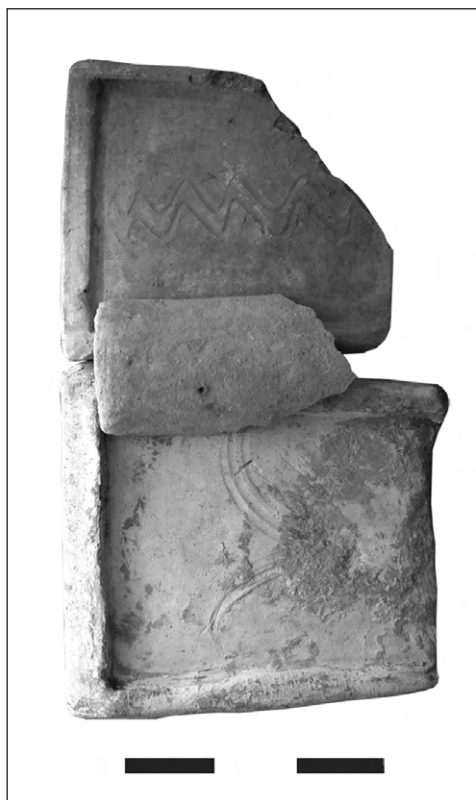
Fig. 3. Roof tiles from the fill of the church
(Photo M. Wagner)

making it by far the largest in Palmyra and one of the largest in Syria. The span of the nave reaches 12.60 m. Lateral aisles are proportionally smaller, but still, they exceed 6 m. Being the largest church building in the city, it was also the tallest. The overall height of the basilica can be calculated at 22 m: 7 m (columns height) + 4 m (height of the arches) + 7 m (distance between the top of the arches and horizontal trusses, including clerestory windows) + 4 m pitch of the roof. The timbered roof was apparently tiled. Some large flat roof tiles and rounded imbrices were recovered from the fill [*Fig. 3*].

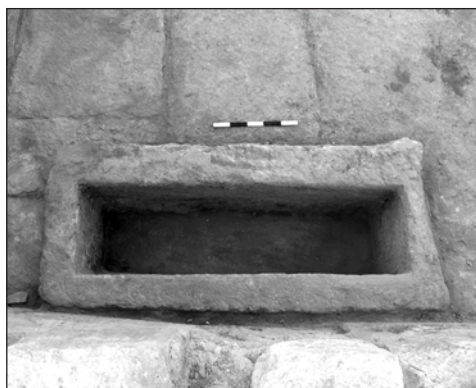
Fig. 4. Reused sarcophagus in the northern church aisle (Photo G. Majcherek)

there was a large (2.10 m by 0.90 m) monolithic stone basin sunk into the floor [Fig. 4]. The basin (reused sarcophagus) has no outlet. Its function remains unknown, although a similar basin found in the Basilica III was conjectured as a holy water container (Gawlikowski 2003: 282).

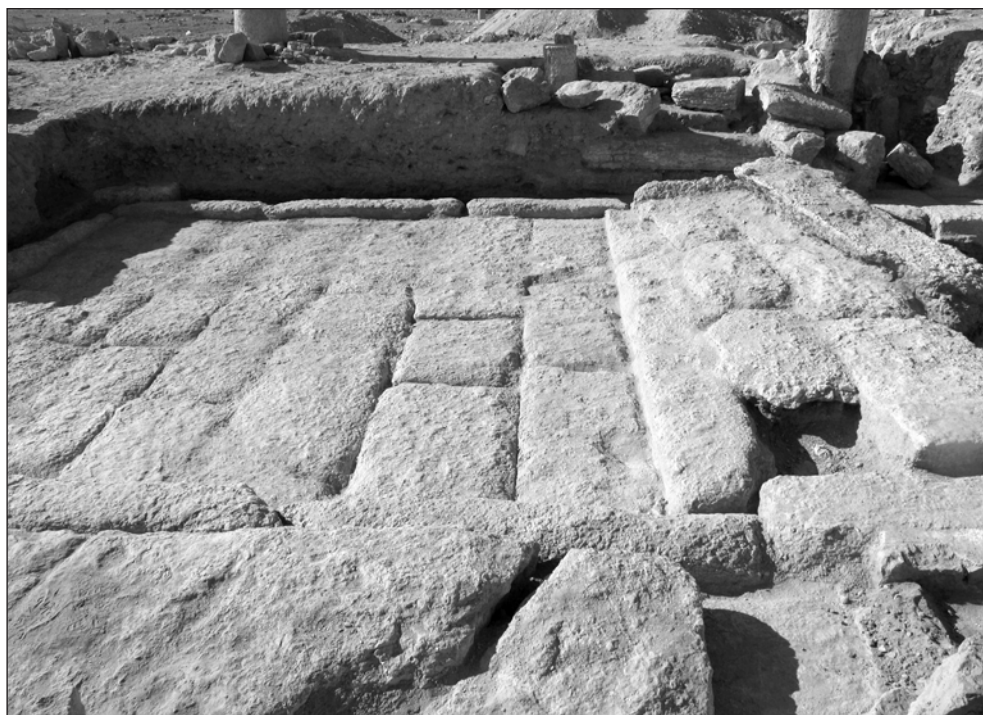
Fig. 6. Basilica IV. Remnants of the *bema* in the nave, looking south
(Photo G. Majcherek)

Of particular interest are the remains of a *bema* occupying the center of the nave. A theoretical reconstruction is possible despite extensive robbing of the feature. It was apparently a large rectangular structure measuring approximately 7.20 m by 6.30 m [see Fig. 2]. A large, right-angled block preserved in the southwestern corner is tangible proof that, contrary to multiple other examples, the *bema* in Basilica IV did not follow the standard hemicycle plan. Although very rare, similarly outlined rectangular *bemas* are known from the small church in Fafertin in Jebel Sem'an (Tchalenko 1979: Figs 81–83) and from the basilica in Dibsi Faraj (Harper 1975: Fig. D). Two wide steps lead to an elevated

podium, most probably accommodating tiered benches for the clergy and a *thronos* for the Gospel (now lost) [Fig. 6].

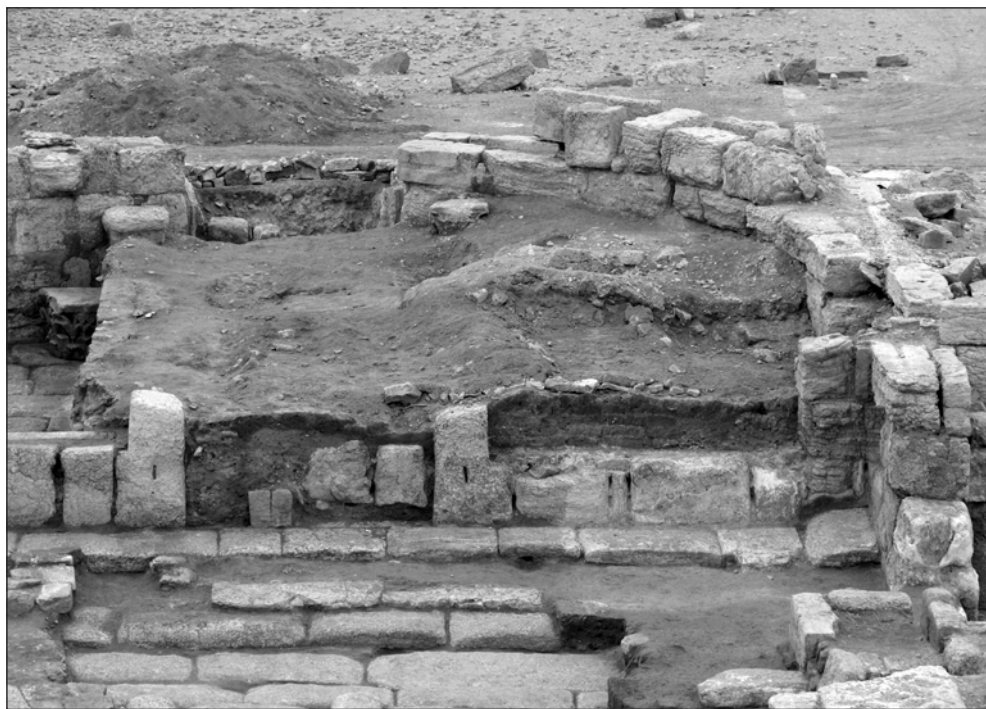
Fig. 8. Remains of the church apse, looking east
(Photo K. Juchniewicz)

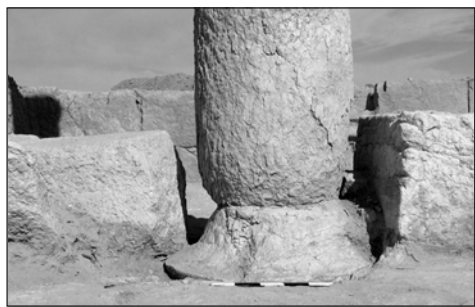
Fig. 9. *Trimmed column of the nave*
(Photo G. Majcherek)

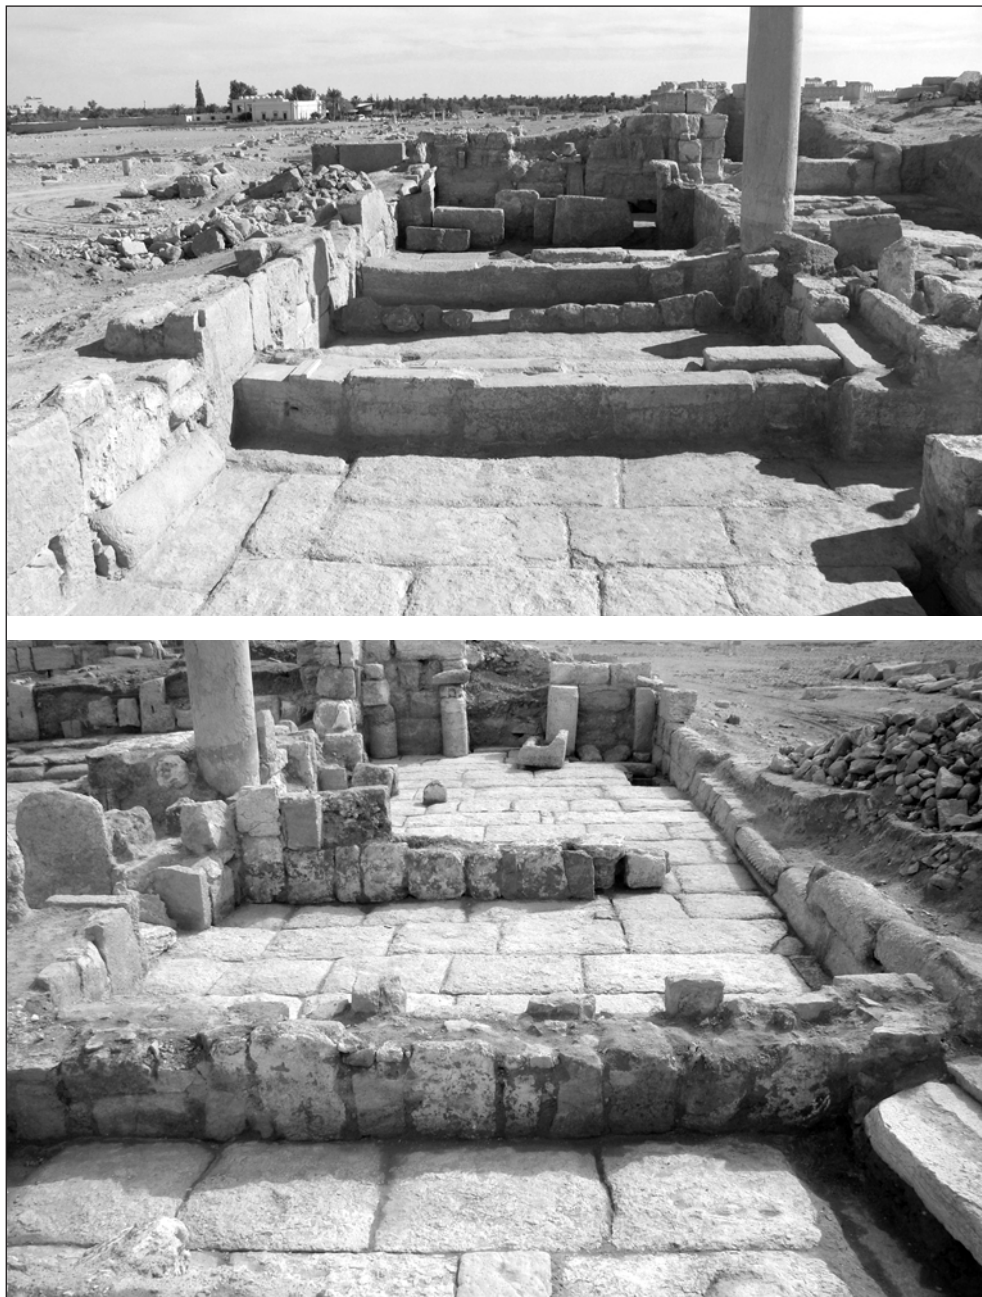
*Fig. 11. Early Islamic structures in the northern (top) and southern aisles, looking east
(Photo G. Majcherek)*

In unit 7, an interesting feature was constituted by two column shafts (some 1.52 – 1.57 m tall, and 0.70 m in diameter) set directly on the church flagging on either side of the entrance and adjacent to its east wall (formerly front wall of the martyrium). Yet another column occupied the northern corner, while a pillar stood in the southern one [see *Fig. 11*, bottom, far back].

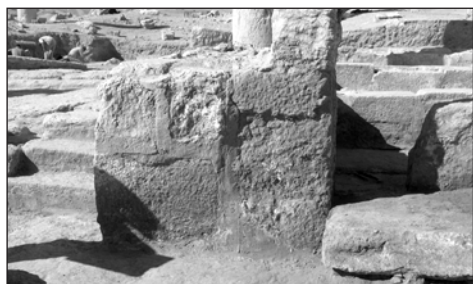
Fig. 12. Pier supporting an arch in chamber 4, looking west (Photo G. Majcherek)

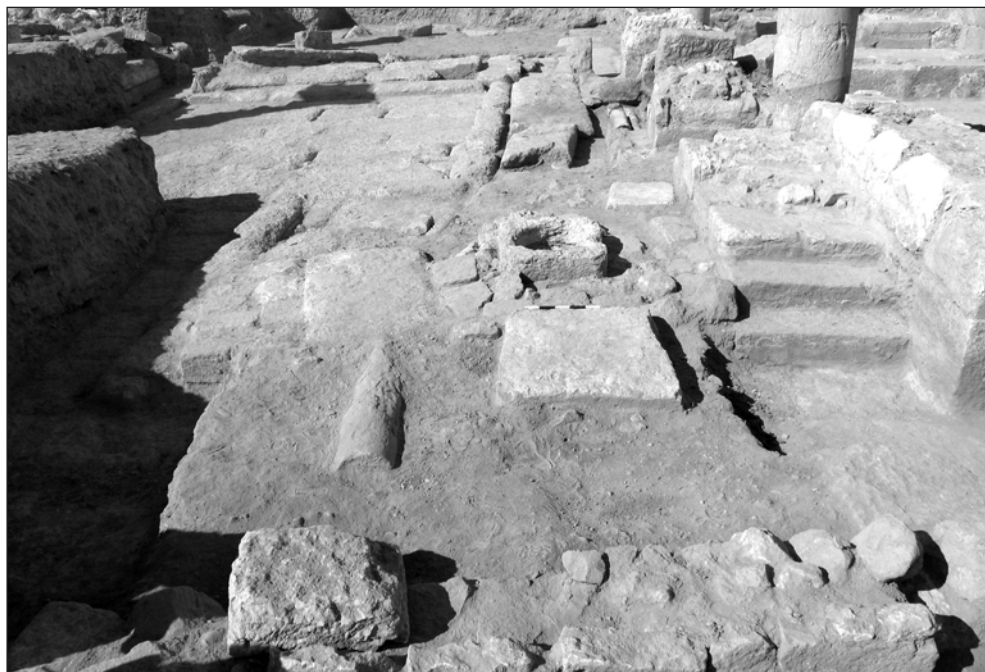
Fig. 13. Courtyard (formerly nave) with early Islamic installation, looking west (Photo G. Majcherek)

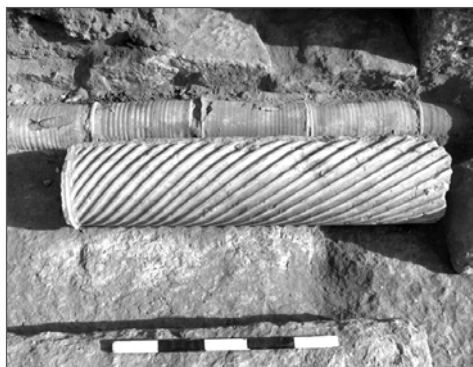
Fig. 14. Terracotta pipe conduit in the early Islamic structures inside the church (Photo G. Majcherek)

The water supply system relied on wells. Two such wells were found in the courtyard. Both were constructed as rectangular ashlar-built shafts leading to wide bell-shaped cavities. The eastern one retained its original well head with a rectangular scatter of cobbling around it [see *Fig. 13*]. The wells in the church were 6.50 m deep, in similarity to several other wells noted in nearby houses located in insula F — clear evidence of a constant water table in the area throughout antiquity and the early Islamic period (Gawlikowski 2007). A water conduit made of terracotta pipes was found running parallel to the walls [*Fig. 14*].

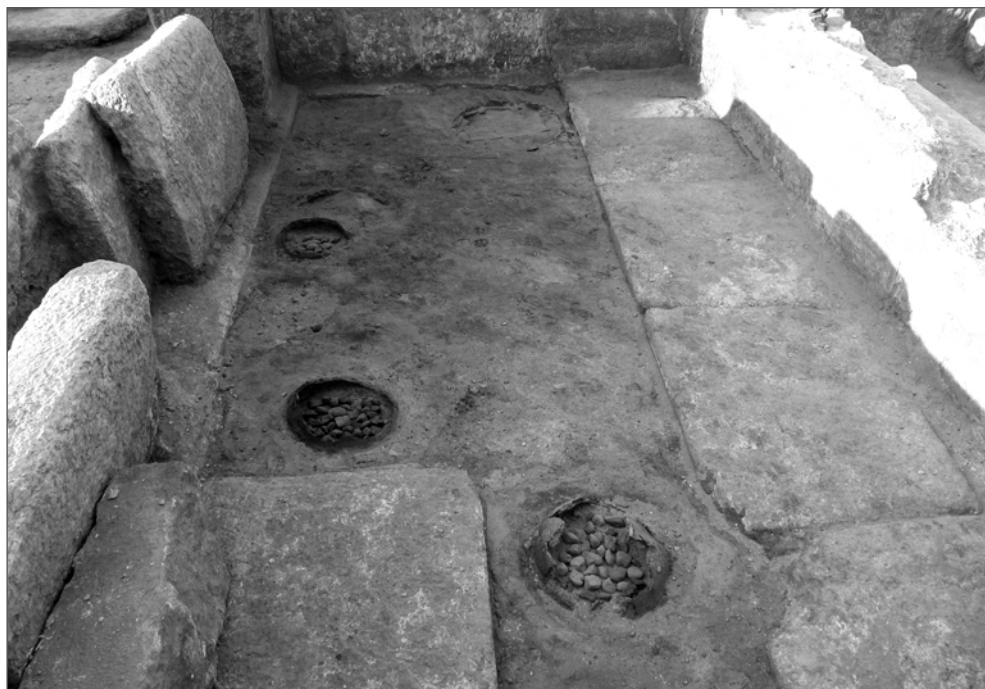
Fig. 16. Ovens in chamber 3, looking south
(Photo G. Majcherek)

Chamber 3 apparently served as a kitchen, as evidenced by four partly preserved small round ovens sunk into the floor in the area where the original church flagging was removed [*Fig. 16*]. A thick deposit of ashes and kitchen waste containing charred animal bones, eggshells

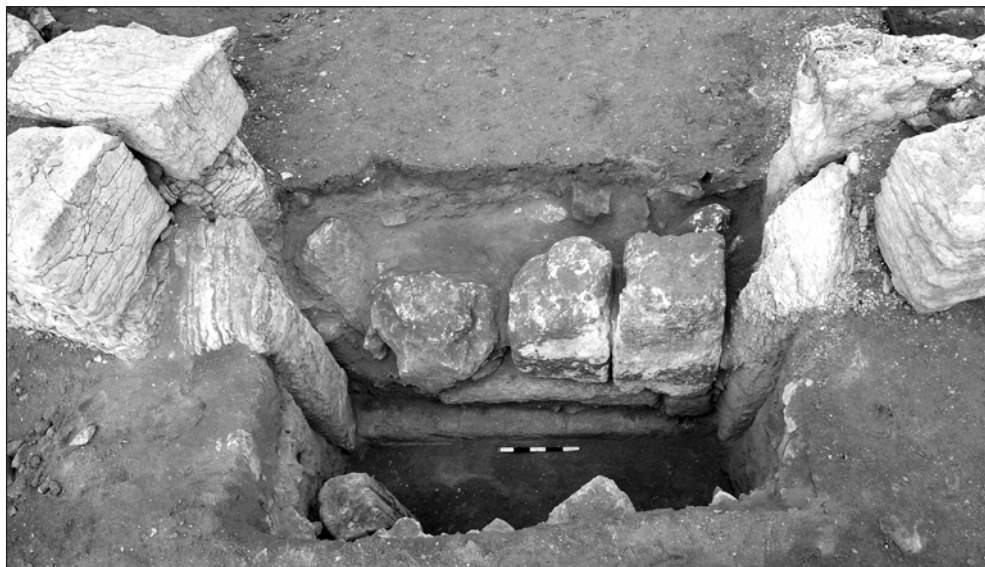
*Fig. 17. New entrance from the early Islamic phase at the top of the apse
(Photo K. Juchniewicz)*

It turned out that the apse also underwent substantial and unusual rearranging. Firstly, it was separated from the former nave by a low parapet wall (1.20 m high), which was most probably a survival feature from the earlier, church phase. A pair of column shafts was found edging the opening immediately behind the central doorway. Two parallel walls forming a passage ran toward the apse top where they touched yet another pair of column shafts topped with reused capitals, flanking a wide doorway pierced at the top of the apse [Fig. 17]. This new wide entrance is certainly a most unexpected feature. The gate (some 2.20 wide) was framed with regular doorposts positioned on a wide threshold.

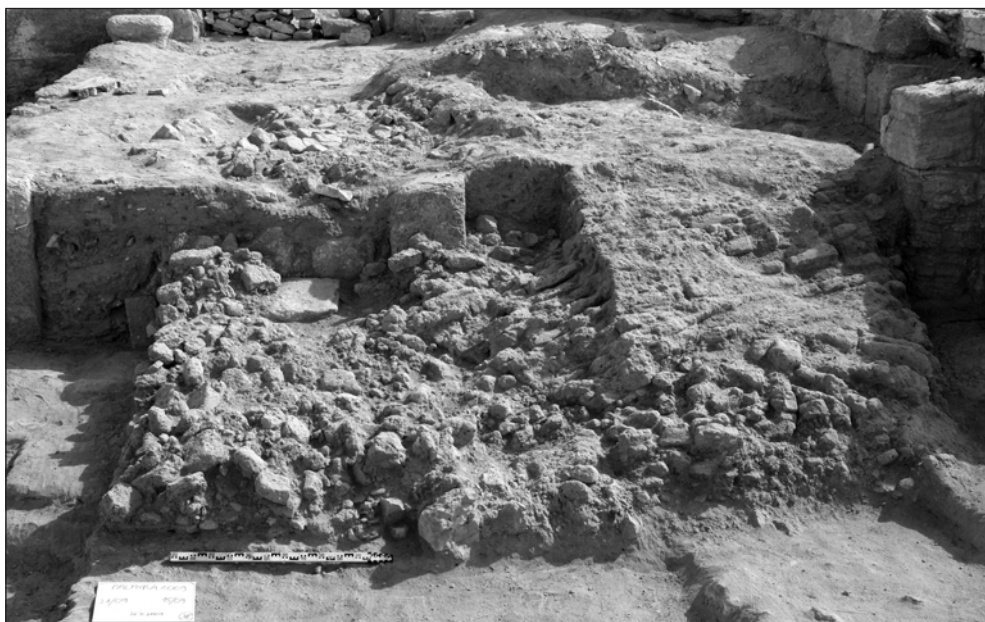
*Fig. 18. Mud-brick collapse in the apse, looking east
(Photo M. Wagner)*

The fill in the apse included abundant mud melt pointing to some mud-brick structure existing in the vicinity. Indeed, a fallen mud brick wall was cleared immediately below the upper strata of the structural collapse. The collapsed structure covered an extensive area in the southern half of the apse. It was made of large square bricks (about 40–42 cm to the side), laid in regular rows with mud mortar still bonding the courses [Fig. 18]. The exact nature of the collapse is difficult to recognize. The westernmost part must have fallen from the parapet wall separating the apse from the courtyard (former nave), as evidenced by several courses of such mud-brick wall preserved on top of it. It is not to be excluded that the eastern part with
