Title: **Alexandria Kom el-Dikka: excavations and preservation work. Preliminary report 2008/2009**

with appendix: **Auditorium E: exploration in season 2009**

Journal: *Polish Archaeology in the Mediterranean* 21 (Research 2009)

Year: 2012

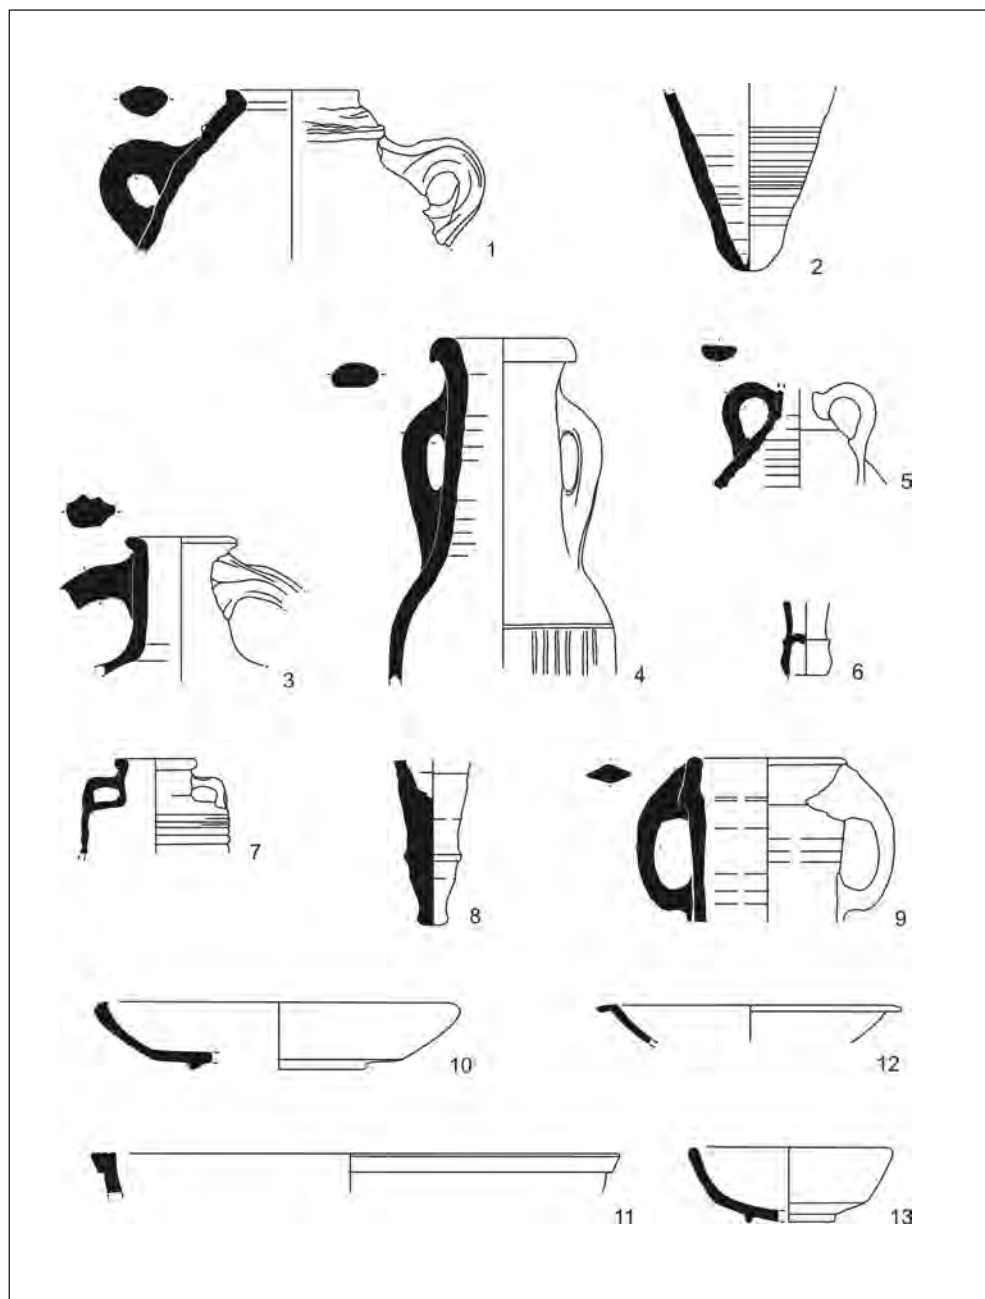
Fig. 1. Selection of pottery from the urban dump  
(Drawing E. Czyżewska, Ł. Wojnarowicz)

The pottery assemblage from the dump layers covered a period from the early 4th to the 7th century AD and revealed a typical range of wares [*Fig. 1*]. Quantification

of the material revealed a majority of amphorae and other coarse wares, domestic wares being recorded sporadically. The ratio clearly indicates a non-domestic provenience for the deposits. The largest group in terms of numbers of vessels was formed by common Mediterranean amphorae. Gazan amphorae predominated as usual, represented by at least three forms illustrating morphological development of the type [*Fig. 1:1–2*]. Different forms of LRA 1 were likewise abundant [*Fig. 1:3*]. Earlier (4th–5th century AD) deposits

included mostly Tunisian amphorae: *Africana Piccolo* and *Grande*, as well as earlier forms of the *spatheion* [Fig. 1:4]. Surprisingly enough, the frequency of micaceous LRA 3 amphorae was also relatively high [Fig. 1:5–6]. It is noteworthy that the bulk of them represented forms indicative of the 4th–early 5th century (with open tubular foot). In contrast, later 5th–6th century forms (with closed foot) were apparently imported to Alexandria on a much smaller scale. Of particular interest was a fairly large group of small, heavily ribbed *Agora M239* type vessels (white-washed red fabric), recorded in Alexandria for the first time in such number [Fig. 1:7]. Nile silt amphorae were represented by two basic forms: LRA 7 and Egloff 172 [Fig. 1:8–9]. Recorded fine wares included several examples of Cypriot Red Slip [Fig. 1:10–11], African Red Slip [Fig. 1:12] and their Egyptian counterparts, both A (Aswan) and B (Nile silt ware) groups spanning the entire period [Fig. 1:13].

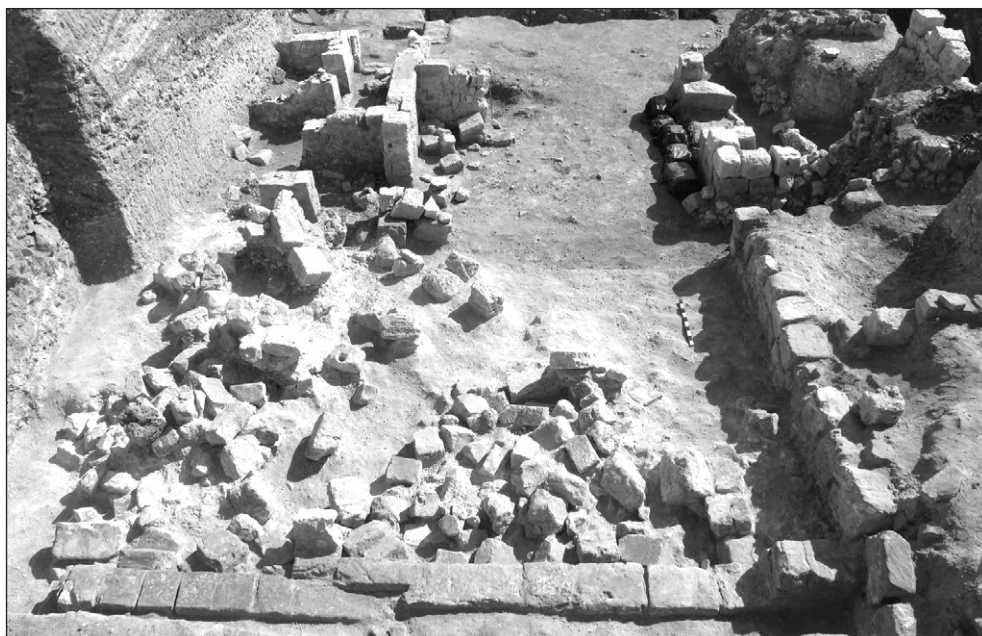
Fig. 3. House FB. Western wing, looking east  
(Photo G. Majcherek)

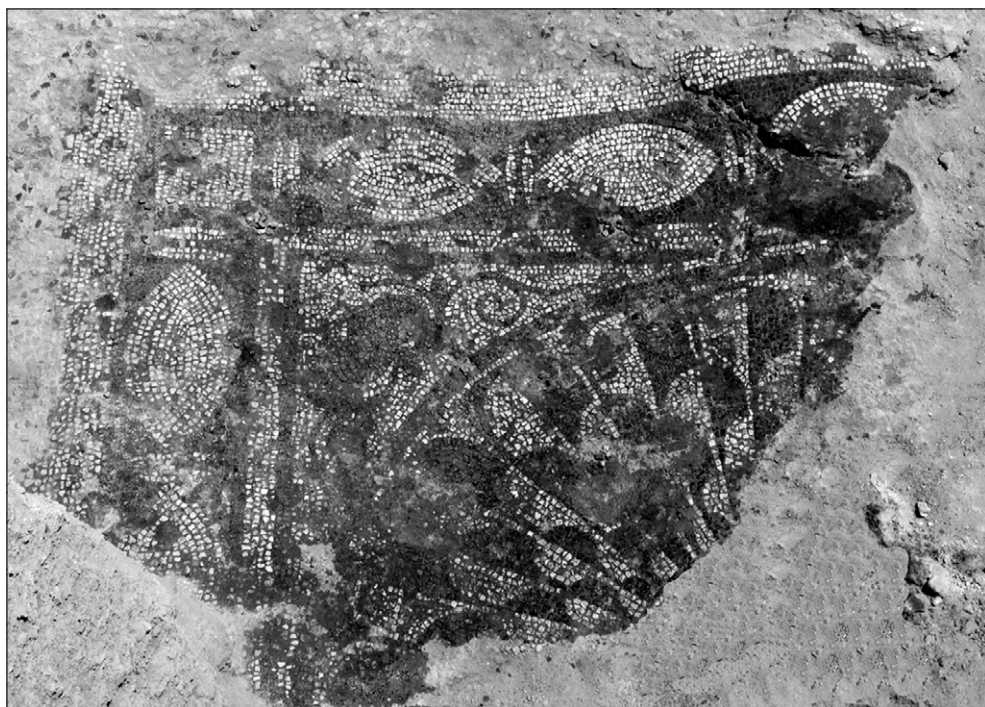
Fig. 4. Mosaic found in room 18 of house FB  
(Photo G. Majcherek)

Room 18 was accessible from the east, from room 14, via a tripartite entrance emphasizing its significance. A large fragment of floor mosaic was cleared in the southeastern part of the room [Fig. 4]. Although only about a quarter of its original surface has been preserved. The ample space along the eastern and northern edge was paved with small, irregular stones with no inherent pattern. The mosaic proper featured a geometric design with some floral elements. Simple border decoration consisted of a schematized astragal pattern in white on a black background. The central field (originally 2.70 m square) was framed by a narrow black band. A shield of bichrome, interchanging scales was inscribed in a square field (for a similar mosaic featuring a shield of interchanging black-and-white scales, discovered in the 1990s in House

MA, see Majcherek 2001: 29–32). The corners of the square were filled with ivy scroll and *hederae*. There is little doubt that the shield must have enclosed a rounded emblema (now lost). The size and location of the mosaic implies that room 18 must have originally extended well to the north (beyond the limits of the trench), and it must have originally measured some 6 m by 6 m. The overall layout of the mosaic floor, positioned centrally in the square room, is typical of an *oikos* rather than a *triclinium*.

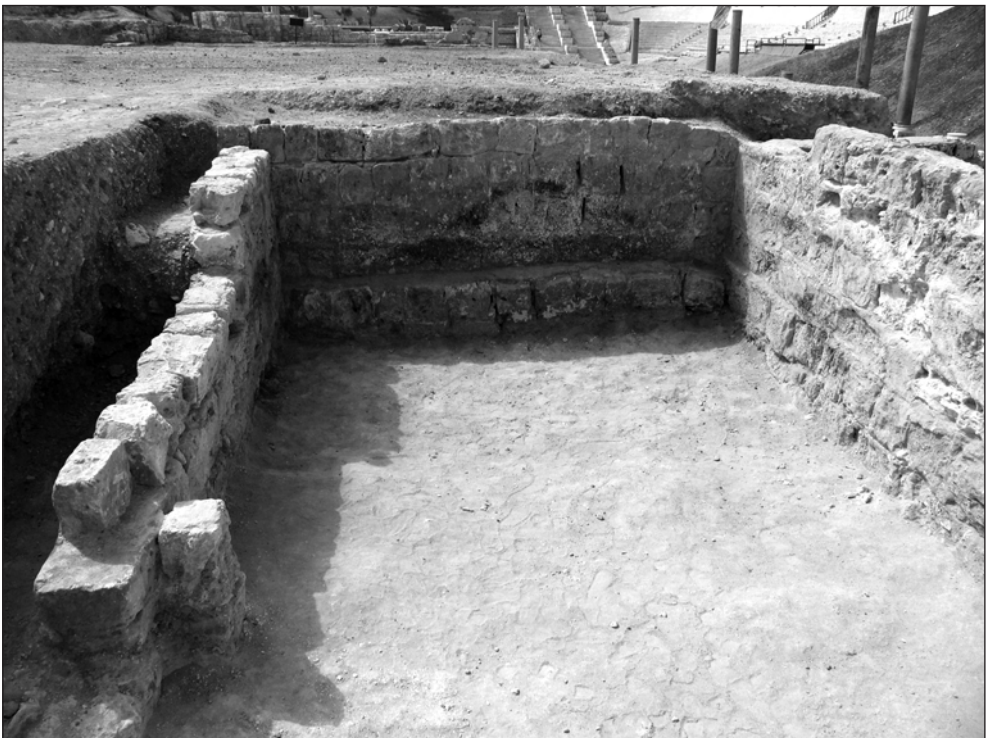
Fig. 6. Auditorium E, looking south  
(Photo G. Majcherek)

Auditorium E, like the adjacent hall D, appears to have been rebuilt substantially in the early 7th century. The benches were dismantled, completely as it turned out in the case of hall E, and the northern parts of the halls were transformed into something entirely different. The original entrances from the north were retained, but a new wall was installed at the southern end, shortening the available space to just 4.40 m [Fig. 7]. The new wall was built in

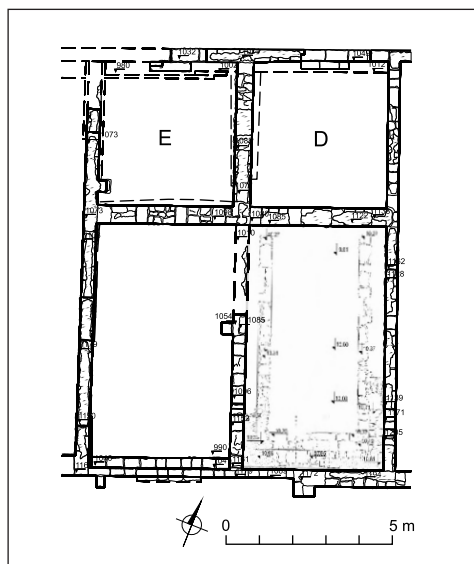
Fig. 7. Plan of lecture halls D and E, final phase from the early 7th century (Drawing D. Tarara, M. Soltys)

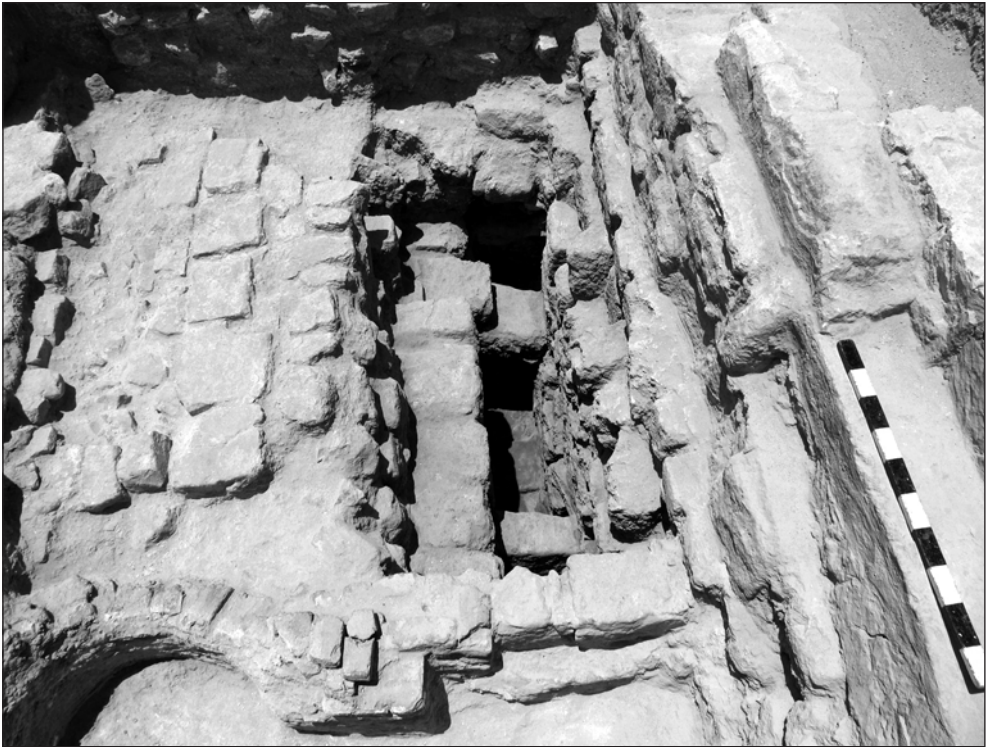
Fig. 8. Latrine channel and lime kiln predating auditorium E (north facade wall of the hall at left) (Photo G. Majcherek)

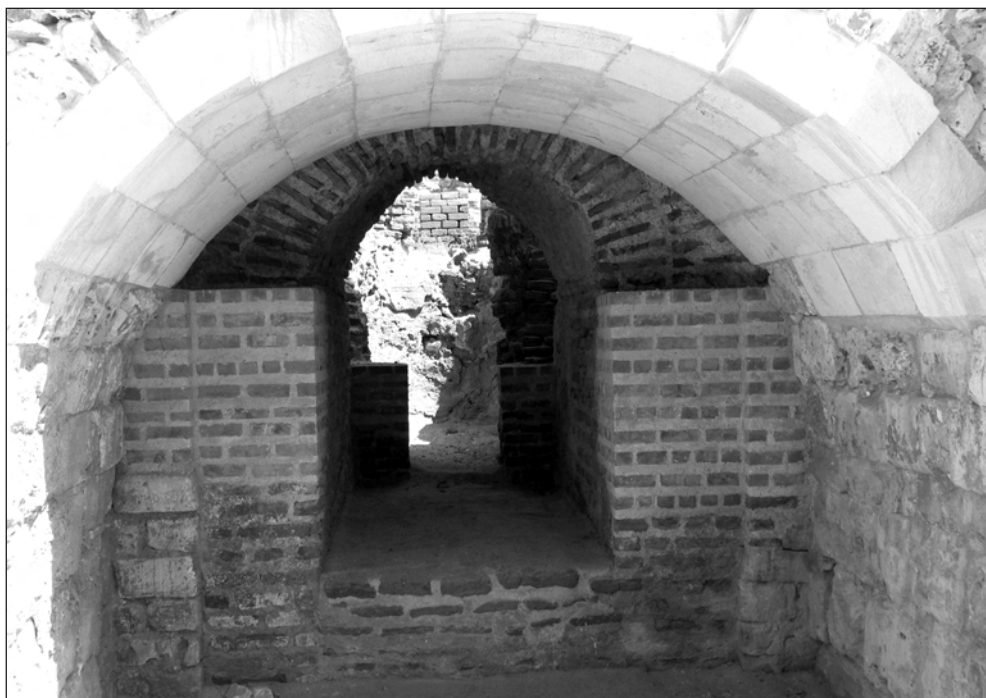
Fig. 10. Bath complex. Underground service area during the 2009 season conservation work (Photo A. Pisarzewski)

To provide a safe and serviceable means of access for future visitors, it was decided to build a modern stairway leading down to the bath cellar. Restoration of the lateral walls of the underground chamber were a prerequisite for this operation. The south wall survived as the lowermost course, while the north one had to be built from scratch, having been dismantled almost entirely already in late antiquity (Kołątaj 1992: 56–62). Walls were reconstituted in modern limestone blocks cut to proper size (50 x 40 x 30 cm) and set in isodomic courses, matching extant ancient walls. Both walls were restored for a distance of 6 m and to a height of 1.30 m. Higher up, slightly sloping retaining walls made of smaller assorted stones (10 courses) were

built. Their height reached ground level, thus creating a sort of casing, into which a stairway was subsequently introduced [Fig. 10].

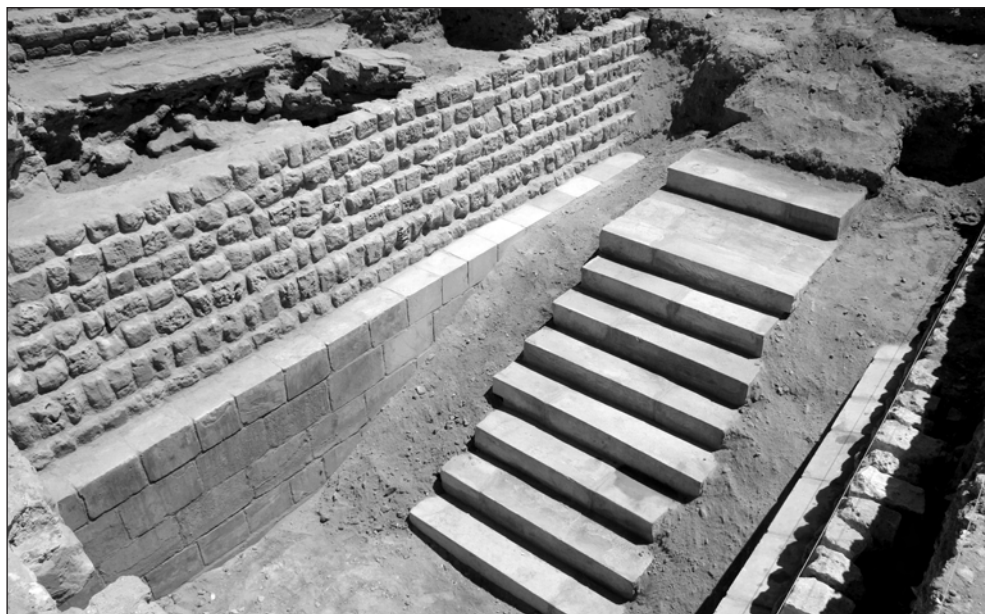
*Fig. 11. Modern staircase leading to the underground service area of the baths  
(Photo A. Pisarzewski)*

The design of this staircase had to take into consideration the vertical distance, more than 3 m, between the floor of the frigidarium and the cellar, as well as modern construction requirements. It was planned as an unobtrusive structure, separated from the ancient substance, but integrated visually with neighbouring monuments. The straight flight of stairs (approximately 5.70 m long and 1.60 m wide) has 15 rises with a wide landing halfway down. As stipulated by modern building standards, the pitch was set at 30 degrees [Fig. 11].

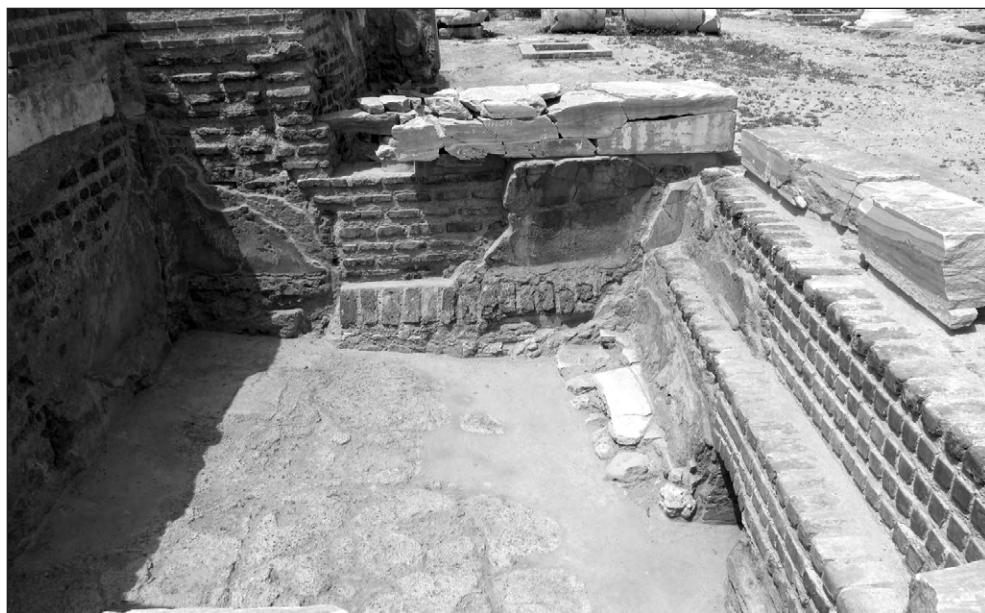
*Fig. 12. Marble-lined pool in the frigidarium of the Imperial bath, state following restoration in 2009  
(Photo G. Majcherek)*

The outer brick facing of the pool having been treated in the previous season, work now proceeded on the conservation from within. The whole structure appeared to be in rather poor condition; some of the bricks were totally disintegrated, large patches of waterproof plaster were found detached from the walls and large cracks in the walls and floor added to the danger of water penetration. Several blocks of the *pluteus* had either subsided or been displaced.

Upon assessing all theoretical and practical considerations,<sup>2</sup> work started with an initial mechanical cleaning of all surfaces, followed by removal of old cement mortar patches and badly corroded steel rods introduced in the 1960s. The vertical cracks in the walls were filled with new lime mortar and damaged sections of walls were completed with new bricks. Edges of extant plastering were protected with lime mortar and their surfaces additionally treated with a 25% solution of polyvinyl alcohol. Missing fragments were completed with new mortar. Blocks of

the marble *pluteus* were dismantled where necessary and reassembled. Loose marble fragments were put together using epoxy resin (ARALDITE PY 1092) with brass rod reinforcements (ø 6 mm). The outlet of the pool located in its east wall was also cleaned and repaired in order to allow unimpeded evacuation of rainwater. Finally, missing fragments of the floor bedding (sunk some 0.60 m below ground level) were completed with new mortar, with some crushed bricks added [Fig. 12].

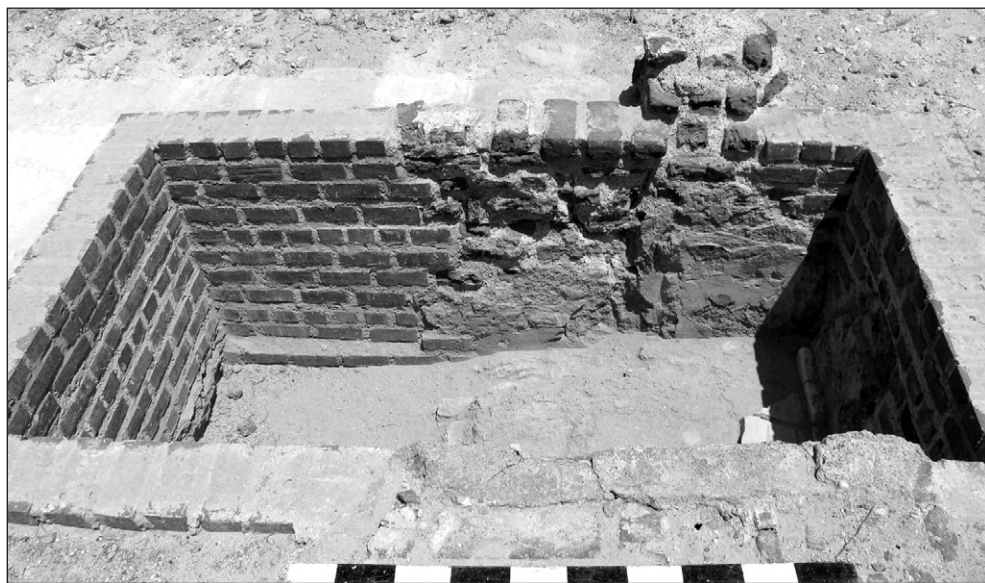
*Fig. 13. Small bathtub in the frigidarium of the bath, state following restoration In 2009  
(Photo G. Majcherek)]*

Preservation work in the frigidarium of the bath also included the restoration of a rectangular brick-made bathtub located in the northern end of the area [Fig. 13]. Loose bricks were fixed with new mortar; missing fragments of walls were completed. A coping of new bricks was laid with an additional insulation layer. Several patches of marble and limestone flooring were consolidated and new protective edges installed.

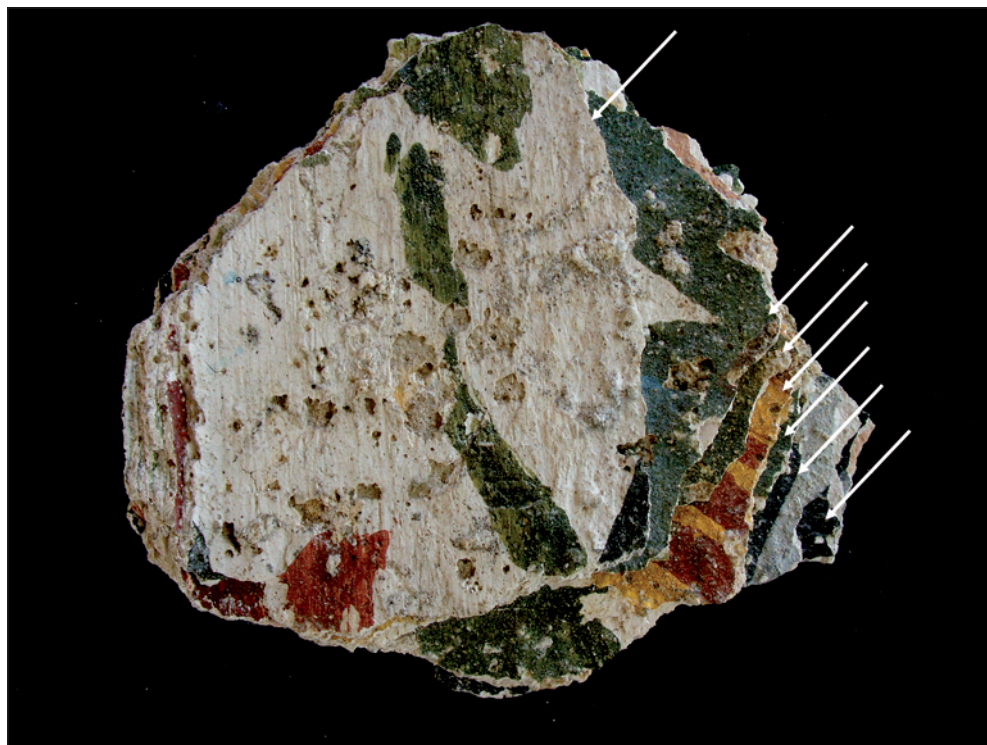
*Fig. 14. Superimposed coats of painted decoration on a piece of plaster from the fill of auditorium E (All photos by K. Lach)*

The wall plaster fragments were meticulously lifted and preserved. In most cases they represented several superimposed coats of painted decoration [Fig. 14]. The chief colors in use were white, yellow, shades of pink and black, as well as to a lesser extent red, blue and green. Most of the discovered fragments were no more than 10 cm across. The number of coats of painted decoration ranged from one to several.

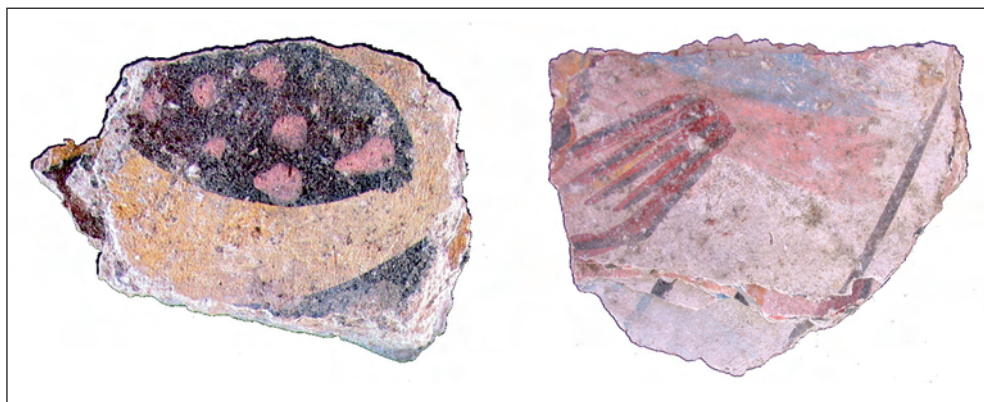
*Fig. 15. Fragments of wall plaster with decoration possibly from figural compositions*

The most frequent motifs of painted decoration consisted of irregular elements, which could have been part of figural compositions [Fig. 15]. The next group in terms of quantity were pieces of wall plaster with a uniform color background,

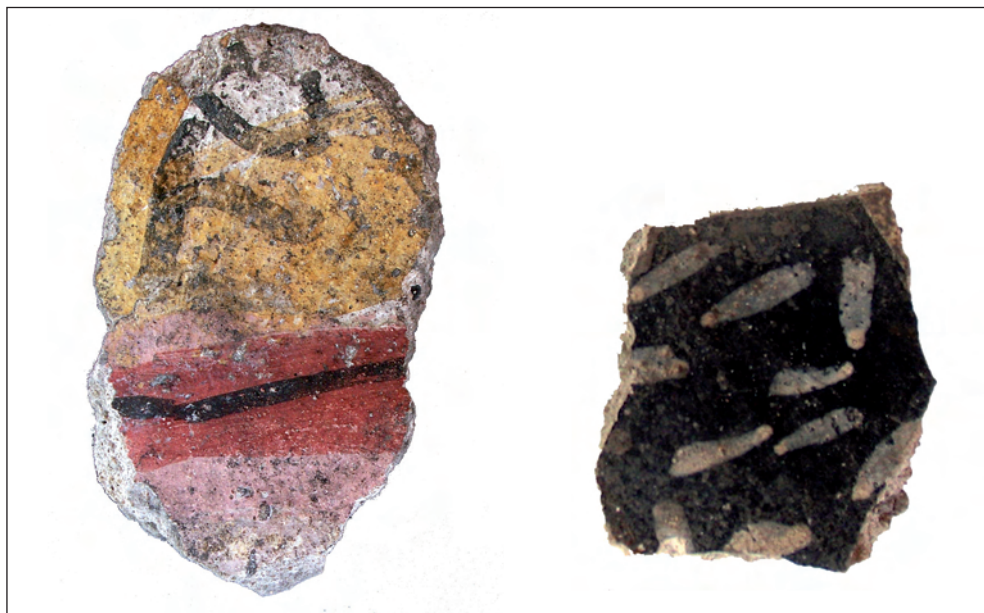
*Fig. 16. Fragments of wall plaster with uniform color background covered with irregular brushstrokes (left) or contrasting splashes*

covered with irregular brushstrokes or contrasting splashes [Fig. 16]. Vegetal motifs were suggested on some fragments, as well as geometric patterns [Fig. 17, top row]. Part of the assemblage bore lines and bands of different width and color [Fig. 17, bottom row].

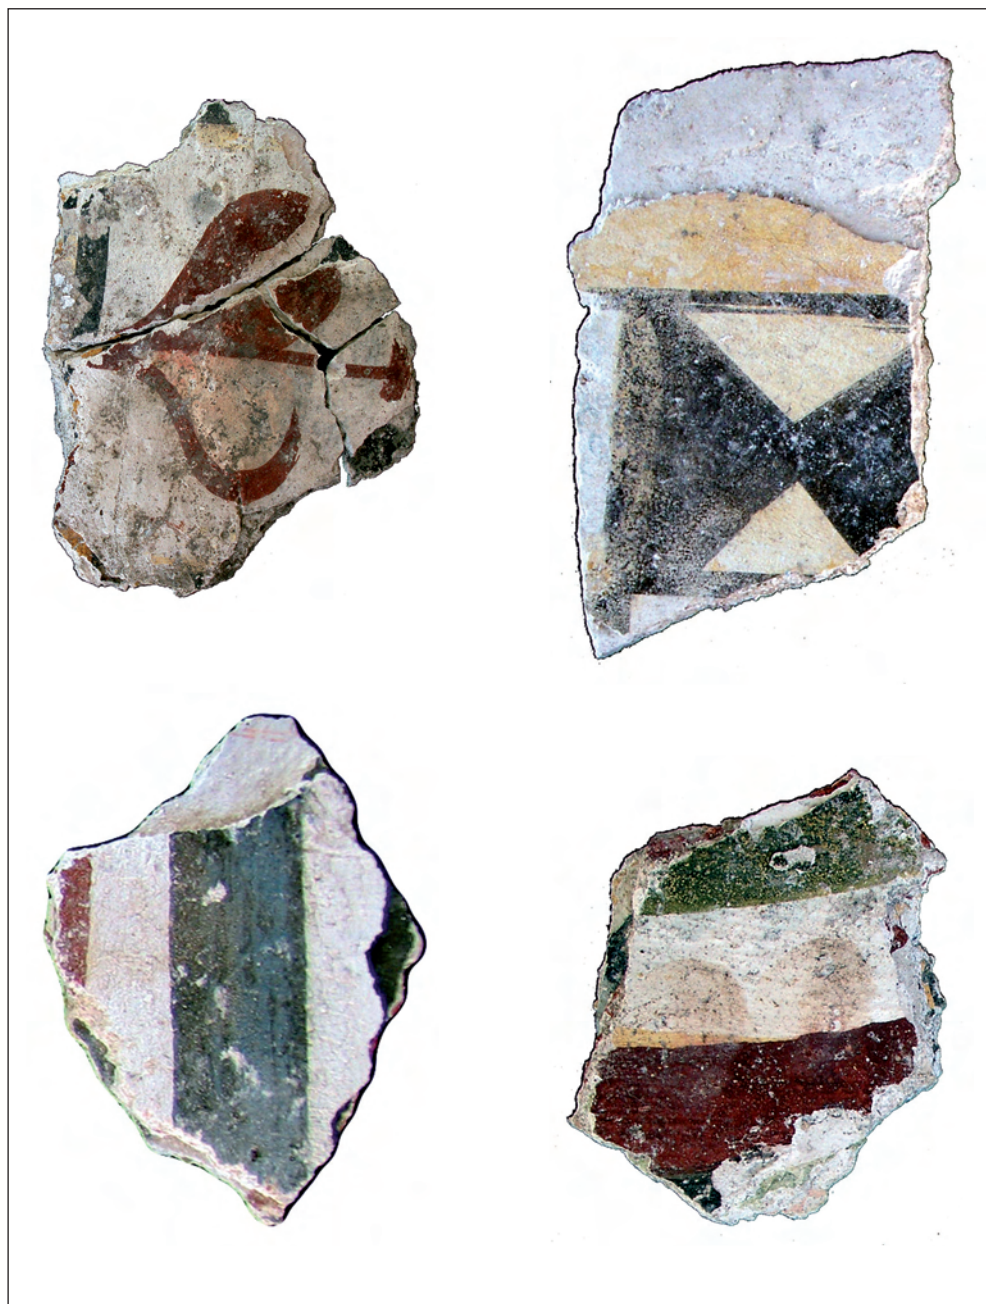
*Fig. 17. Fragments of wall plaster with vegetal (top left) and geometric motifs (top right) and color lines and bands (bottom row)*
