Title: **Buildings on Site B at Naqlun (Nekloni)**

Author(s): Szymon Maślak

Journal: *Polish Archaeology in the Mediterranean* 21 (Research 2009)

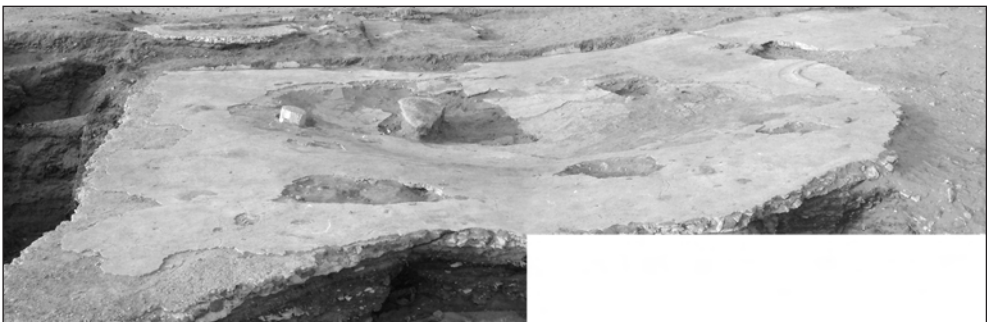
Fig. 2. Vestiges of the pavement in units B.22, state after excavations in 1992 (Photo W. Godlewski; montage of original documentation)

The pavement in unit B.22 was the largest continuous fragment cleared: approximately 8.85–9.55 m by 9.55 m (see Godlewski 1993a: 44; Godlewski *et alii* 1994: 210). The northern and northeastern limits of this floor were well-defined, while the western, southern and southeastern edges were damaged severely and the corresponding walls had all but disappeared. There were other gaps in the surface of the pavement and much of the central part had subsided [*Fig. 2*].

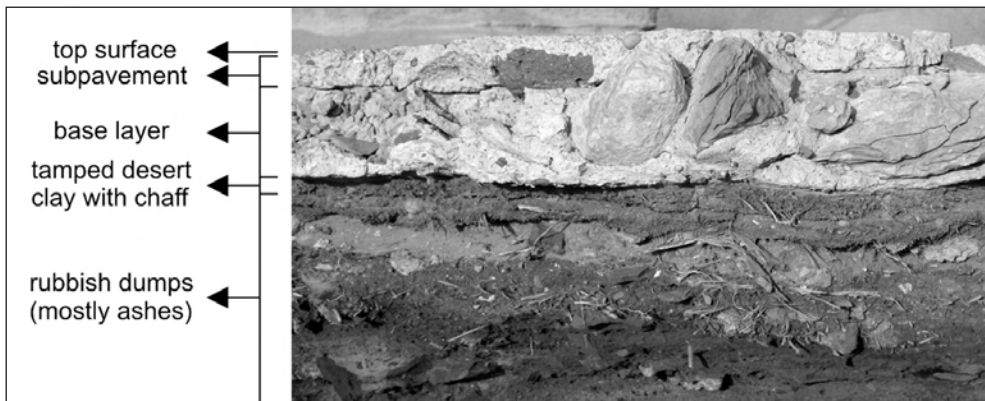
Fig. 3. Cross-section through the pavement in unit B.22
(Photo S. Maślak)

The pavement is admittedly the best preserved feature of unit B.22. The significant depression in the central part could be explained by the collapse of heavy columns (or pillars and/or wooden posts, see Godlewski 1993a: 45), which would have damaged the pavement surface and caused the soft refuse dump under the pavement to subside; indirectly, it is considered as proof of there being a peristyle courtyard in this unit. The pavement itself was made of four consecutively laid technical layers [Fig. 3].⁴ The bottom layer is a thin layer of light grey tamped desert clay containing large amounts of chaff.⁵ It corresponded to the walls identified as footing of the vertical structural elements of the possible courtyard in unit B.22. A base layer approximately 10 cm thick lay on top of this earthen layer. This second layer was composed of densely packed baked brick, purple or dark

purple-grey in color, 23.5–24 x 10–11 x 5–6 cm, laid mostly as headers on edge (both upright and inclined), more seldom in flat position. The bricks were mixed with stone rubble, both set in grayish lime mortar (with sand, coarse gravel and some ground ashes added). The sub-pavement directly above it, was 2–3 cm thick; it was made using the same binder as in the layer below. The smoothed uppermost layer (only 1.5 cm thick) was the proper pavement and walking level. It was made of creamy-colored lime mortar containing large amounts of fine sand.

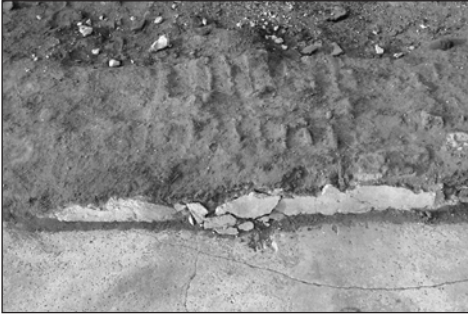
Fig. 5. Plaster on the southern face of the north wall of unit B.22 (Photo W. Godlewski)

masonry. The foundation brick course is set only 0.10 m below the level of pavement in soft ashy deposits. It is made of headers on edges shifting into simple headers. The lowermost brick courses of the wall show headers or stretchers in the faces. The core on this level is filled with headers or irregularly laid bricks, brick fragments and mortar. However, as the original photographic documentation from the 1992 season demonstrates, the bonding above the two lowermost courses consisted of courses of headers-on-edges alternating with courses of stretchers in the faces. The wall, at least in the bottom part, was coated with white lime plaster [Fig. 5].

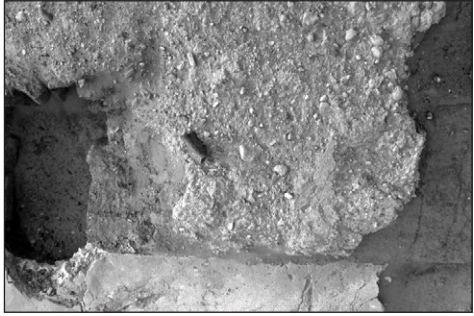
Fig. 6. Pavement of unit B.23 overlying wall dividing the unit from B.21 (Photo W. Godlewski)

A structural interbonding of the east and north walls of unit B.23 and the north wall of unit B.21 cannot be determined beyond doubt and in consequence it cannot be said that the unit was part of the original building. No clear division between them is observable at first glance, but the state of preservation precludes a satisfactory determination. Only the foundation courses of the east and north walls of unit B.23 have survived, showing headers on edge in both faces. They mark the limits of the unit pavement on these sides, which is not the case of the wall separating unit B.23 from the southern unit B.21. The pavement of the northern unit overlies partly the lowest courses of the wall, ending sharply at the edge of the pavement of unit B.21, not overlapping any part of the latter [Fig. 6].

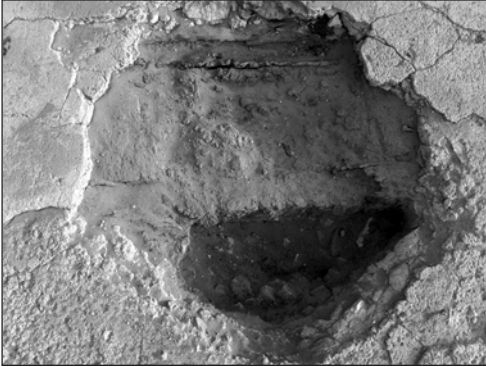
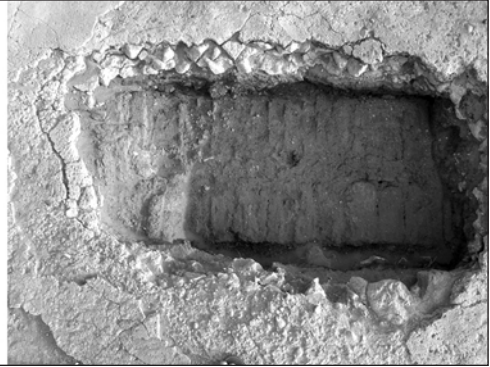
Fig. 7. Postholes with wall at the bottom and wooden planks, westernmost in south row (right) and in the center (left) (Photo W. Godlewski)

elements have survived at the bottom of three of the postholes on the southern side [Fig. 7]. This sun-dried brick wall, which was below the pavement, may never have been much higher. It was 0.55 m thick, constructed of sun-dried bricks (23-24 x 12.5 x 5-5.5cm) made of mud mixed with chaff, and had planks of palm wood (approximately 12-13 cm wide, i.e., one brick wide) embedded along both of its faces. The evidence of the bedding of this wall, which was much deeper than the north outer wall of the unit, is of structural importance. There is no trace of the wall in the cross-section at the western end of the pavement and it is very likely that it did not go much beyond the level of the pavement; it could have served as a footing for some vertical structural elements.

damaged posthole half way between them must have been of the same kind. Fragments of palm wood planks and sun-dried bricks at the bottom of two surviving postholes are certainly the remains of footing similar to that found farther to the south.

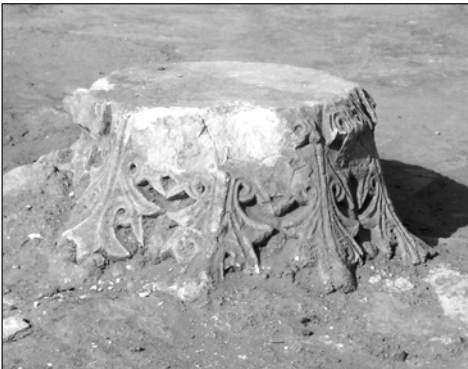
Fig. 8. Limestone capital Nd.92.400 (Photo W. Godlewski)

Few objects have survived from the original architectural decoration of the interior and all of them were certainly reused. A fragment of a small stone column shaft (diameter approximately 35cm) was found in the westernmost post-hole of the northern row in unit B.22. The easternmost hole in the same row produced a limestone capital Nd.92.400 (H. 0.36 m, W. of base 0.45 cm) with stylized leaves of

acanthus (Godlewski 1993a: 45) [*Fig. 8*]. It stood upside down and could have been reused as a column base. The capital is dated to the early 6th century (Godlewski 1993a: 45).

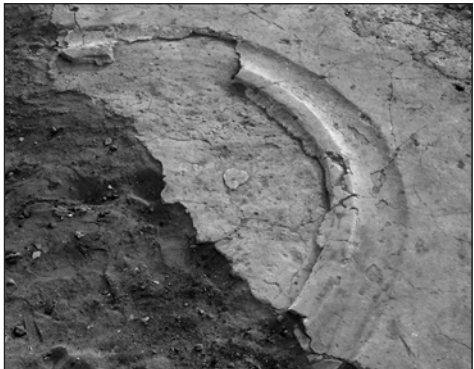
Fig. 9. Semicircular feature at the eastern end of B.22 (Photo W. Godlewski)

The most remarkable feature in unit B.22 was recorded at the eastern end of the east-west axis of the unit. The structure is only partly preserved, but it appears to have been semicircular in plan, measuring 2.50 m in diameter [*Fig. 9*]. It is unlikely to have been circular, projecting into unit B.21 as much as into B.22, but the pavement abutting the structure from unit B.21 is almost entirely lost (the surviving edge of the pavement to the north may be evidence against the reconstruction of the structure as a circle projecting into both units). The structure consists of a shallow semicircular depression on the outside (approx. 0.20 m wide) and a convex semicircular band on the inside (approx. 0.10 m wide). Scanty jagged remains indicate that another semicircular depression, similar to the outer one, could be expected inside. All these features were first drawn skillfully with a sharp tool in the sub-pavement (see below), and after that shaped, certainly with another tool running perfectly on the radius of a circle, in the uppermost layer of the same pavement. It is difficult to say what had stood inside these concentric circles by the wall (or in place of the wall) dividing units B.21 and B.22. The function of the structure is unknown. It may have been part of a larger device, the other parts of which are missing along with the unpreserved fragments of the pavement in unit B.21.³

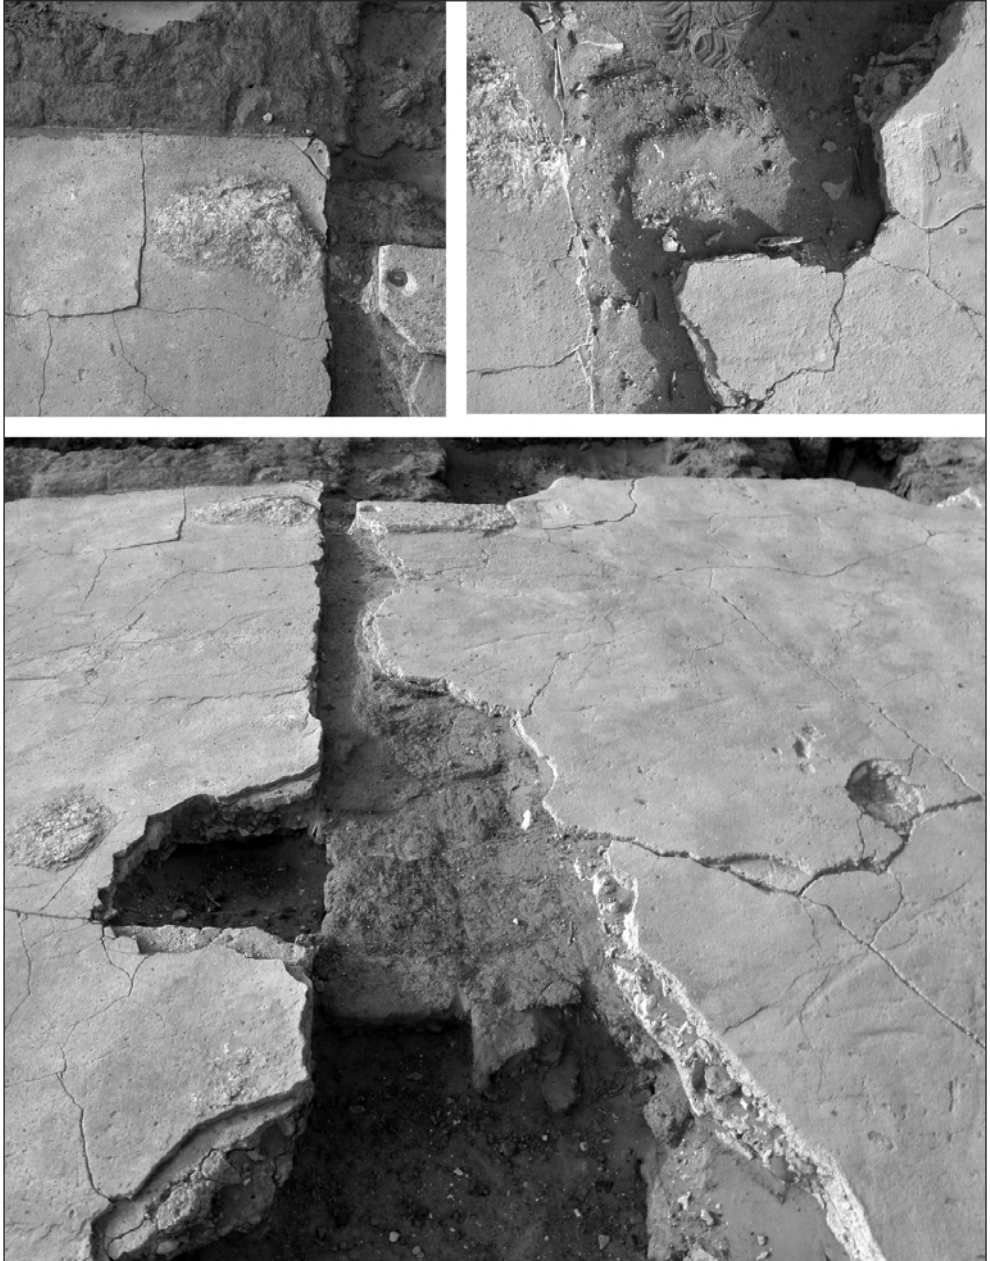
Fig. 10. Pavements of units B.22 (left) and B.21: top left, northeastern corner and socket to right; top right, impression of moving door panel in the pavement on right (note removed socket); bottom, general view of the partition between units (Photos W. Godlewski)

The northeastern corner of the pavement in unit B.22 is perfectly preserved [Fig. 10]. The plain edge of the pavement here is clear evidence of a wall (or some other long and vertical structure) dividing units B.22 and B.21. Regrettably, little has

A rectangular limestone slab (49 x 23 x 5–8 cm) was inserted into the pavement in the northwestern corner of the unit. The circular cavity in one of the corners certainly served as a door socket. The position of the slab, as well as the rounded impression of the bottom edge of a door panel in the pavement surface [Fig. 10, top], resulting

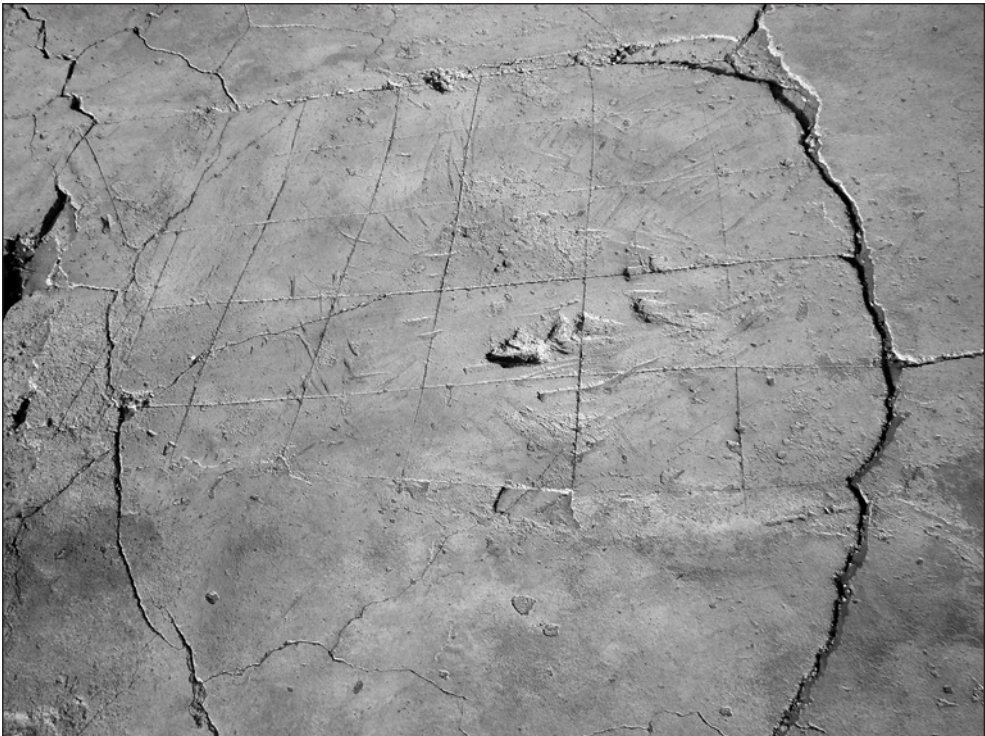
Fig. 11. Checker pattern in the pavement of unit B.21
(Photo W. Godlewski)

The pavement of unit B.21 preserved some remarkable features. A checker pattern incised in the central part of the pavement is one of them [Fig. 11]. The pattern is trapezoidal (approximately 1.75 m by 1.25–1.40 m), skewed slightly west of north. Four small holes (approx. 0.10 m square) were drilled around it, more or less equidistant from one another. These holes are probably evidence of missing posts, made likely of wood. One can only guess that the checker pattern was covered with a light, probably wooden, four-legged

structure, perhaps a table or canopy(?). Immediately to the south of the checker pattern there is another incised design, only partly preserved, consisting of rectangular panels, each divided into four triangles by two diagonal lines. These incised drawings resembled board games in everything except the size, which was unusually large.

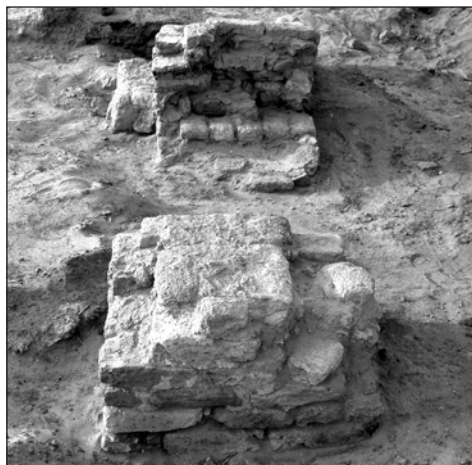
Fig. 13. East wall of room B.2 seen from the south; pillar(?) from older structure in the foreground (Photo W. Godlewski)

The east wall of unit B.2 was preserved in better condition in its central and northern parts; at the southern end only single bricks have survived. The central part of this wall may be older than the rest of it judging by the different building technique, hence it could have been left from an otherwise unevenced earlier structure [*Fig. 12*]. This wall fragment is rectangular in plan (0.72 m by 0.52 m), resembling a pillar. At the bottom it shows baked brick fired yellow (25.5 x 12.5 x 7 cm) and bonded in mortar of light brown clay mixed with huge amounts of chaff. The upper part is distinctively a later addition. It is built either of baked brick fired red (24–26 x 11–13 x 6–7 cm) or of sun-dried brick (24 x 12–12.5 x 4.5–5.5 cm), both bonded in plain mortar of gray mud

with chaff. The bonding features bricks laid flat, stretchers in the faces and headers at the corners, but fragmented bricks occur as well. The northern section of the east wall of room B.2 has the same thickness (0.71–0.72 m) as the pillar-like structure in the central part of the wall. Sun-dried brick (of mud with chaff mostly, 24.5–25 x 11.5–12 x 5–5.5 cm) is the chief building material in this case. Several fragments of baked brick (fired both red and yellow, unknown length x 12.5–13 x 5–6.5 cm) are used haphazardly in the construction. Wall faces show flat-laid bricks without any pretence to regularity in the bonding. A foundation course, mostly of headers on edge, stood on a layer of ashes (charred *sebbakh*?).

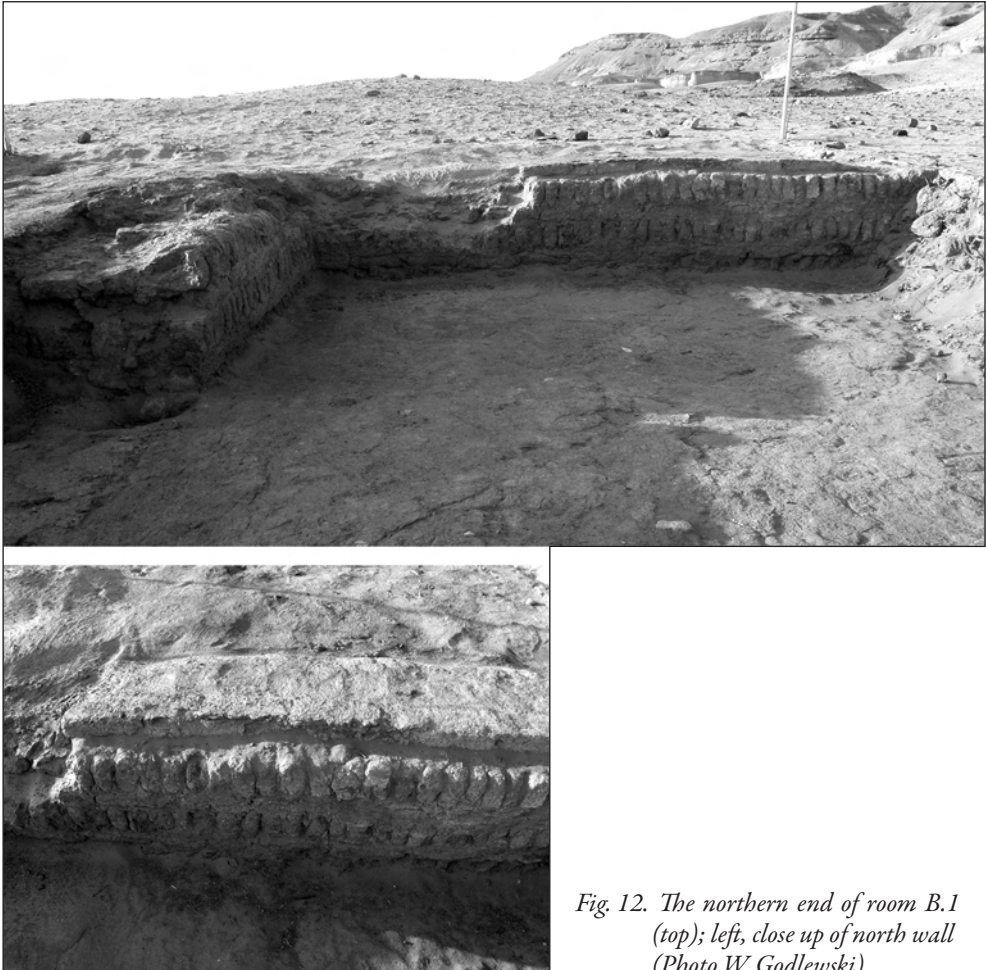
Fig. 12. The northern end of room B.1 (top); left, close up of north wall (Photo W. Godlewski)

The floor in unit B.1 marked in negative the course of the south and much of the west walls. The north wall [Fig. 13]

and the surviving part of the west wall featured a long and shallow recess set about 0.45 m above floor level. This shelf, which was about 0.10 m deep, extended nearly the entire length of the inner faces of these walls. The bonding of these walls was fairly standard: alternating courses of stretchers and headers on edge. Headers on edge were present also in the foundation course of the west wall, which stood directly on the leveled surface of tamped *sebbakh* (?),

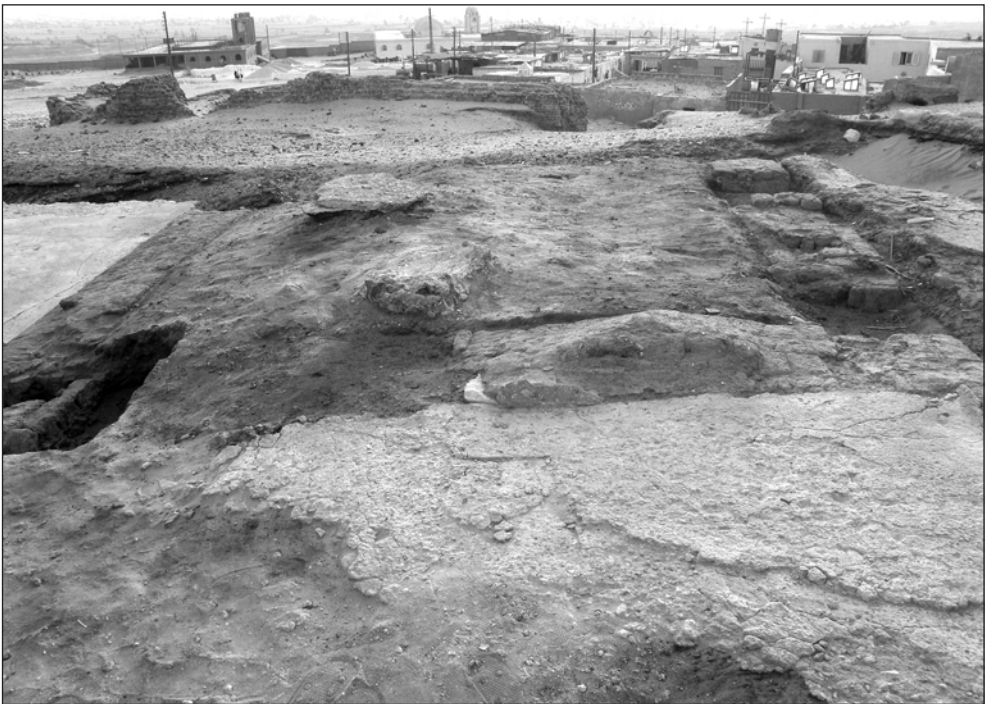
Fig. 14. View toward the medieval and modern compound of the monastery with the church of the Archangel Gabriel with the remains of units B.23–B.26 in the foreground, looking west (Photo W. Godlewski)

The row of units added in the second phase along the north side of units B.21–B.22, was founded on a yet higher level. Unit B.23, measuring approximately 2.80 m in width and at least 3 m in length, may have belonged to the original phase of the building (see section on walls above). However, the overall layout of the western complex and the level of the foundations of unit B.23 are in stark contradiction with this idea. Units B.25 and B.26 are clearly later extensions; they are a little wider than B.23 and measure approximately 3–3.20 m in width and more than 2.20–3 m in length.

complex, one should take into consideration its location [Fig. 15]. It was definitely located higher on the plateau than other parts of the monastic compound further to the north and the modern monastery with the church of Archangel Gabriel to the west [Fig. 14], this being due in part to natural landscape features and in part to the accumulation of refuse on the site. But it was not the elevation of the site, which played the most important role. The building lay on the absolutely southernmost fringe of the monastic complex with no other architectural remains to the south of site B. Even the refuse dump, which extends there now, appears to have been relocated

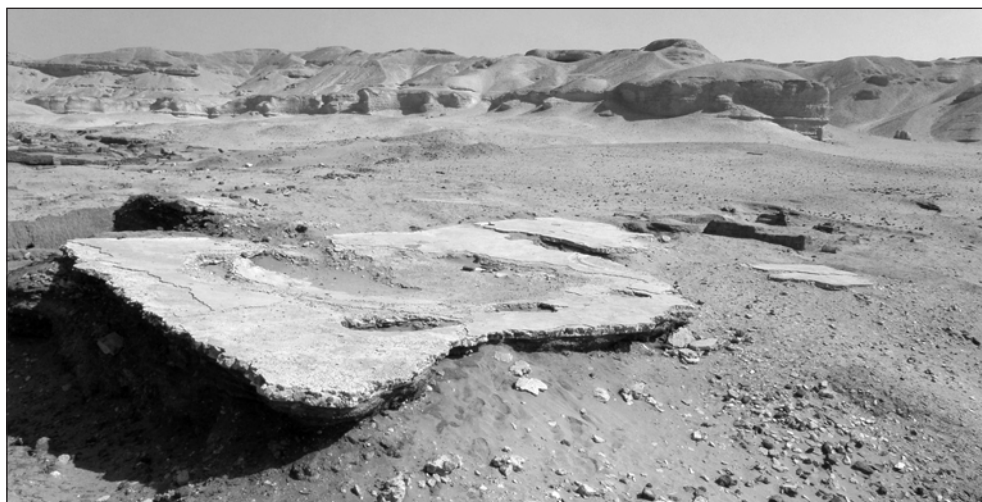
*Fig. 15. View of units B.21–B.22 in the foreground, looking west toward the *gebel* (Photo W. Godlewski)*
