Title: Alexandria. Excavations and preservation work on Kom el-Dikka. Preliminary report 2009/2010

Author(s): Grzegorz Majcherek

Journal: *Polish Archaeology in the Mediterranean* 22 (Research 2010)

EXCAVATIONS AND PRESERVATION WORK ON KOM EL-DIKKA, PRELIMINARY REPORT 2009/2010

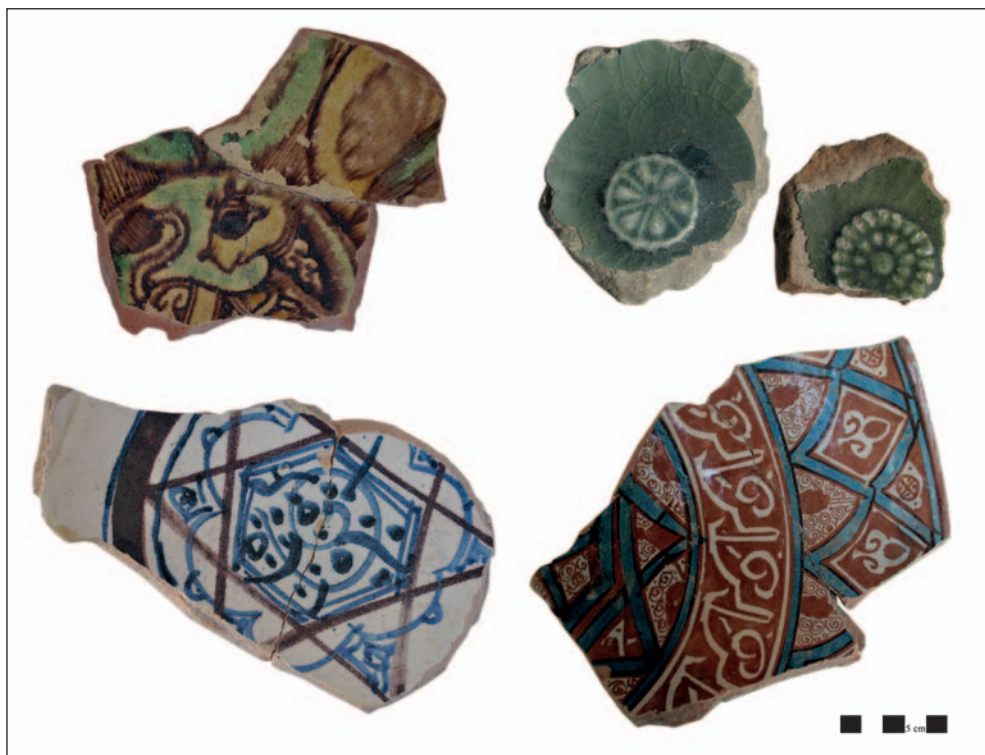
Fig. 1. Early Islamic wares from the Kom el-Dikka excavations: top right, Chinese celadon ware imitations, Mamluk period (14th–15th century); bottom right, Hispano-Moresque lusterware (14th–15th century); top left, Raqada ware (9th–10th century); Hafsia glazed ware (13th–15th century) (Photos M. Redlak, A. Zawadzka, J. Brochocki)

of pottery fragments (over 500 examples) representing Egyptian-made, Mamluk-age (mostly 14th–15th century AD) imitations of Chinese celadon wares [Fig. 1, top right]. The ware was decorated with incised motifs (rosettes, stars and festoons), covered with a characteristic transparent or opaque greenish-turquoise glaze. Two other assemblages of pottery of Western origin were also examined; the resultant studies were submitted in fulfillment of requirements for MA degrees

at the University of Warsaw. One of these was a sizeable collection of ceramics imported from Ifrikiyya (examined by Anna Zawadzińska). Apart from some Aghlabid, Raqada-type wares [Fig. 1, top left], most of the recorded sherds making up this group were dated to the reign of the Hafsid dynasty (AD 1228–1574) [Fig. 1, bottom left]. The other was an equally substantial collection of potsherds of Hispano-Moresque lusterware [Fig. 1, bottom right] (studied by Jakub Brochocki).

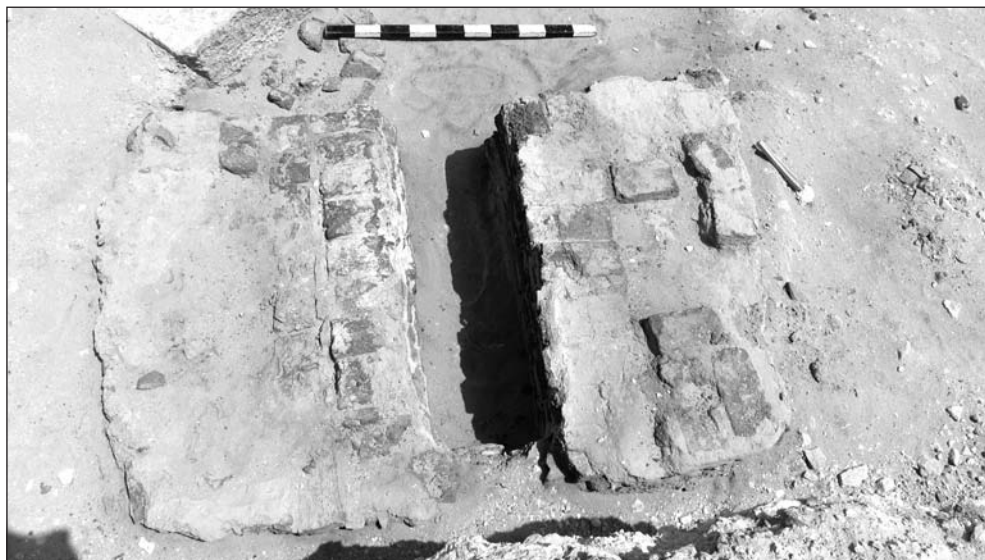
Fig. 4. Oven in area Q
(Photo G. Majcherek)

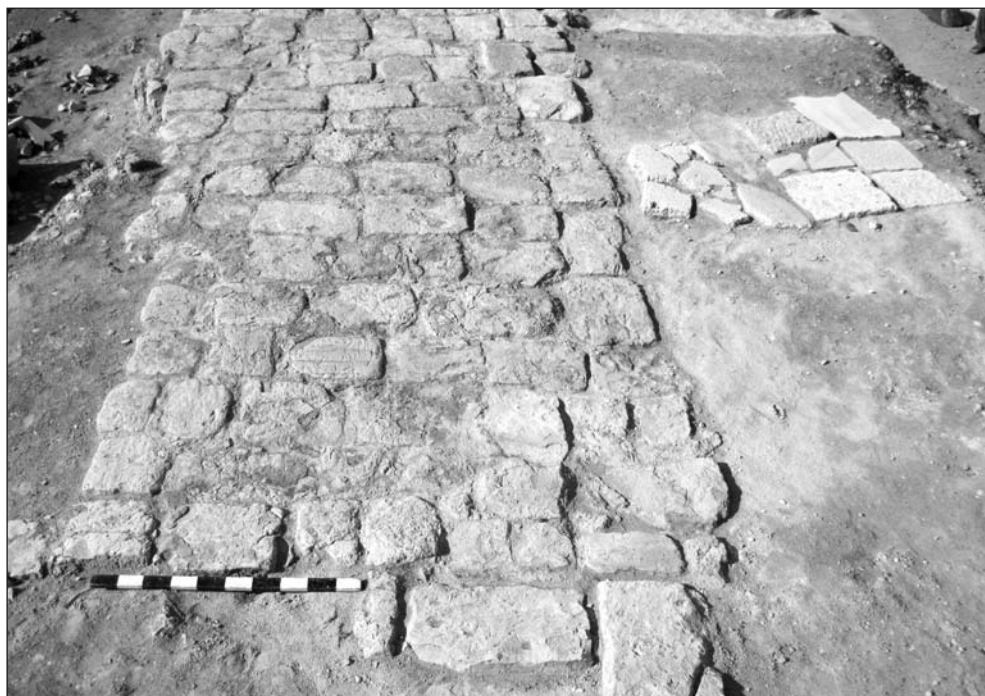
Fig. 5. Late pavement in area Q
(Photo E. Kulicka)

corresponding with that of the southern bath portico, although no original paving was preserved there. A higher level, however, produced a series of metallated floors, usually reinforced with lime, crushed bricks and pottery. It apparently lost its original function. A large brick-masonry kitchen oven occupied the middle of the area [Fig. 4]; similar ovens were previously cleared in the vicinity (Rodziewicz 1984: 278–279, Figs 295–296). It seems that towards Late Antiquity the entire area gained a new, service function, catering to bathers' needs. Still later the whole area was backfilled, substantially raised and repaved with reused pavers [Fig. 5]. However, the purpose of this refurbishment remains unclear. The chronology of this latest phase

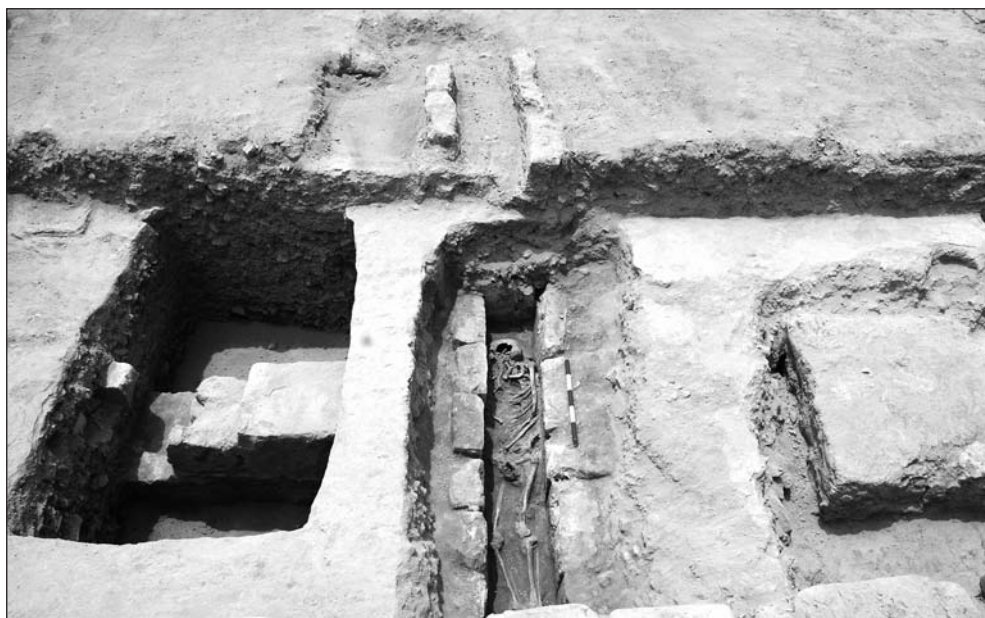
Fig. 7. Graves of the Lower Necropolis in area AS
(Photo A.M. Kotarba-Morley)

During the first phase of excavations in this area, several largely disturbed early Islamic graves, both stone structures and simple internments (Lower Necropolis, graves AS 320–340), were explored [Fig. 7]. The skeletal material, although seriously deteriorated, was duly stored, to be examined in due course by an anthropologist.

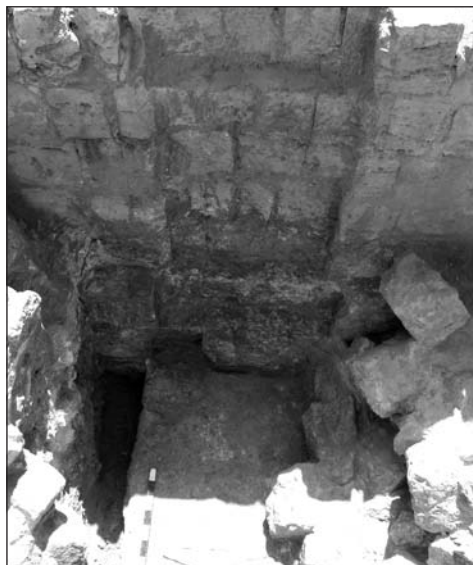
Fig. 9. Abutment of the east-west wall and the portico back wall (Photo A. Smilgin)

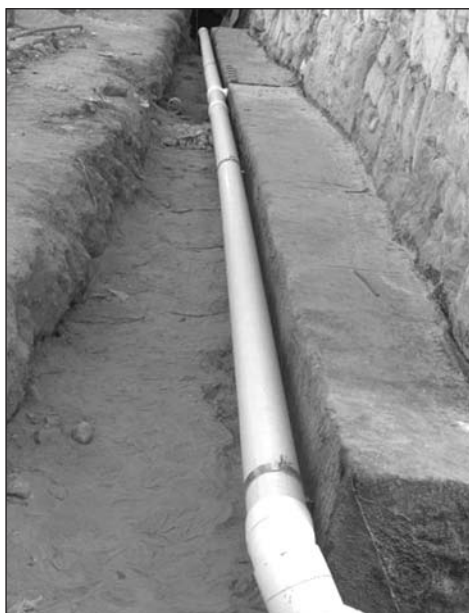
Fig. 10. Consolidated foundations and rainwater drainage of the east wall of the mosaic shelter (Photo J. Brochocki)

The foundations of the east wall of the shelter, which made use of a Late Roman wall, were cleared down to the footing

along the entire length of the wall (approximately 16 m). The deteriorated wall structure was repaired, missing or deteriorated blocks being replaced with new ones and the whole foundation consolidated with new mortar. The top and side surfaces of the foundations were rendered and waterproofed with pitch coating [Fig. 10]. Additional waterproof coating of double-folded polyethylene insulation sheets was applied for more effective anti-damp protection. To prevent further water penetration, the wall coping was consolidated and reshaped with a slight fall towards the outside.

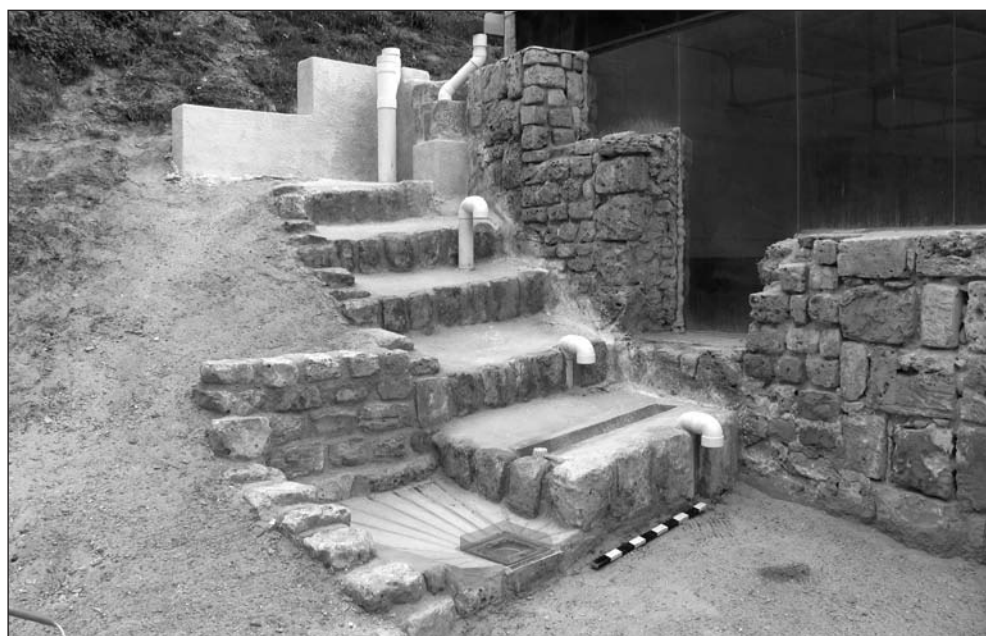
Fig. 11. Redesigned drainage system, plan and section (opposite page) and view of the southeastern corner of the shelter with the new drainage in place (top) (Drawing Z. Nawrot, M. Polak; photo G. Majcherek)

The faulty rainwater disposal system was redesigned to collect rainwater from both roof slopes and to drain it off to a nearby ancient well [Fig. 11]. The gutters were either remodeled or new ones, shaped of squared sheet iron, introduced along the eaves of the roof. New downspouts (PVC Ø 100 mm) were installed at the eastern ends of both gutters. The downpipes discharged into the main drain (PVC Ø 100 mm) buried along the east wall, emptying into an ancient well located north of the shelter. The installation took into account Alexandrian climate, being designed to cope with frequent copious winter downpours.

An additional drying installation was introduced in the southeastern corner of the shelter, which is the part of the structure that is the most liable to water seepage and hence most endangered [see Fig. 11]. As in other locations along the eastern elevation, the foundations were first consolidated and pitched. Then, the trench was filled with aggregate and gravel. Ventilation shafts of PVC pipes of varying length, corresponding to the rise of the ground, were installed vertically at 1.00–1.30 m intervals. The largest shaft (PVC Ø 150 mm, 5.15 m long) was positioned in the corner and was topped with a turbovent-rotary chimney cowl (Chanard-type). Considerable differences of atmospheric pressure have made the installation extremely effective in removing damp from the lowermost part of the foundations.

The adjacent section of the escarpment was reshaped into a series of cascading terraces designed to slow down slope erosion and minimize water infiltration. A side drain leading to a gully was installed by the lowermost terrace. The gully was then connected with the main PVC drain running along the east wall.

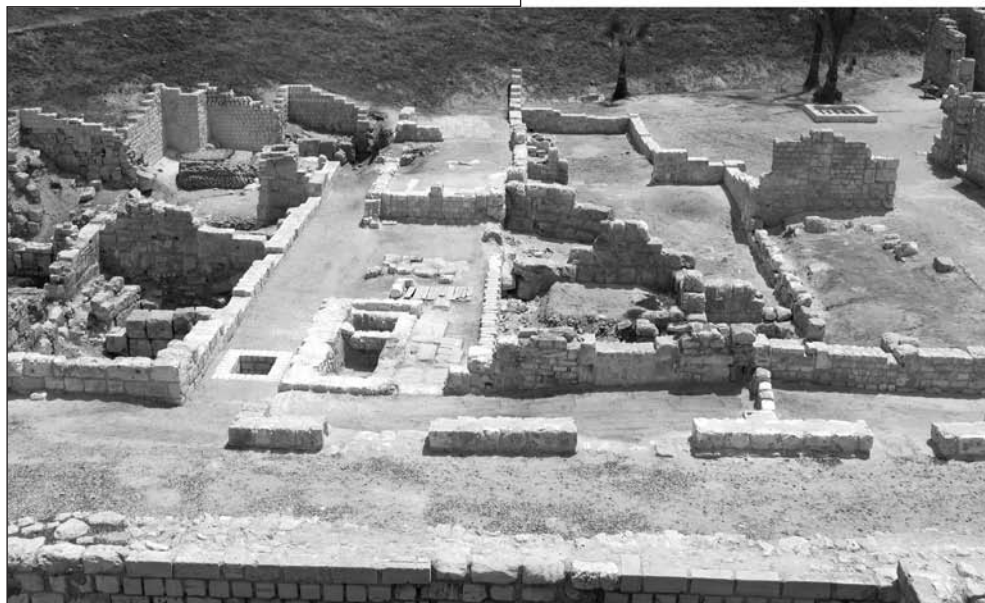
Fig. 13. Houses G and H, following wall restoration in 2010, looking east; top, plan of the area, restored walls marked in gray (Drawing K. Karpińska; photo G. Majcherek)

The south and east walls of room G18 were restored (altogether a stretch of 9.5 m) and the south walls of rooms G15 and G14a were also rebuilt. The restoration stopped one course above ground level as the excavation did not record the location of doors [Fig. 13, far back]. Most of the original walls (as evidenced by the extant sections) were structured in the pillar technique with a large block made of pillars set at regular intervals and the space between them filled with smaller assorted stones. In building H conservation was limited to the consolidation and partial restoration of the southern elevation [Fig. 13, top]. A large section of the wall (approximately 14 m long, 0.45–0.50 m thick) enclosing the southern wing of house H was restored to a height of approximately 1.10–1.30 m. Here the wall was structured in regular masonry with large ashlar set in isodomic courses. The restored wall courses were separated from the original masonry with a layer of bitumen tar paper, acting as both

anti-damp insulation and a recognizable border between the original fabric and modern additions. Ancient blocks found during excavations were used for the reconstruction in accordance with procedures previously established at the site (properly seasoned modern stone was not available).

A narrow east–west lane (perpendicular to street R4) dividing houses G and H was re-arranged to prepare the area for public display [see *Fig. 13*]. The operation included backfilling of some post-excavation trenches and surface leveling. A city sewer of Late Roman date running along the lane was also subjected to limited conservation. Several sections along the southern elevation of house H were consolidated and a manhole giving access to the sewer was partly restored. The manhole coping was rebuilt and made flush with the street level to secure safe traffic for visitors.

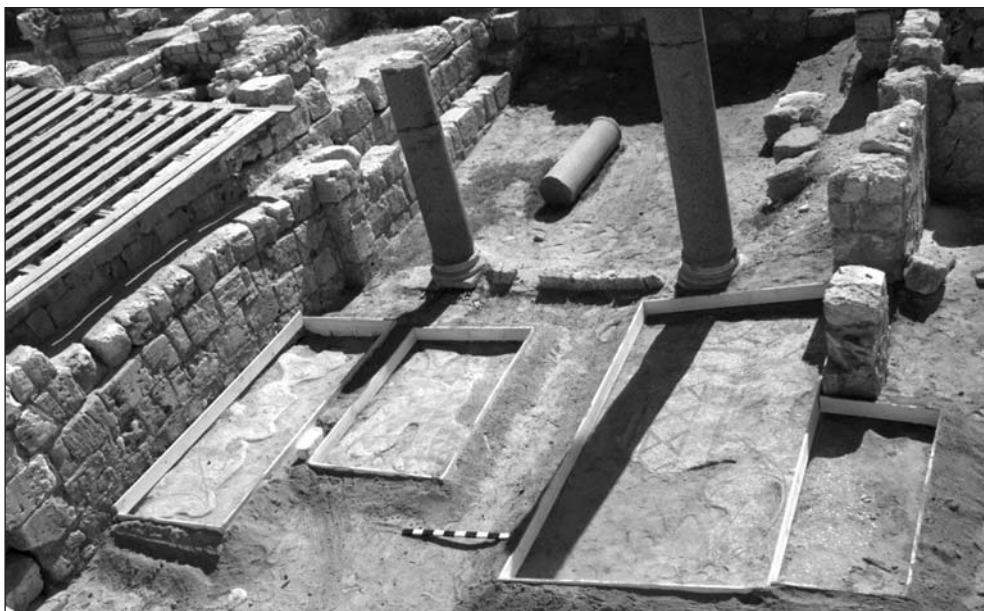
*Fig. 15. Mosaics protected in area F (House FB)
(Photo R. Mahler)*

Current maintenance preservation included, as usual, multiple locations and issues, ranging from basic procedures applied to wall fabric (tapping and grouting) to more elaborate ones, like stone replacement and shaping the wall coping. Measures were also taken to protect a fragmentary black-and-white mosaic with a geometric design discovered in house FB (Majcherek 1999), which was threatened by continuous heavy rains and vegetation. To preserve the integrity of the mosaic and to shield it from rainwater, the mosaic was protected with a specially built wooden casing [Fig. 15] and covered with a thick (0.15–0.20 m) protective layer of clean sand.
