Title: **The eastern tower at Banganarti 1**

Author(s): Mariusz Drzewiecki

Journal: *Polish Archaeology in the Mediterranean* 23/1 (Research 2011)

Abstract: In 2010 and 2011, excavations in the area of the eastern tower on the site of Banganarti 1 were carried out on archaeological layers altogether 4.50 m thick, comprising architectural remains and occupational layers associated with the tower and the nearby architecture. Two principal phases: wall I and wall II, were distinguished. A tower was observed in both phases. During the first phase the tower may have undergone some modification (subphases Ia and Ib), during the second, a new bigger tower was constructed on top of the earlier remains and a network of buildings interconnected by corridors, staircases and courtyards was constructed against the inside face of the wall.

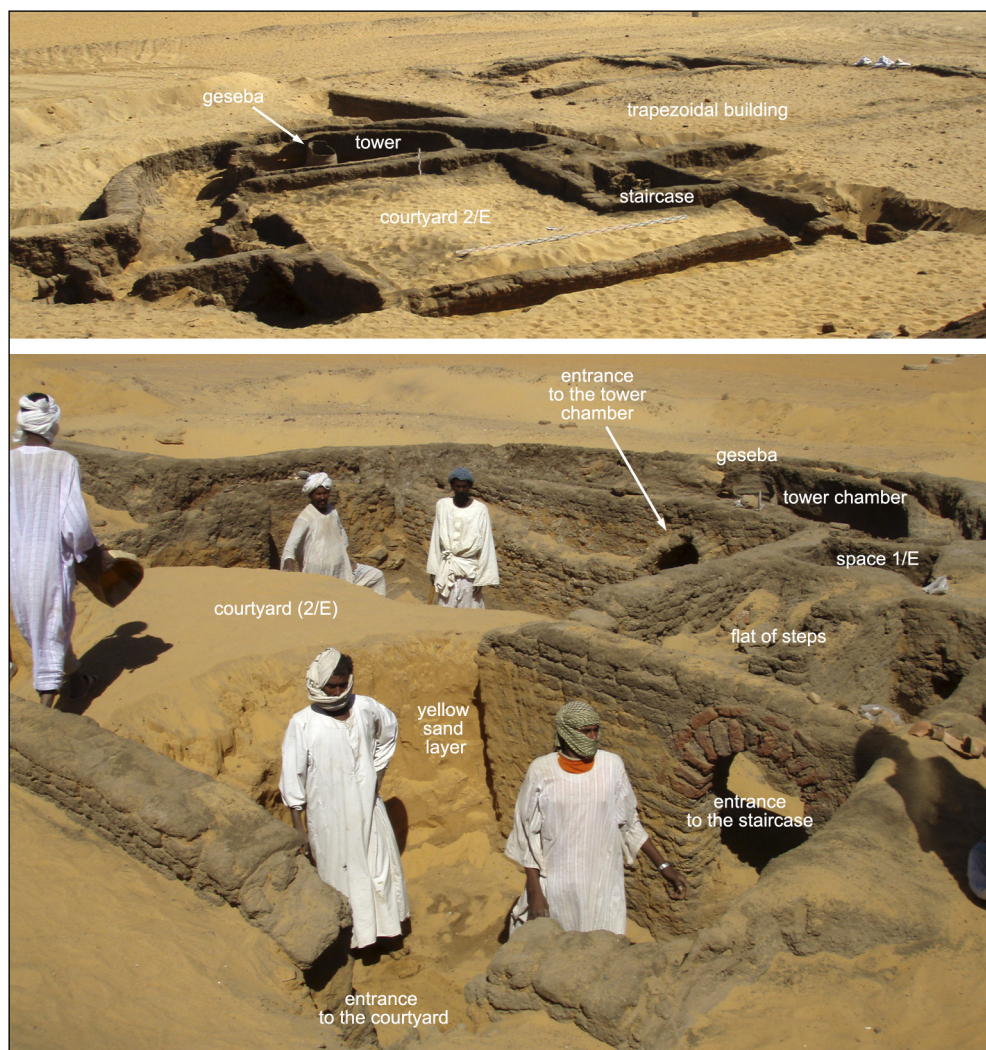
Fig. 2. Eastern tower after the tops of the walls had been cleared of sand; bottom, view during exploration of the humus layer inside the ruins in 2010 (Photo M. Drzewiecki)

Next, the interior of the tower started to be explored [*Fig. 2*, bottom]. To avoid problems with collapsing baulks, the

All recorded surface traces of the eastern tower [see *Fig. 2*, top] should be linked

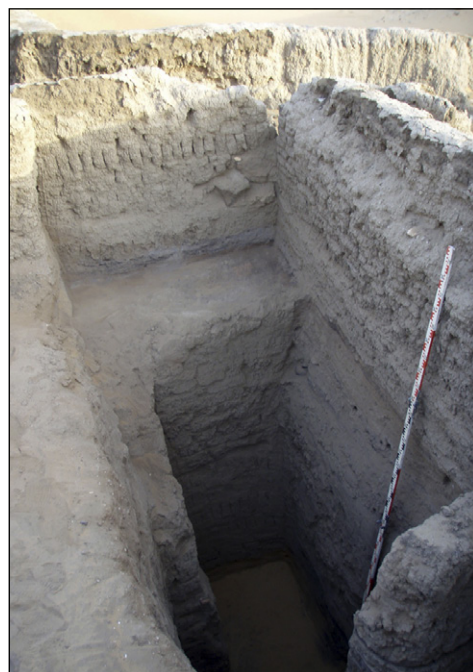
Fig. 4. Trench 6/E/2010, northwest and northeast (seen in Fig. 3) profile with level staff set against the wall face (Photo M. Drzewiecki)

appeared in a successive subphase [see *Figs 3, 4*]. The presence of an interbonded cross-wall flush with what has been identified as the tower wall from subphase Ib and its absence in the section of the wall corresponding to subphase Ia corroborates this observation [see *Fig. 3*].

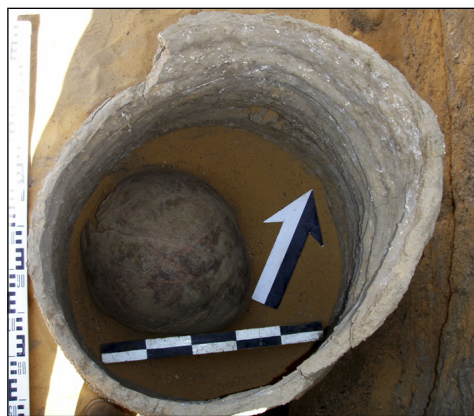
Fig. 8. Geseba container with another pot (Inv. No. 19/2010) inside it, found in the fill of the eastern tower chamber from the second phase (Photo M. Drzewiecki)

The remains of an unbaked clay container of the *geseba* type were recorded inside the chamber, standing directly against the chamber wall below the springing of the vault. In order for it to have been used, it would need some space above it for pouring in and taking out grain. Its position right below the spring of the vault in this chamber suggests that the vault had already collapsed by the time that it was placed in position. Another pot, this time fired, was found inside the *geseba*, presumably reused in this location [*Fig. 8*]. Seeds (to be examined by a specialist) were recorded in the fill inside the *geseba*.

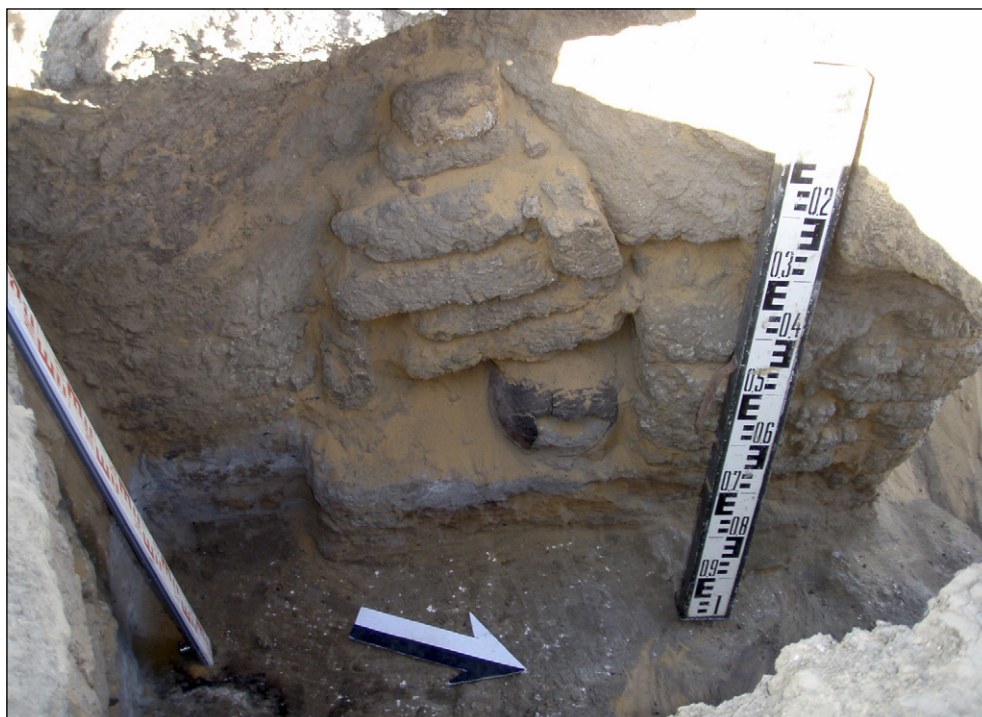
Fig. 12. Small chamber 1/E, blocked entrance to the corridor under the staircase
(Photo M. Drzewiecki)

the doorway was found blocked with a cooking vessel at the bottom and mud bricks above it [Fig. 12].
