Title: **Banganarti and Selib: season 2011**

Journal: *Polish Archaeology in the Mediterranean* 23/1 (Research 2011)

Abstract: The report summarizes work carried out during the 2011 season by the archaeological and restoration mission at Banganarti (Upper and Lower Churches, eastern tower of the fortifications, house SW1 in the southwestern part of the church enclosure) and at two sites in Selib: the church enclosure at Selib 1 and the Meroitic settlement at Selib 2. In the case of the earlier Selib church, inscriptions on the outer wall of the church have confirmed its dedication to St Menas. A baptistery tank associated with the oldest church on site and a lime-plastered rectangular tank approached by a flight of steps were also discovered. A large earthenware polylobed tray was recorded from the fill of the latest trench

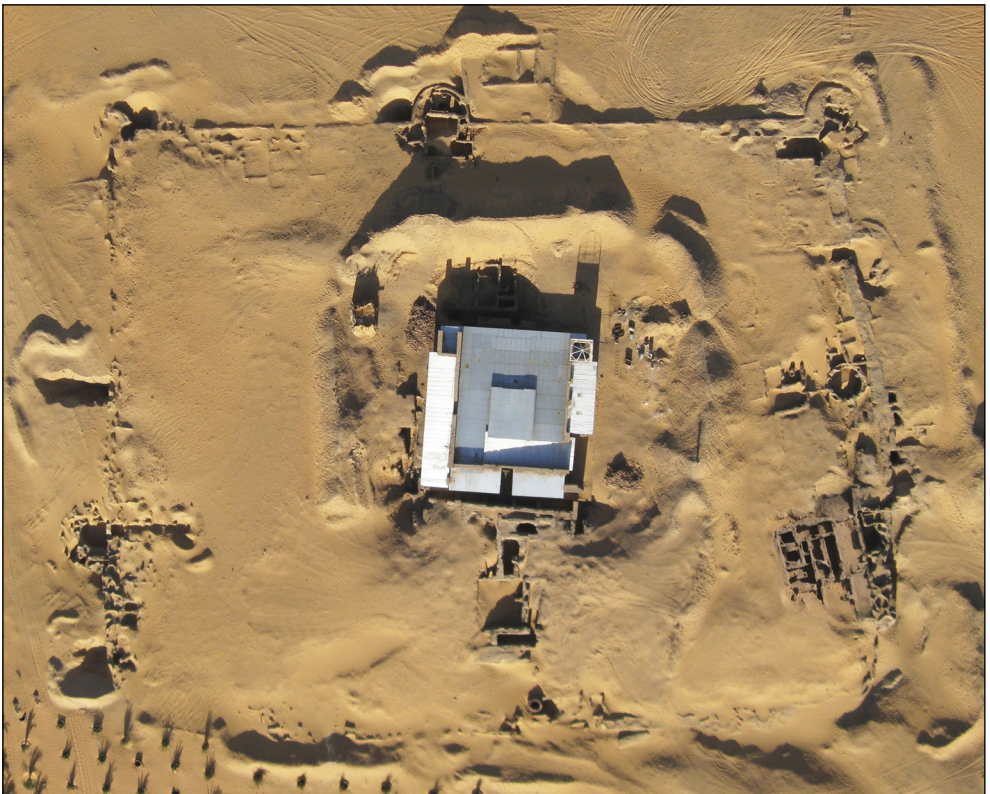
*Fig. 1. Banganarti on an aerial (kite) photograph taken at the end of the 2011 season
(Photo B. Żurawski)*

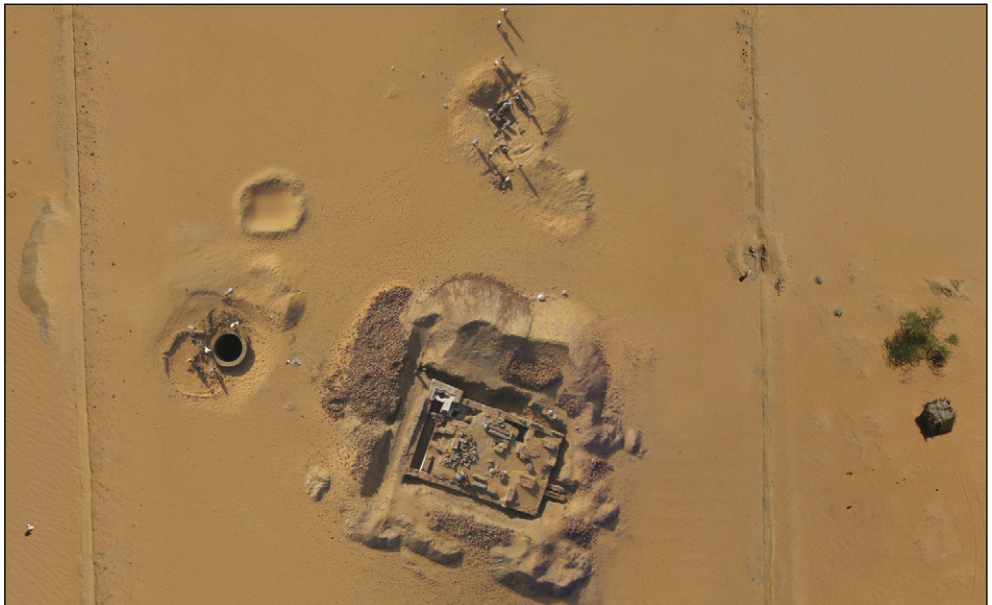
*Fig. 4. Aerial (kite) photograph of the Selib 1 site taken in February 2011
(Photo B. Żurawski)*

Excavation on the site of the church enclosure (trench supervisor and documentalist A. Cedro) concentrated on clearing the area in and around the church uncovered in the previous season (Żurawski 2011; Żurawski *et alii* 2013)¹ and investigating the earliest phases of the complex [Fig. 4]. Altogether 12 trial pits were dug. The walls of the building were tested in extended trenches: 8 (south wall), 6 (north wall), 11 (west wall). The southern entrance to the building was explored in trench 7 and the area just inside the church entrance on the south was excavated in trial pit 12, while the southeastern corner of the main nave (including part of the oldest east wall) was explored in test pit 10. The northeastern section of the church was tested in trench 5, where the baptistery was located. Trench 1 (later joined with test pits 7 and 8) revealed the southern buttress of the latest church and
