**MARINA EL-ALAMEIN POLISH-EGYPTIAN CONSERVATION MISSION:
RESEARCH AND CONSERVATION IN THE 2011 SEASON**

Keywords: Marina el-Alamein, Tomb T17, Southern Baths, architecture, research, preservation, anastylosis

MARINA EL-ALAMEIN POLISH–EGYPTIAN CONSERVATION MISSION: RESEARCH AND CONSERVATION IN THE 2011 SEASON

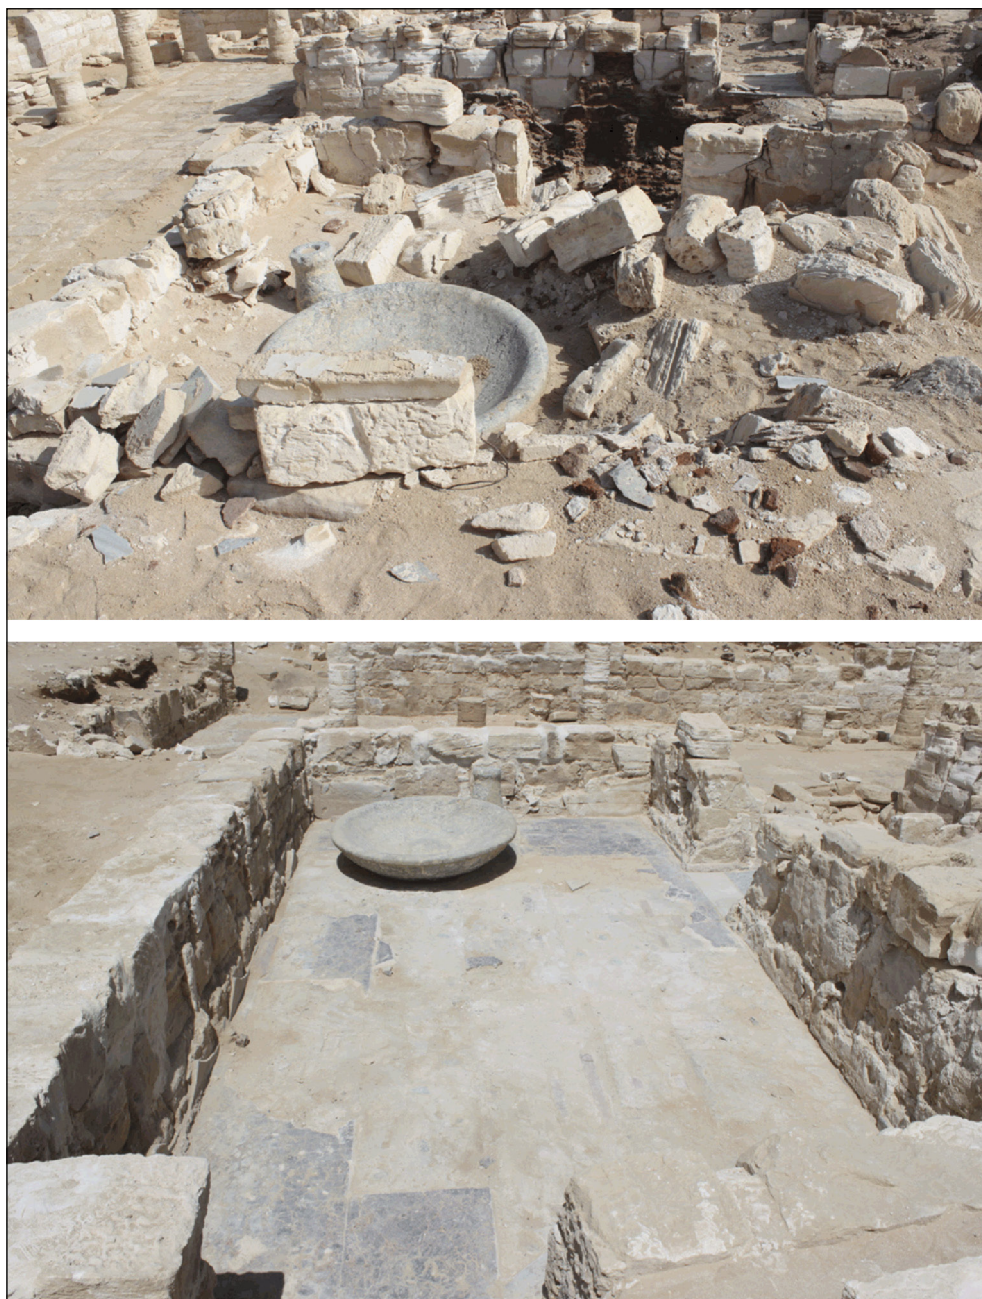
Fig. 4. Room 5 of the Southern Baths, before (top) and after conservation in 2011, views from the south (top) and east (Photos R. Czermer)

In the presumed tepidarium (room 5), big slabs of dark grey marble were laid out quite regularly as a pavement and similar slabs of lighter marble were used for the wall facing. The latter have survived only fragmentarily at the base of the wall. As for the floor, more than 10 big slabs have survived, some of them intact, others requiring protection measures in order to be permanently displayed. Broken pieces were fitted together and slab edges protected, both on the floor and on the walls. Walls surviving up to 1.5 to 2.5 courses above the floor were reconstructed to a height of 2.5 blocks above the floor, that is, about 0.75 m, in

order to protect the marble relics from prevailing western winds and to enable a clear display, especially of the marble *labrum's* relic standing against the west wall [see *Fig. 4*, bottom].

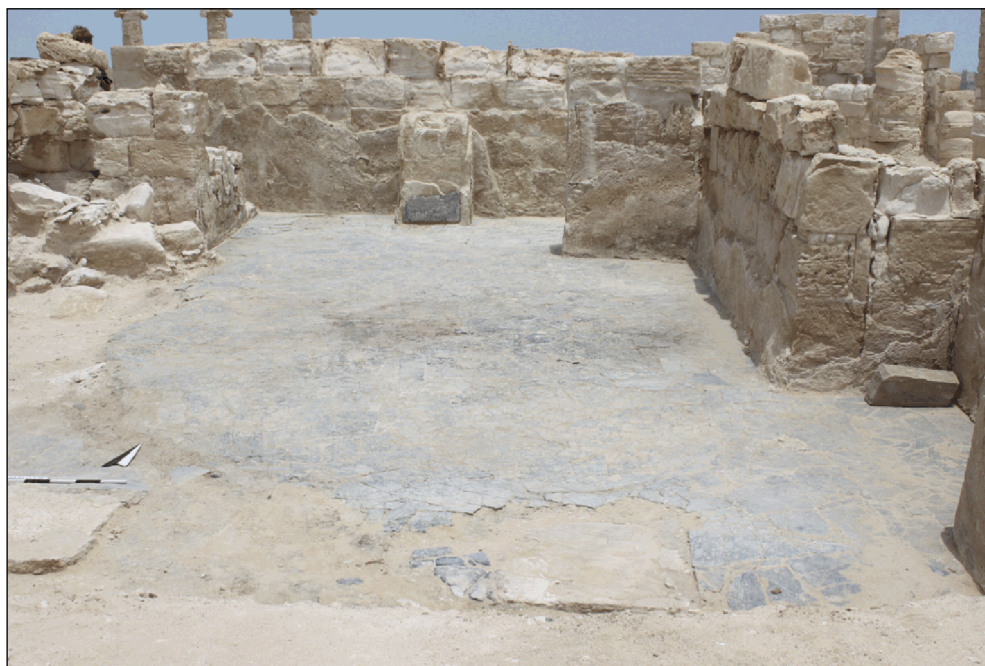
Fig. 5. Room 8a of the Southern Baths, view from the south after the 2011 season (Photo R. Czerner)

was furnished with a doorway 4.45 m wide and two columns standing in the middle; their foundations were preserved in place [Fig. 5] as well as fragments of marble column shafts, either one or two, in the rubble fill. At the north end, a passage, 2.93 m wide, opened into a transversal passage that led to the east, into the adjacent basilica. A door led west from the hall (its southern section) into room 5, and there was one more door, further to the south, into a corridor leading towards the southern portico of courtyard 4. A door led east from the hall into a small room 9 and another one further to the south into a room that has not been investigated as yet. Hall 8 had a marble floor and walls that were plastered and polychromed.

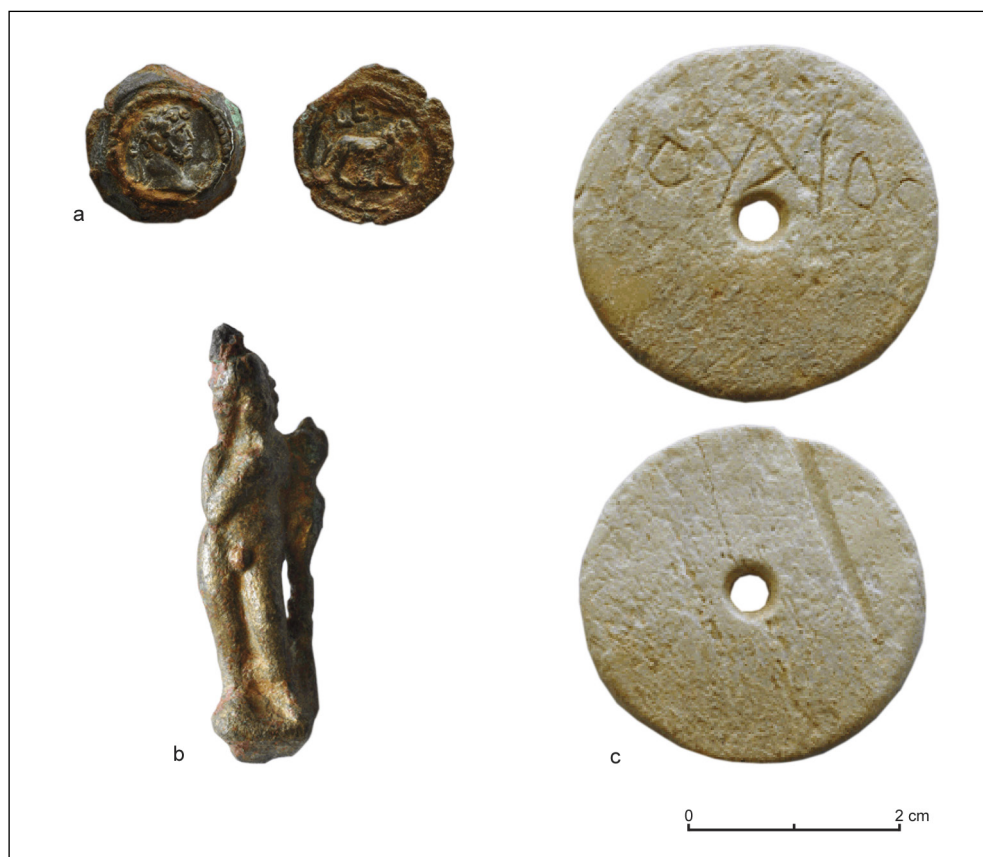
Fig. 6. Finds from the Southern Baths: a – bronze coin from the reign of Hadrian (AD 120/121, Egyptian issue); b – bronze pendant in the form of a figure of Harpocrates; c – bone disc with inscription (Photo P. Zambrzycki)

The evidence to date indicates that the baths were used in the 2nd and 3rd centuries AD. They were destroyed, probably in an earthquake, in the later 3rd century. Surface finds included a bronze pendant in the form of Harpocrates [Fig. 6:b]. The naked god is wearing a double crown. In his left hand he is holding a cornucopia, the right one is raised with his palm close to his mouth, probably showing the characteristic gesture for “silence”. The other interesting item is a small bone disc with a hole in the centre and an inscription written in Greek letters: the Latin name (*nomen*) IOULIOS (Greek version of IULIUS) (A. Łajtar, personal communication) [Fig. 6:c]. It may have been used as an entrance ticket.
