SELECTED CONSERVATION WORK IN MARINA EL-ALAMEIN IN THE 2012 AND 2013 SEASONS

Marlena Koczorowska, Wojciech Osiak²

BATH COMPLEX: CONSERVATION OF WALLS, PLASTERS AND FLOOR MOSAICS

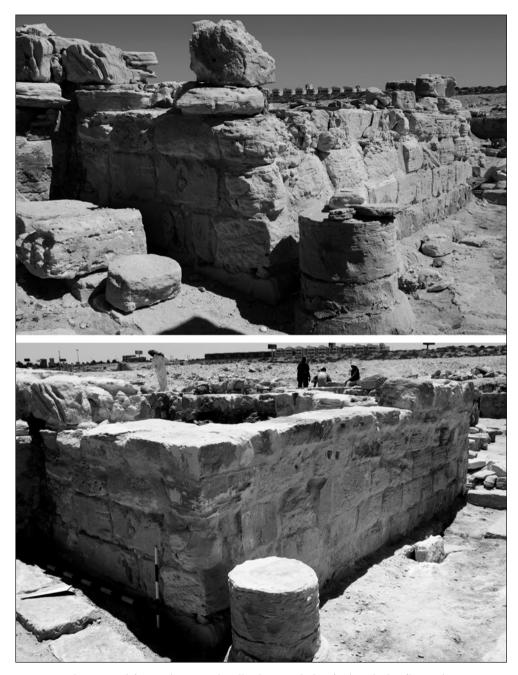
Fig. 1. Bath courtyard (room 4): external walls of room 7 before (top) and after (bottom) conservation in 2012 (Photos R. Czerner)

Protective bands were introduced around numerous relics of plaster and wall painting on the east, south and west walls. Patches of stone were prepared for the east wall (surrounding the alveus = room 7a). Slabs 15-20 cm thick were used, matching their size to the original blocks. They were mounted then in prepared sockets using mineral limecement mortar with sand filler. Several eroded remnants of limestone blocks and lime mortar were removed from the top layers of the wall. Slabs matching the original ones were found to replace them, and they were set with the use of mineral mortar [Fig. 1].

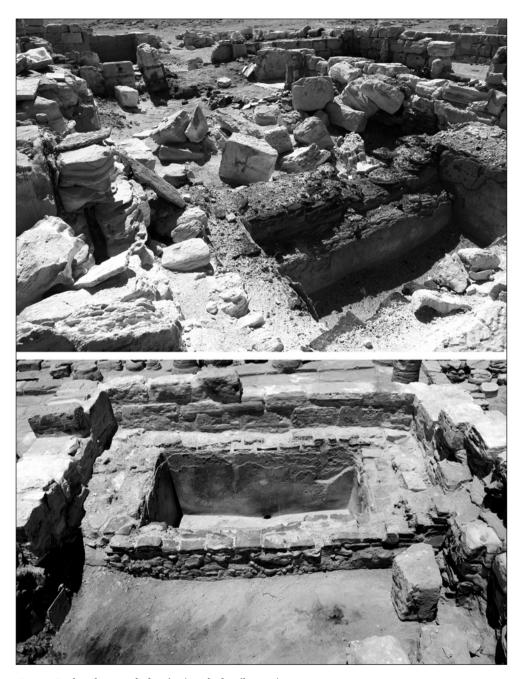
Fig. 2. Baths, alveus 7a before (top) and after (bottom) conservation in 2012 (Photos R. Czerner)

In the *alvei*, 7a and 7b, protective bands were put around the edges of plaster that had become detached from the wall. Damaged joints were filled in with limecement mortar with sand filler (six parts sand to one part lime to one part white cement). Putties from mineral mortar as above were used to protect the edges of preserved plaster on the walls of the bath. The top surface of the wall surrounding the alveus (7a) was reconstructed in places [Fig. 2].

The biggest breach in the east wall built of broken stone was filled with blocks of local limestone set in lime mortar. Apart from sand, finely crushed pottery was used as filler to make the mortar similar to the preserved original one. A layer of ancient bricks salvaged

from rubble heaps lying nearby was placed on the tops of the wall. Whole bricks or pieces of them were chosen and fitted not to exceed 4 cm in height and 24 cm in length. Four whole bricks and 10 fragmentary ones (surviving 30–50% of the original brick) were used. Lime–cement mortar as above was used with ceramic filler similar to the original one preserved in the ancient mortar.

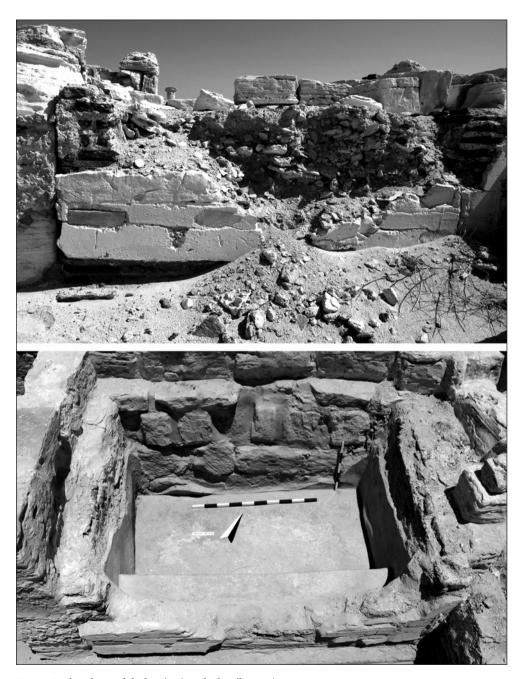
Fig. 3. Baths, alveus 7b before (top) and after (bottom) conservation in 2012 (Photos R. Czerner)

In the other *alveus* (7b), it was necessary to protect numerous extensive relics of plasters. On the front (southern) wall, big losses in the corners were filled in and bands were put around the mortar which used to be the base for setting a facing of marble slabs. Deep losses of the joints were filled in, as well as gaps in the upper parts of the wall resulting from intensive weathering of the limestone [Fig. 3].

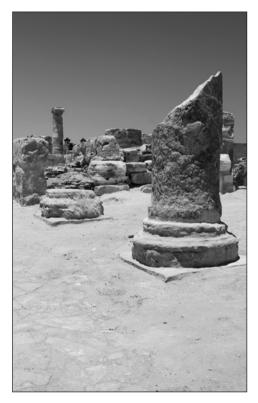
Fig. 4. Baths, room 8a–8b: marble columns after partial anastylosis and conservation in 2012 (Photo R. Czerner)

Square plinths were levelled above the marble floor in room 8, preparing the place for the anastylosis of two ancient marble bases [Fig. 4]. Horizontal insulation against humidity in the form of bitumen paper of high resistance was introduced between the plinths and the bases. The biggest losses in the bases were filled in with lime-cement mortar in proportions as above. Joints were filled between the plinths and marble. A relic of a column shaft made of similar veined marble was placed on the eastern one of the two bases. The shaft had been found in this room in the previous season. It was smoothed on the surface and mounted with the use of mortar as above. A joint was introduced. The two plinths were partly reconstructed to a square plan in order to make their geometric form more evident.

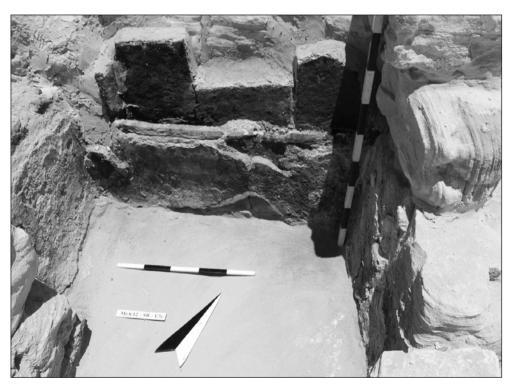
Fig. 5. Baths, room 7c: element of the heating system after conservation in 2012 (Photo R. Czerner)

Relics of plasters and vertical ceramic elements of the heating system were protected [Fig. 5]. Mineral mortar as above was used. The loss of ceramic elements amounted to about 60%. The best two matching elements from among the pieces that were recovered during excavation of the chamber were mounted in place, next to the only surviving one. Mineral mortar as above was used for the purpose. The ceramic elements were restored with glue. The highly weathered wall around the ceramic elements was made smooth and reinforced with lime–cement mortar.

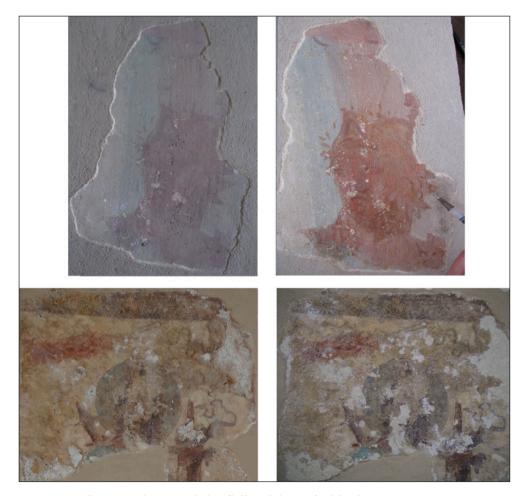
QUEEN IN NAUTICAL CROWN [Fig. 6A top]

Fig. 6A. Wall painting fragments, before (left) and during (right) salvage conservation in 2013: top, portrait of a queen in nautical crown; bottom, depiction of Heron (Photos M. Koczorowska)

cleaned from the surface. The painting had undergone thorough conservation in 1999, after being transferred to substitute ground. Damp in the storeroom caused the thin paint layer to become detached from the mortar layer and to start to crumble. In numerous places the paint and mortar layers have also become detached from the substitute ground.

This transfer proved to be in the worst condition, 80 percent of the surviving original having become detached. A considerable part of the painting was missing from the top right corner. The whole surface of the paint layer was covered with a salt deposit about 0.5 mm thick, which became hard and strongly integrated with the polychromy. The painting had become much less clear, and was rising and swelling due to the constant migration of salt to the surface.

The weakened spots were reinforced by injection of PRIMAL AC 33 with water (1:3), after an earlier reduction of the surface tension by ethanol with water (1:1). Wet layers were pressed against the ground with flat marble pieces, and simultaneously small fragments of nonadhering paint layer were put in place. The process was completed with the making of the final documentation.

Standard documentation was made. The paint layer was cleaned of loose deposits. In 1999, the painting had been cut from the wall with a fragment of the limestone block that was the original ground. A thorough conservation of the paint layer together with the mortar layer was carried out at the time. The damp in the storeroom affected this piece in similar way as the previous two transfers.

Injections of PRIMAL AC 33 with water (1:3) were made after an earlier reduction of the surface tension by ethanol with water (1:1). Wet layers were pressed against the ground with flat marble pieces and with spatulas, and simultaneously small fragments of the paint layer non-adhering to the ground were put back in place. Empty spaces where the mortar layer had degraded and started to crumble were filled with a suspension of LEDAN TC1 in water (1:1). Losses in the mortar layer were filled in next, using lime-sand mortar with filler consisting of fine-grained sand and marble powder (1:1) in a proportion of 1:3, adding water with about 2 percent of PRIMAL AC 33 as plasticizer. The layer of mortar applied was minimally thinner than the original, and its surface was smoothed. Next, a kind of levelling white-wash made of LEDAN TC1 colored with pigments was applied to the newly filled spots. Retouch is planned using pigments with 5 percent solution of PRI-MAL AC 33 in water. Final documentation was made.

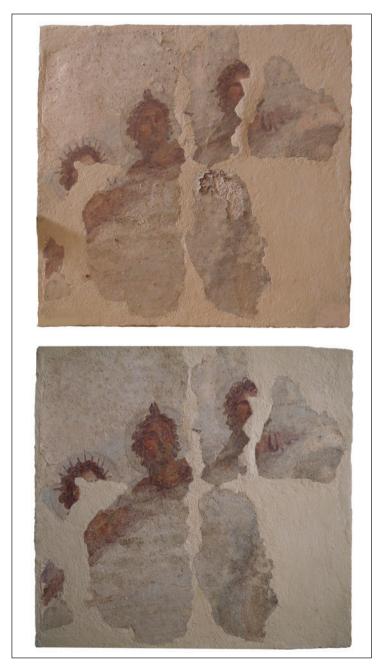
Fig. 6B

Fig. 6B. Wall painting fragments with representations of Helios, Harpokrates and Serapis before (top) and after (bottom) salvage conservation in 2013 (Photos M. Koczorowska)

The same preliminary procedure was followed in the case of the second transfer which had also been conserved in 1999 and which also suffered from the damp in the storeroom. About 60 percent of the mural had become completely detached from the substitute ground and a considerable part of the painting was missing from the central section.

As in the case of the first transfer, injections of PRIMAL AC 33 with water (1:3) were made after an earlier reduction of the surface tension by ethanol with water (1:1). Wet layers were pressed against the ground with flat marble pieces, and simultaneously small non-adhering fragments of the paint layer were replaced. Furthermore, wherever the mortar layer had degraded and crumbled, empty spaces had formed, depriving the original paint layer of a support substrate. These spaces were filled with a suspension of LEDAN TC1 with water (1:1). Next, losses of mortar were filled with lime-sand mortar with filler consisting of fine-grained sand and marble powder (1:1) in a proportion of 1:3, adding water with about 2 percent of PRIMAL AC 33 as a plasticizer. The layer of mortar applied was minimally thinner than the original, and its surface was smoothed. Next, on the filled in spots a kind of levelling whitewash made of LEDAN TC1 colored with pigments was applied. On the ground prepared like this, a retouch is planned using pigments with 5 percent solution of PRIMAL AC 33 in water. Standard final documentation was prepared.
