**Title: THE NICHES OF THE VESTIBULE OF THE ROYAL MORTUARY CULT COMPLEX  
OF THE TEMPLE OF HATSHEPSUT IN DEIR EL-BAHARI**

Author(s): Mariusz Caban

Journal: *Polish Archaeology in the Mediterranean* 24/2, *Special Studies: Deir el-Bahari  
Studies*, edited by Z. E. Szafrński

Year: 2015

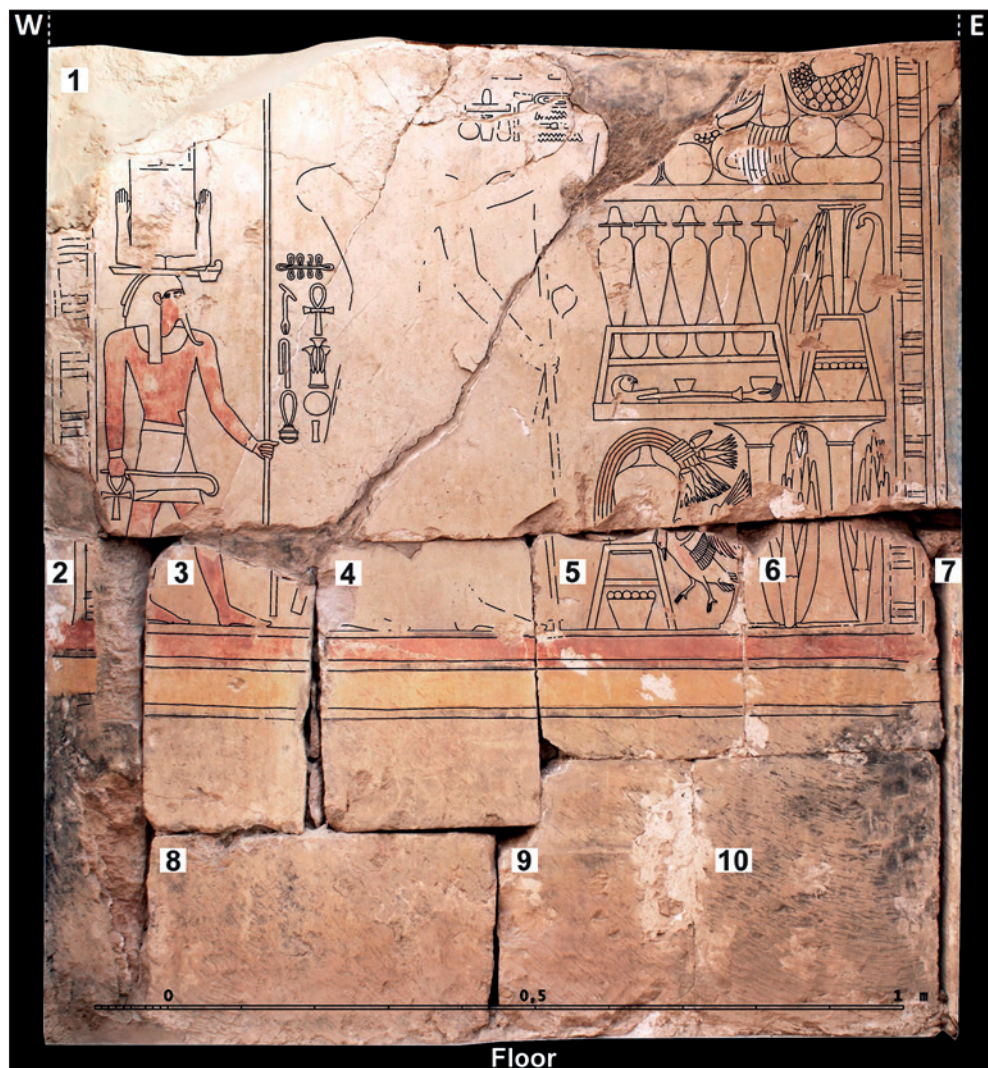
Cracks are occasionally seen through whole blocks, visible also in neighboring halls wherever the walls are just one block thick and decorated on both sides. The biggest deformations are observed currently on the north wall of the niche [Fig. 2].

Fig. 2. North wall of niche B (Egyptological interpretation M. Barwik, drawing M. Caban, A. Stupko, M. Puzskarski; photos M. Caban)

The illustration combines a photographic record of the blocks with epigraphic documentation of the relief. Blocks 1, 2 and 7 have more than one decorated face, which constitute the corners of the two niches, A as well as B. Block 2 is at the same time the northwestern corner of niche B and the southwestern corner of niche A, the face of the east wall of the vestibule and the jamb of the entrance to niche B. Blocks 1 and 7 served an analogous function on the opposite side, forming furthermore the face of the west wall of the Room of the Window. The remaining blocks are faced on two, opposite sides: the north wall of niche B and the south wall of niche A.

Having cracked in half, block 1 now consists of two pieces that have moved apart to either side of the wall axis, causing the corners with the east and west walls to cave in and the block surface to bulge out into the Room of the Window. This shift can be seen in the deformation of the relief at the joining of blocks 2 and 3 to the west and of blocks 4, 5, 6 and 7 to the east. Traces of repairs could be seen in the gap between blocks 3 and 4 after the cleaning of the joint, both a light white mortar and dark gray modern mortar. A light white mortar was used for repairs at the joining of blocks 1, 5, 6 and 7, where there are many peeling chips, the bulges and edges of the relief with remnants of paint ensconced

A computer reconstruction of the decoration on the north wall of niche B was prepared using special software that permitted the blocks to be placed in their original position, compensating for the deformation of the relief. It was thought that correcting the position of the blocks will make the relief whole again, but the result was not satisfactory as far as the joining of the original relief at the

junction of blocks 1 and 2 [see *Fig. 2*]. The ornamental checker band was still displaced by about 4 cm. A gap 4 cm wide would have had to exist between blocks 2, 3 and 8 for the line of the checker band on both blocks to match up. This would make the whole wall wider. It was assumed that the position of blocks in the lower parts of the wall of the niche was unchanged and consequently the wall was not made wider by these 4 cm in the reconstruction.

The stabilizing work that French egyptologist Émile Baraize carried out in this part of the complex as part of his excavation and reconstruction program in the 1930s may have affected the niche decoration. A dark-colored mortar [see *Fig. 2*] testifies to these activities. Some decisions taken then would not pass muster today (such as cutting the original capitals of the columns in the Shrine of

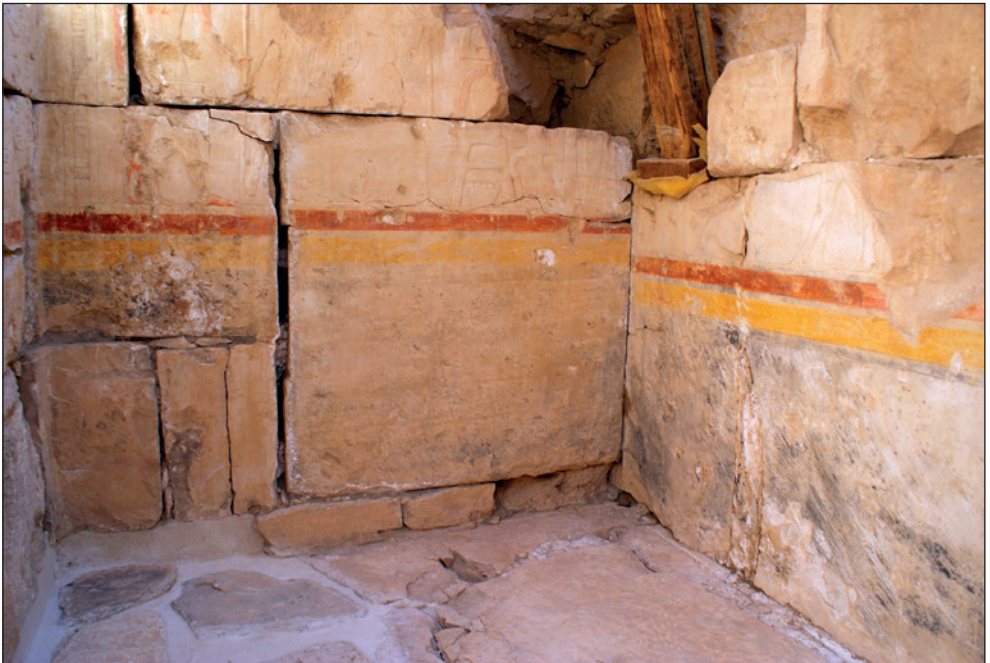
in this mortar. The checker band running along the western edge of block 1 misses the continuation of this band on block 2 by 3.8 cm. In this corner, on the west wall of the niche, level with block 2, there is evident flat chiseling of the stone surface, extending the north wall of the niche to the west. In effect of these processes, the two walls at this level meet at less than a right angle. The chiseling was painted over and traces of this paint have been preserved. On the other side of the wall, the same deformation of the relief and traces of repairs with a light white mortar can be observed in the decoration of niche A.

Fig. 4. North wall of niche A and the displacement of the dado band in the northeastern corner (Photo M. Caban)
