# MARINA EL-ALAMEIN

## CONSERVATION WORK IN THE 2007 SEASON

Stanisław Medeksza

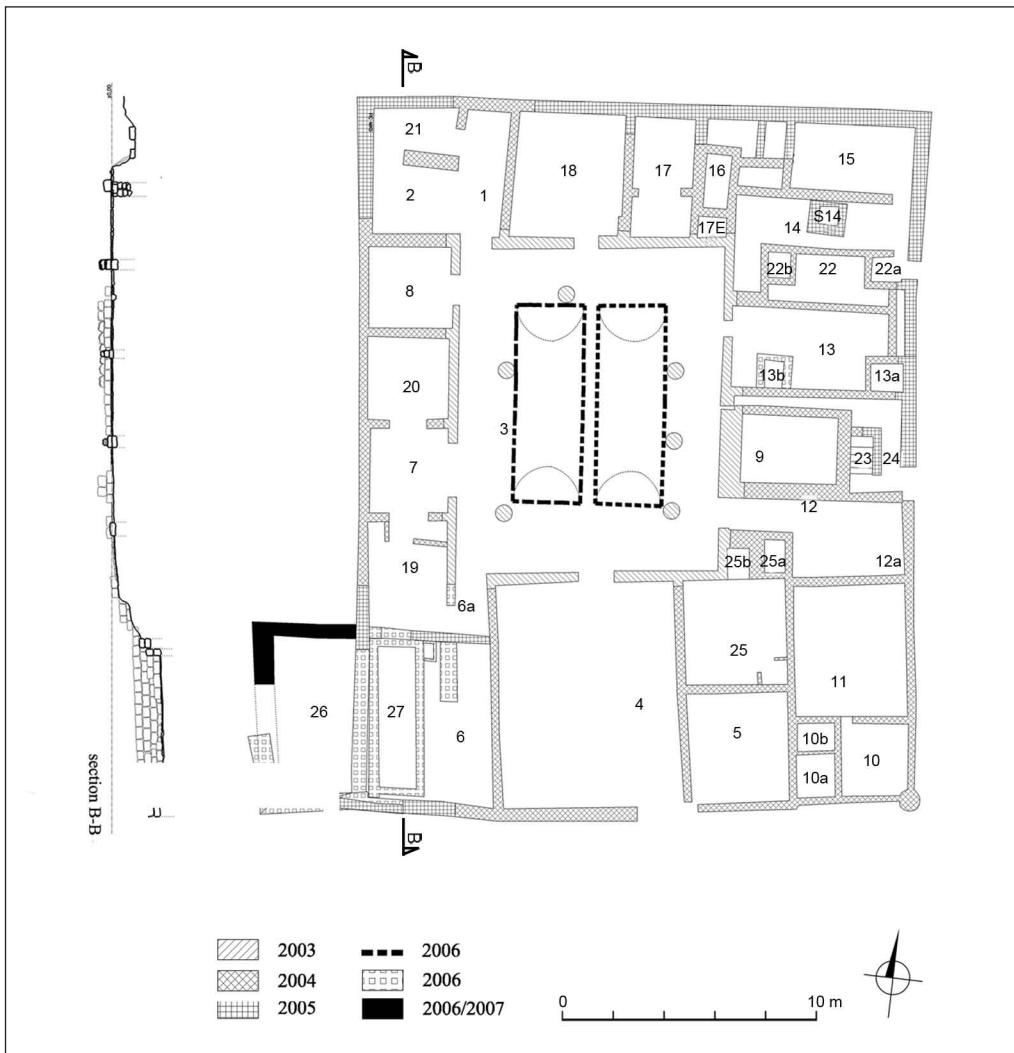
Fig. 2. House H1. Updated inventory plan after the 2007 season; on left, N-S section through the western wing looking east (Plan M. Krawczyk-Szczerbińska)

Owing to repeated rebuilding in Antiquity the house poses considerable difficulties not only for the study of particular construction phases, but also for the building-conservation works which need to take into account all the different stages in an effort to select elements for display. A full architectural and functional interpretation is pending completion of archaeological testing [*Fig. 2*].

Quake-related damages to the wall structure have largely obliterated the original wall bonding, hugely encumbering research on the building stratigraphy. Nonetheless, the latest phase of the building now appears as a rectangle with the long axis aligned N-S. The units identified in 2006, Rooms 6 and 26, appear not to belong to the 4th century phase, the amphorae and other pottery discovered there pointing to their use in the building of the 2nd and 3rd century. Also the foundation trench for the western perimeter wall of the 4th century house cut across this cooking and storage area, confirming its earlier date (the storage wares found in these apparent cellars are dated to the 1st, 2nd and 3rd centuries). In the 4th century, unit 6 was subdivided and

follow the various cavities that appeared in the building as a result of the damages incurred. Furthermore, the foundations under the footing were constructed in antiquity of blocks laid crosswise to wall axis, while above the footing the blocks, 0.30 m thick, were placed lengthwise in the walls. By the end of the season the

southwestern corner and west wall in the center (by Rooms 20, 7 and 19) were completed, advancing the task of closing the rectangular outline of the house. A marble block which had served presumably as a pedestal under a lifesize bronze statue, was set up in its original position in Room 7. The west wall after restoration will serve as

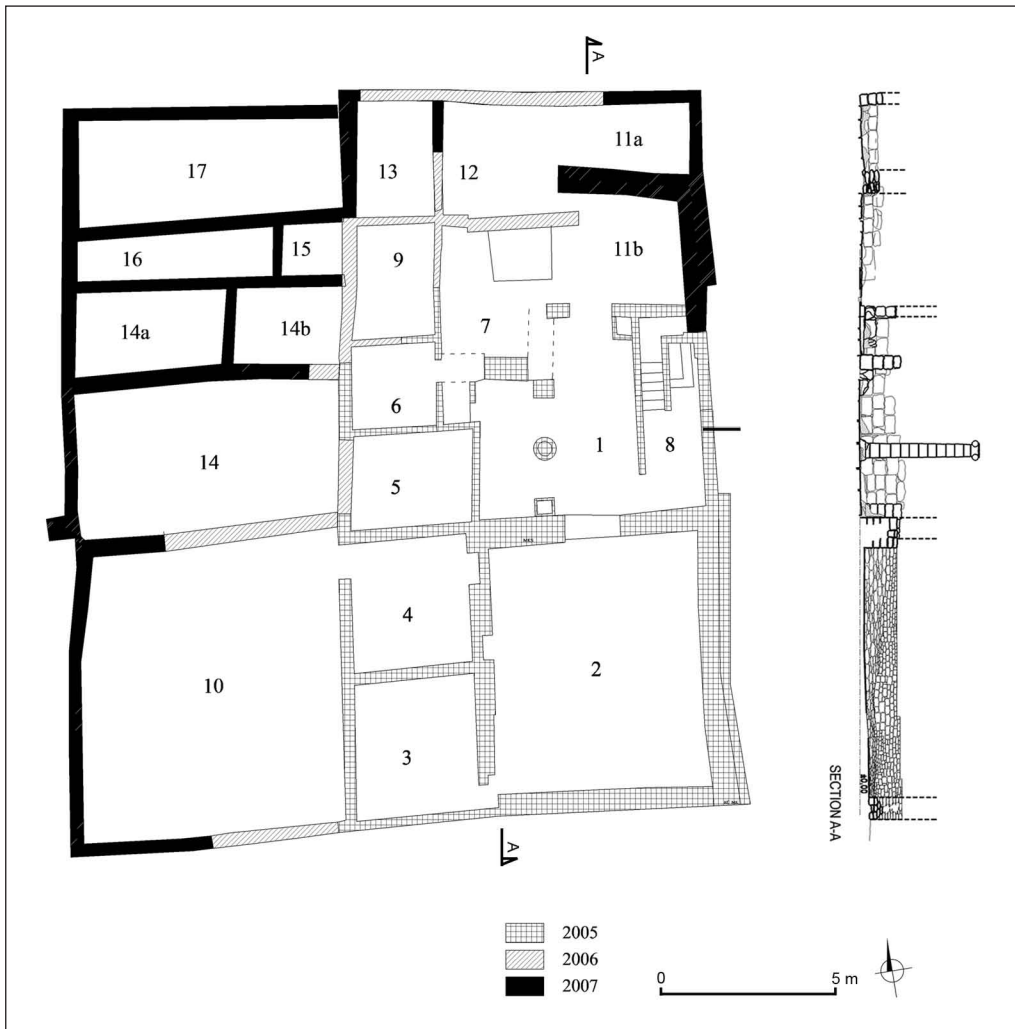
Fig. 4. House H2. Updated inventory plan after the 2007 season; on right, N-S section through the eastern wing looking east (R. Czerner, updated M. Krawczyk-Szczerbińska)

wall of Room 10, already partly cleared in 2006. The northwestern part of the house was also cleared. A courtyard (14) with double portico presumably opened north of Room 10; this courtyard was later divided by an E-W wall into compartments 14a: 3.25 by 2.20 m and 14b: 2.20 by 3.55 m. Originally, the courtyard had measured 6.25 m N-S by 5.40 m E-W. Two stylobates under the

columns of the portico were preserved in the courtyard, 0.52 m wide, which makes them equal to 1 cubit. They are parallel to the east and west walls of Rooms 14, 14a and 14b, at a distance of respectively 1.00 m and 1.10 m. The clearing of floors in the next rooms to the north revealed further subdivisions inside the house. Room 15 (1.50 by 1.80 m) contained a marble Attic base with octagonal

Only three fragments of walls were restored, mainly the west wall closing room 10 and 14 in the uncovered part (the viewing platform should be dismantled before the work can be completed). The broken-stone wall between Rooms 1 and 7 was raised along a stretch 2.50 m long, and the south wall and part of the wall around Room 3 were also reconstructed.

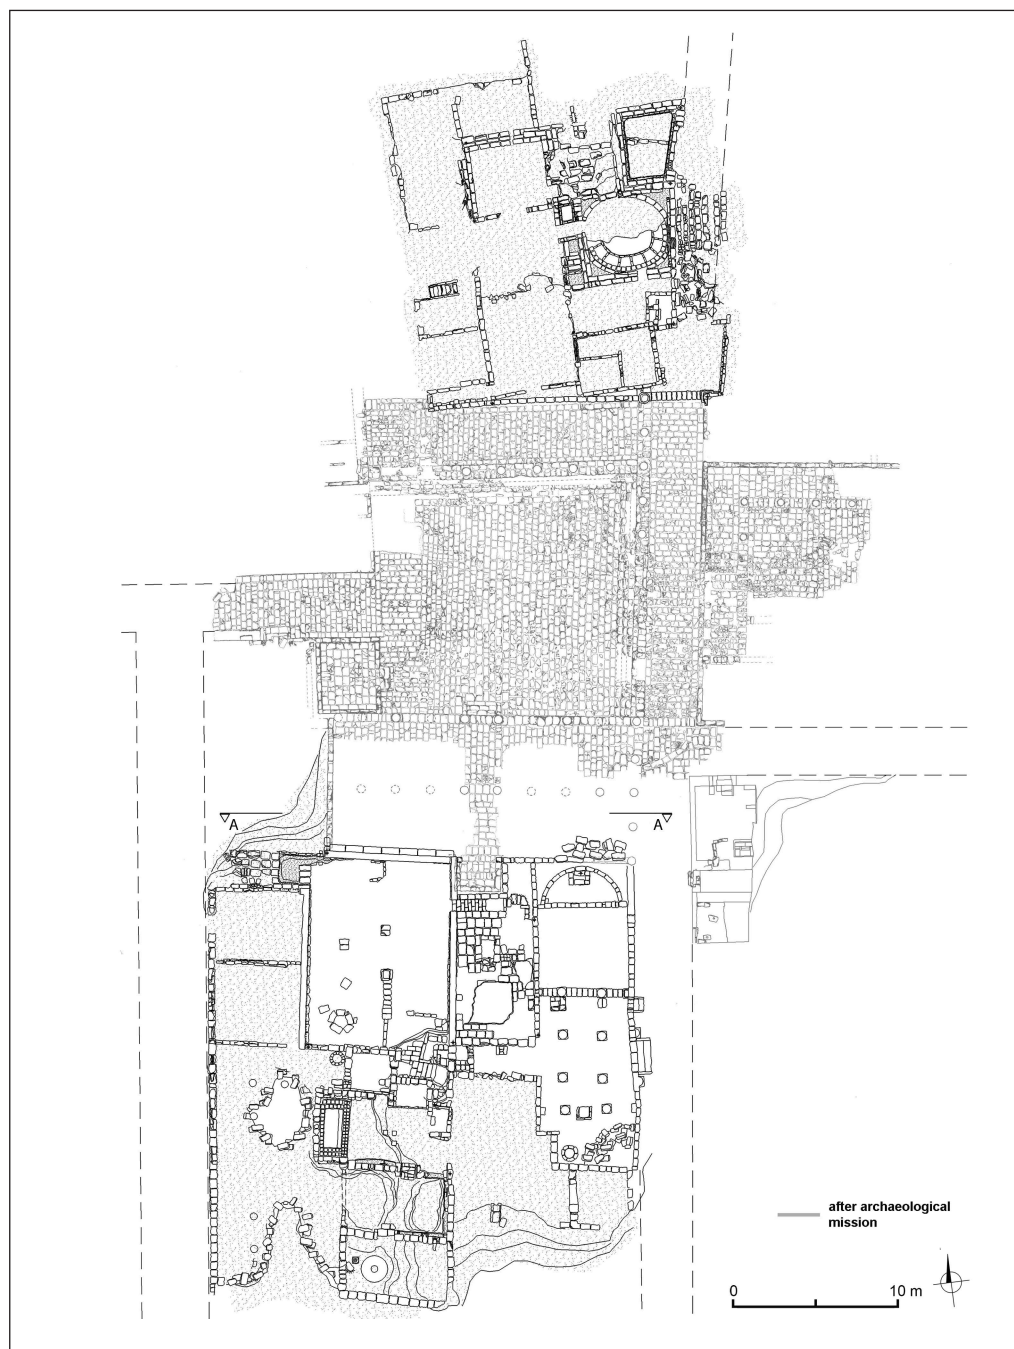
Fig. 6. *Plan of the Main Square and Baths, updated inventory plan for 2007 (Plan J. Dobrowolski, A. Błaszczuk, updating by M. Krawczyk-Szczerbińska)*

The deep portico on the south side of the main square had a double row of columns of the pseudo-Ionian type commonly used in Marina. An anastylosis to full height of two westernmost columns in the second, back row of the portico was completed in 2007 [Figs 6–7]. Five drums accounting for more than half the height of a third column in this row were also reintegrated, preparing them for full anastylosis in the coming season. The engaged column closing the front row of columns on the west was raised to the height of two drums.
