Title: **Marina el-Alamein. Conservation work in the 2009 season**

Journal: *Polish Archaeology in the Mediterranean* 21 (Research 2009)

**Abstract:** In 2009 the Polish–Egyptian Restoration Mission to Marina el-Alamein proceeded with another season of conservation work in heavily constrained circumstances. Architectural studies preceding building conservation work were carried out in House H1, where the Mission has been active over the past few seasons. It was established that the house had an inner peristyle consisting of two tiers corresponding to building floors: pseudo-Corinthian of the Marina type on the ground floor and pseudo-Corinthian or pseudo-Ionic of the Marina type on the upper floor. A similar tiered architectural decoration was noted in the incomplete peristyle (unit 4) of the Southern Baths just off the presumed Main Town Square. Work continued on clearing the chambers of the baths and accomplishing preservation, conservation and subsequently building restoration works. A marble plaque with an inscription, found previously, was subjected to conservation treatment once standard condition monitoring demonstrated progressive deterioration of the state of this object

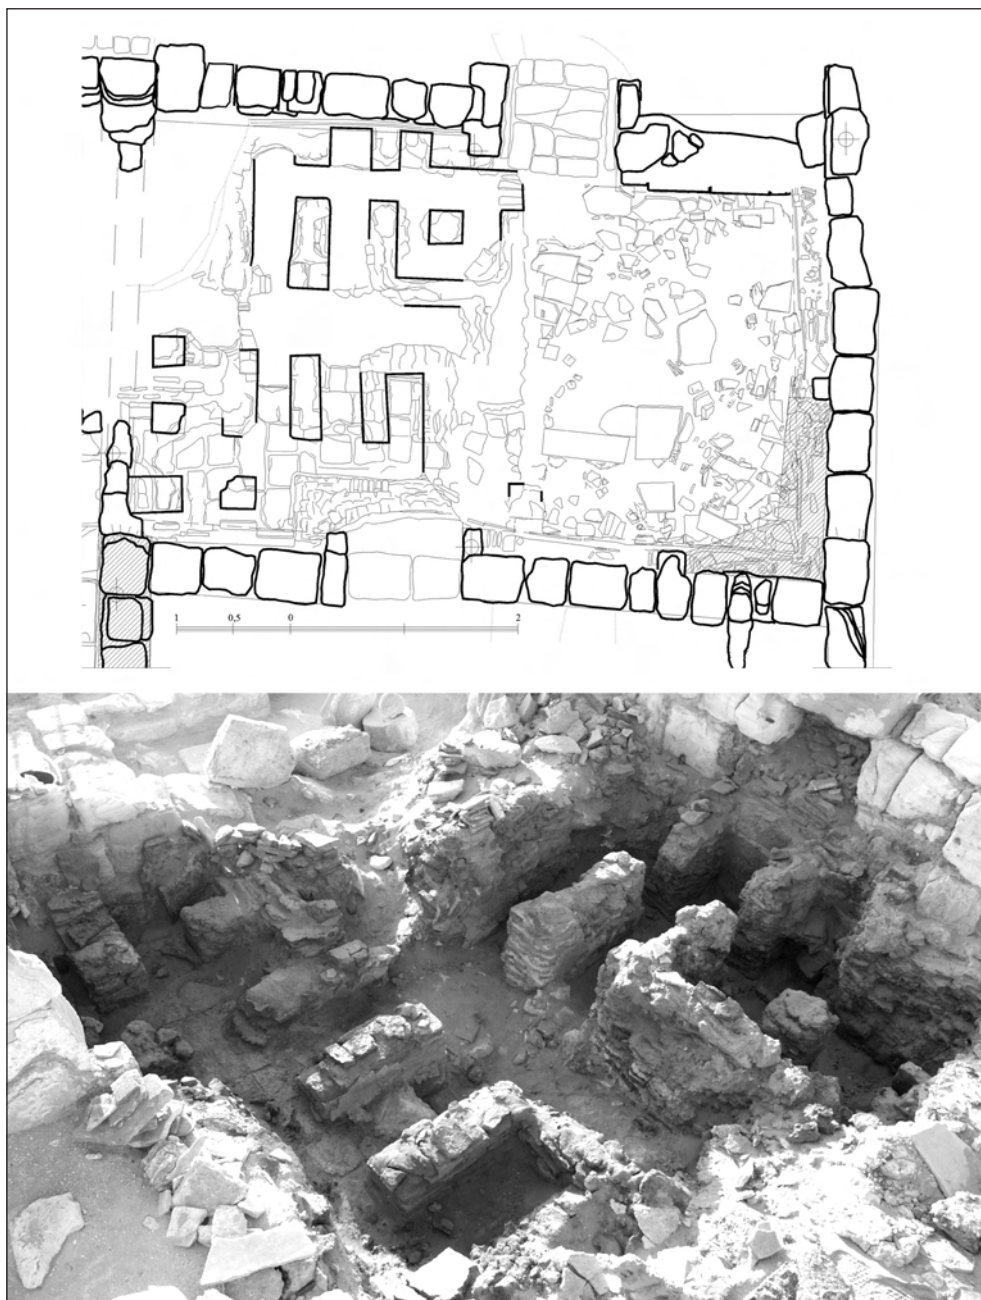
*Fig. 12. Hypocaust cellar in unit 6 of the Southern baths: inventory plan (top) and general view (Drawing A. Brzozowska; photo S. Medeksza)*

A study of the heating system in unit 6 showed that the hypocaust cellar was built entirely of ceramic tiles averaging 28 cm square in size. The structure comprised a set of square *pilae* supporting the *suspensura*, reinforced with walls built of ceramic tiles between some of them [Fig. 12]. Some of these spaces were vaulted. It is not clear why this system of reinforcements was put in. Perhaps there was a need to reinforce the foundations for the *tepidarium* pool. Another and perhaps more likely reason is better circulation of heat from the *praefurnium* to other parts of the heated cellar. The heating furnaces themselves have yet to be located.

Unit 6 was cleared and emergency conservation was carried out [Fig. 11]. Immediate consolidation with chemical agents (PARALOID B-72) helped to stop the destructive processes at least momentarily.
