# MARINA EL-ALAMEIN CONSERVATION WORK IN 2004

Stanisław Medeksza et al.

A Polish-Egyptian Restoration Mission from the Polish Center of Archaeology of Warsaw University completed its tenth season of field conservation at the Early Roman town of Marina el-Alamein, working in April and May 2004.<sup>1</sup> Financial limitations on the Egyptian side necessitated the program to be reduced to a minimum. Reconstruction activities with few workers and using building materials leftover from the previous season did not actually start until April 14.

The work program in 2004 covered houses H10"E" and H19, H19a in the southern part of the town, H1 and H21c in the northern part, and tomb complexes T1GH, T1K, T12 located in the southwestern part of the necropolis (see previous report in PAM XV (2004), Fig. 1 for a plan of the site).

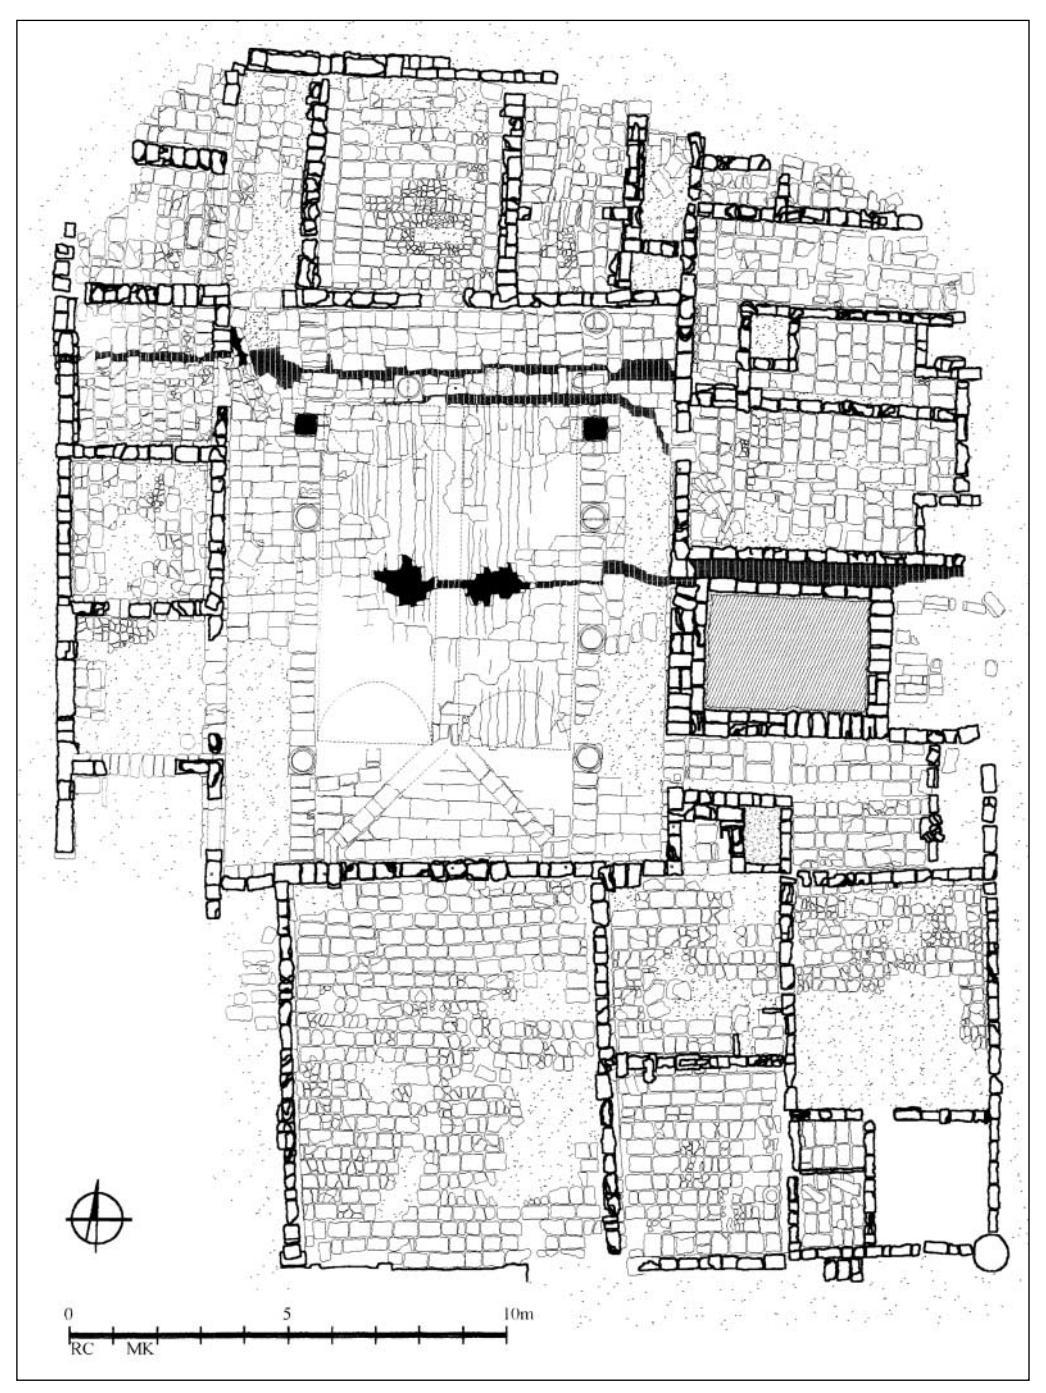
Fig. 1. Inventory plan of House H1, following clearing work in 2004 (Drawing R. Czerner, M. Krawczyk)

Work began with routine clearing and maintenance assessment of previously conserved structures.<sup>2</sup> Concurrently, an architectural inventory was taken and the documentation of House H1 completed [*Fig. 1*], revising earlier plans and descriptions, which had not had the benefit of a thorough clearing of the structure during the original rescue excavations by inspectors from the Egyptian Antiquities Organization in 1986-1987.

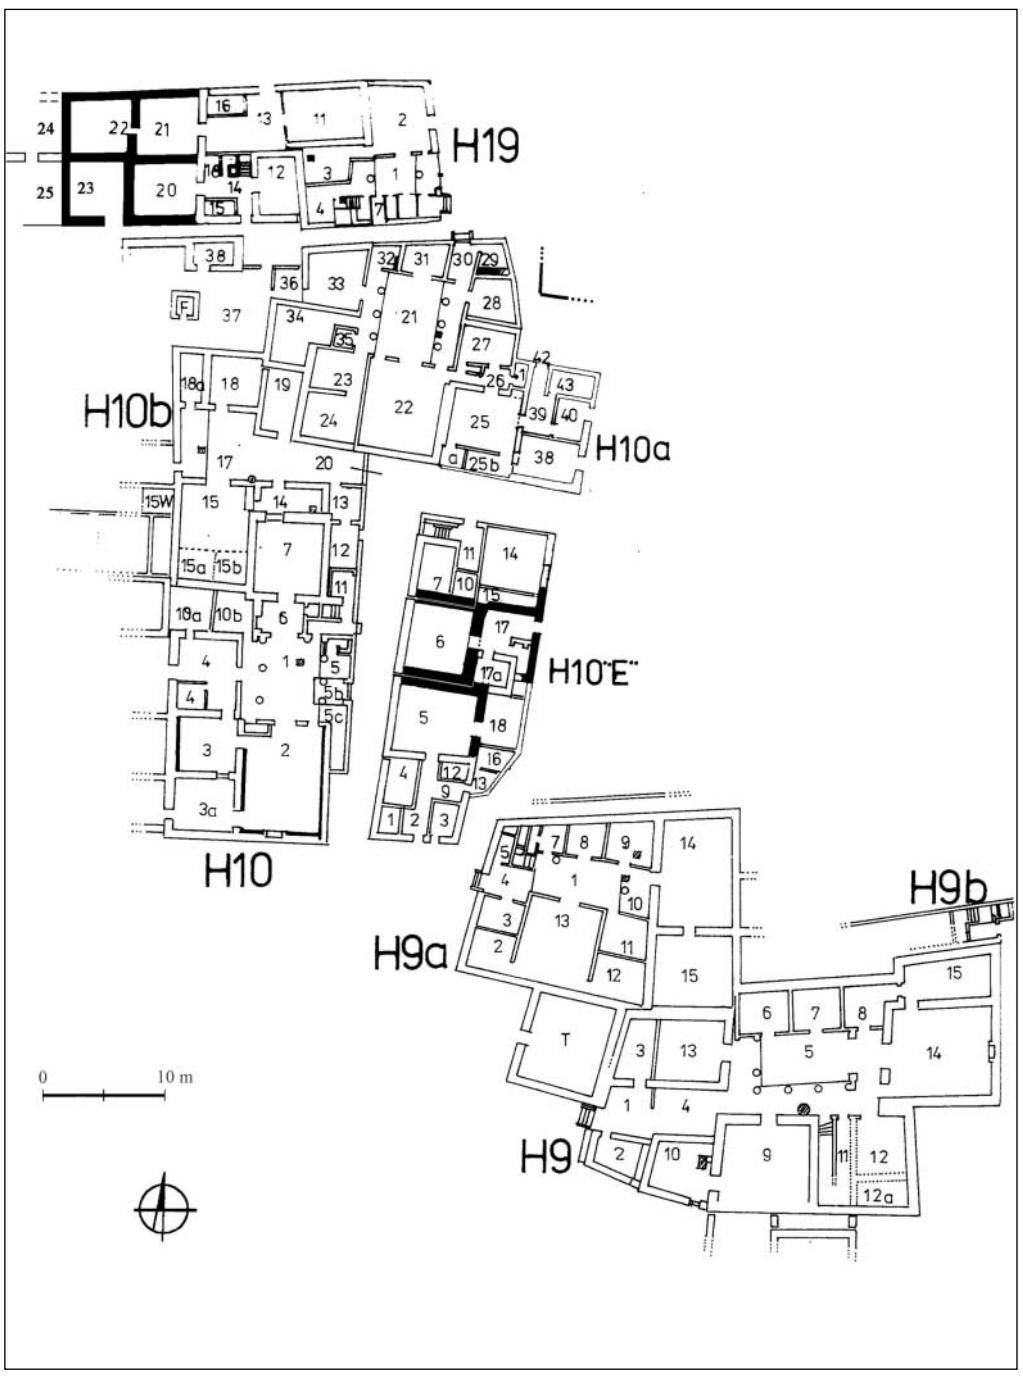
Fig. 2. Plan of complex of houses in the southern part of the ancient town (Drawing S. Medeksza)

In the area of House H10"E" [*Fig. 2*], where work has been ongoing since 1998, especially with regard to reconstructing the street arrangement in an effort to enhance the display potential of the houses in this district, walls were built up to an average height of 1.20 m. Architectural phasing was emphasized by varying the height of walls, pointing work and finishing touches on the bondwork in the central part of the house, in rooms 5, 6, 15, 17 and 17a. Building-conservation work was completed on the eastern outer wall separating rooms 15, 17 and 17a from the eastern N-S street.

Continued clearing work conducted under archaeological supervision in House H19 made it evident that all rooms numbered from 11 up were part of the next house in this insula [cf. *Fig.* 2], which was bounded on the north by a 2.00 m wide alley similar to the one on the south. Room 22, and parts of 23 and 24, as well as 25 were now investigated. It appears that rooms 21, 22 and 25 were added to the western wall of room 20, while 24 was added to 22, corrupting in many places the original street grid. Preservation work on surviving walls was completed, replacing the clay mortar in the broken-stone bondwork with lime mortar in the accepted proportions (6:3:1) of sand, slaked lime and white Portland cement. Walls were built up to an average of 1.20-1.40 m (in rooms 20, 21 and 22, and the eastern wall of 23). Well-fitted stone chips in a limecement mortar forming a protective cap on the top of surviving walls will eliminate the danger of the clay being washed out by corrosive rains.

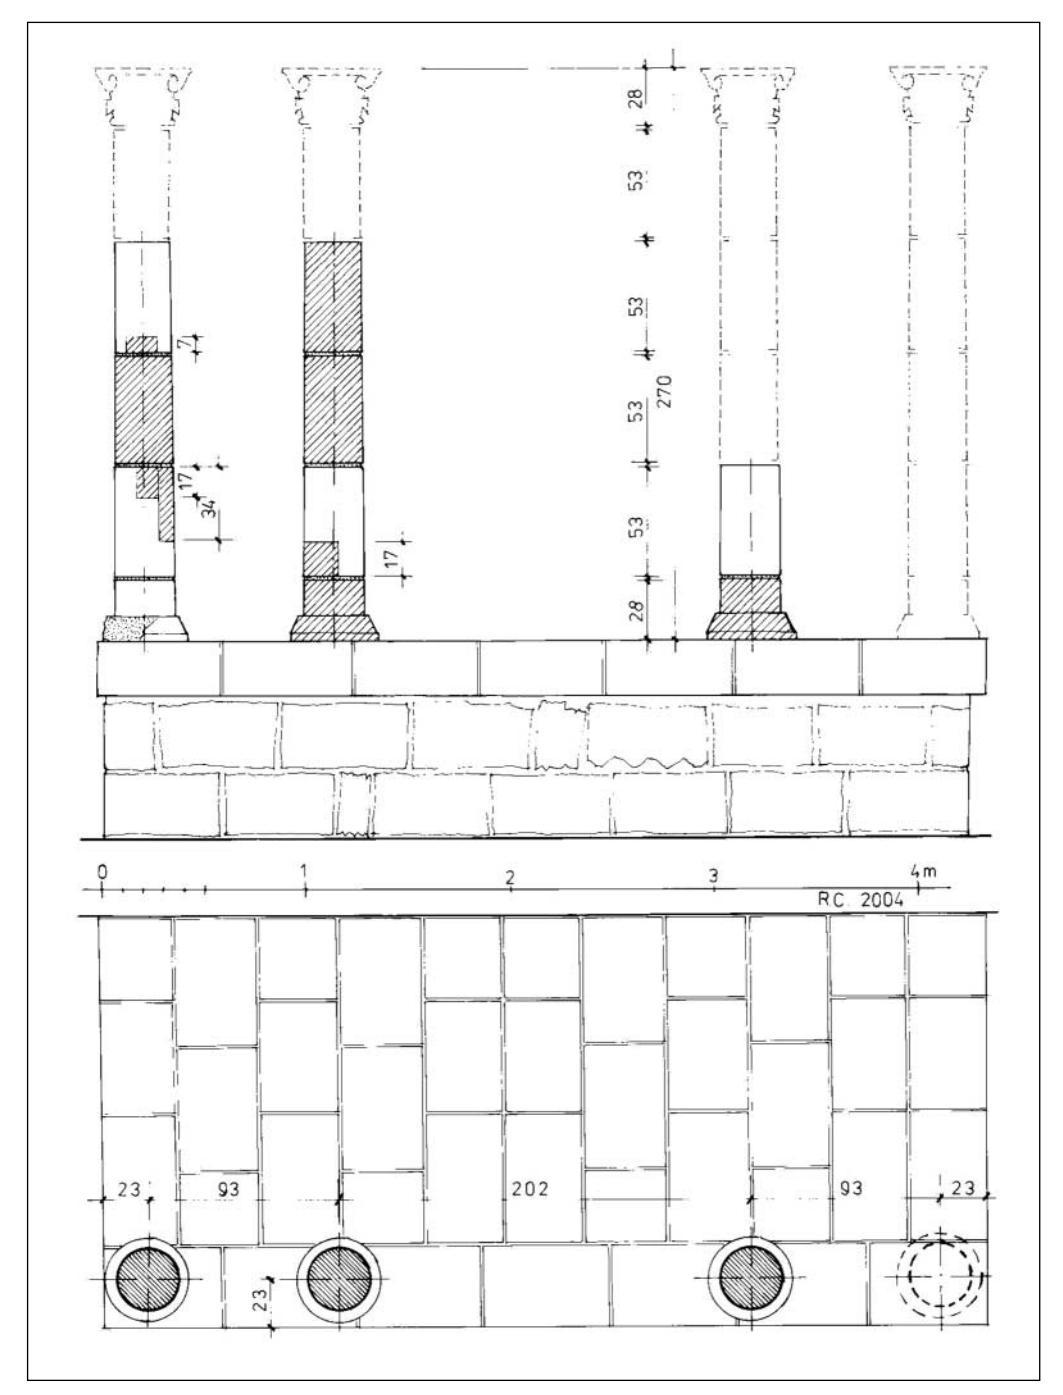
Fig. 3. Drawing reconstruction of the commemorative monument in House 21c (Drawing R. Czerner)

Last year, the parapet of the commemorative monument connected with an inscription dedicated to Commodus, occupying the two square "cubicles" (2a and 2b, 4.40 x 2.00 m) in House 21c was reconstructed.<sup>3</sup> Work continued this season on a partial reconstruction of this monument. Three of four columns which had once formed a portico together with the engaged pillars in the back wall were reerected on the podium. The arrangement of the portico was reconstructed on the grounds of an analysis of preserved architectural elements and comparative studies [*Fig. 3*].

Each column had originally consisted of four drums, each 0.53 m high and from 0.31 to 0.29 m in diameter. One drum with painted plaster featuring a floral design was preserved in 2001-2002 (for future museum display).<sup>4</sup> Four other drums have been preserved, plus a base 0.28 m high and one capital, also 0.28 m high. These elements were reinforced and

the losses filled in with limestone of parameters like the original.<sup>5</sup> Four new drums and two new bases were made for the purposes of anastylosis, which should be completed in the coming season, using elements prepared this year.

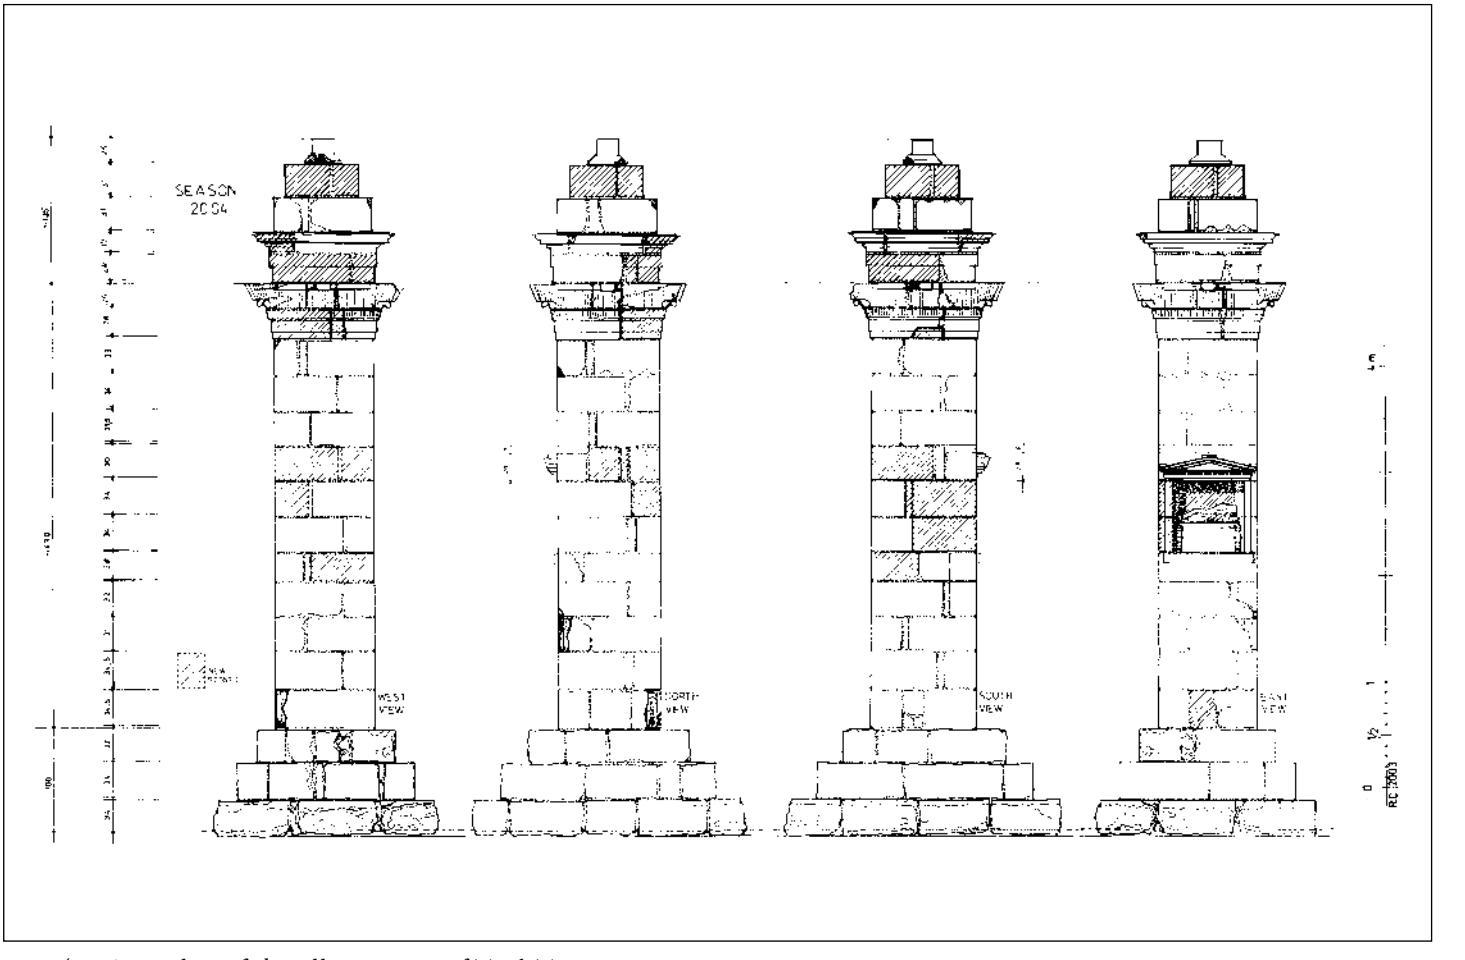
Fig. 4. Anastylosis of the pillar structure of Tomb T1K (Drawing R. Czerner, based portly on earlier documentation by J. Dobrowolski)

The anastylosis of the pillar structure of Tomb T1K was completed largely in the past season. (The tomb had been excavated in 1994,<sup>6</sup> and it was then that the inventory drawings were prepared and a drawing reconstruction of the superstructure proposed).7 This year an architrave was introduced crowning the cornice, two receding courses of blocks and the base of a small pillar topping the structure [Fig. 4].8 Most of the elements were original and were found toppled around the tomb. Only two of four architrave blocks and the blocks of the second course above the cornice had survived. The rest have now been reconstructed in new limestone. The corner fragment of one of the four blocks forming the full circumference of the cornice was broken off and lost. There were other losses as well, requiring full workshop conservation<sup>9</sup> that included desalination. Epoxy resin (KEMAPOXY 150 by C.M.B., produced in Egypt) was used to fasten the corner piece made in new limestone, reinforced with two stainless steel rods. Larger losses were filled

in with new limestone, smaller ones with mineral putty (binder-to-filler ratio 1:3). The binder was a mixture of slaked lime with white Portland cement (1:1), the filler crushed lime. A small amount of 5% solution of acryl resin (PRIMAL AC 33) was added to the mortar.

Specialist conservation work on this tomb superstructure covered also a structural reinforcement of the carved elements of the tympanum above the small niche holding a sculptured stela in the middle of the east side. A silicon stone strengthener (OH by Remmers) was used for the purpose.

The anastylosis of all the elements was carried out using traditional methods with mortar in accepted proportions of sand, slaked lime and white Portland cement (6:3:1). The bigger losses were filled in with putty and a finishing chromatic unification was carried out using mineral pigments.

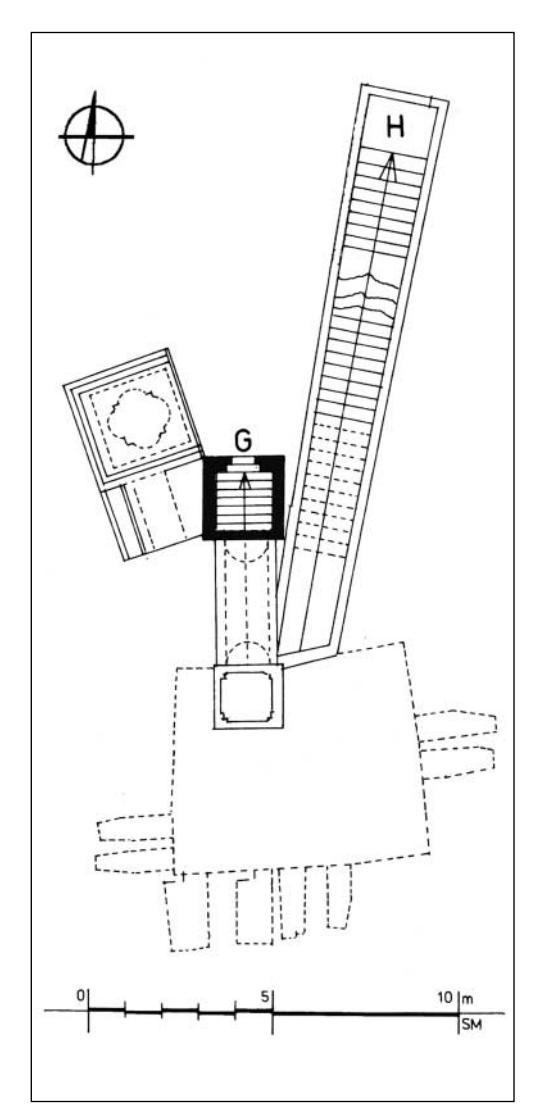
Fig. 5. Plan of bypogeum T1GH and neighboring pillar tomb T1D (Drawing S. Medeksza)

Following upon previous conservation work in this hypogeum,<sup>10</sup> which included the restoration of dromos H and the decorated casing of the light shaft of the hypogeum in 2002-2003 [*Fig. 5*], the mission now proceeded with a partial reconstruction of the entrance kiosk to dromos G [*Fig. 6*].<sup>11</sup> Since it seems likely that the kiosk was destroyed already when the neighboring pillar tomb T1D was con-

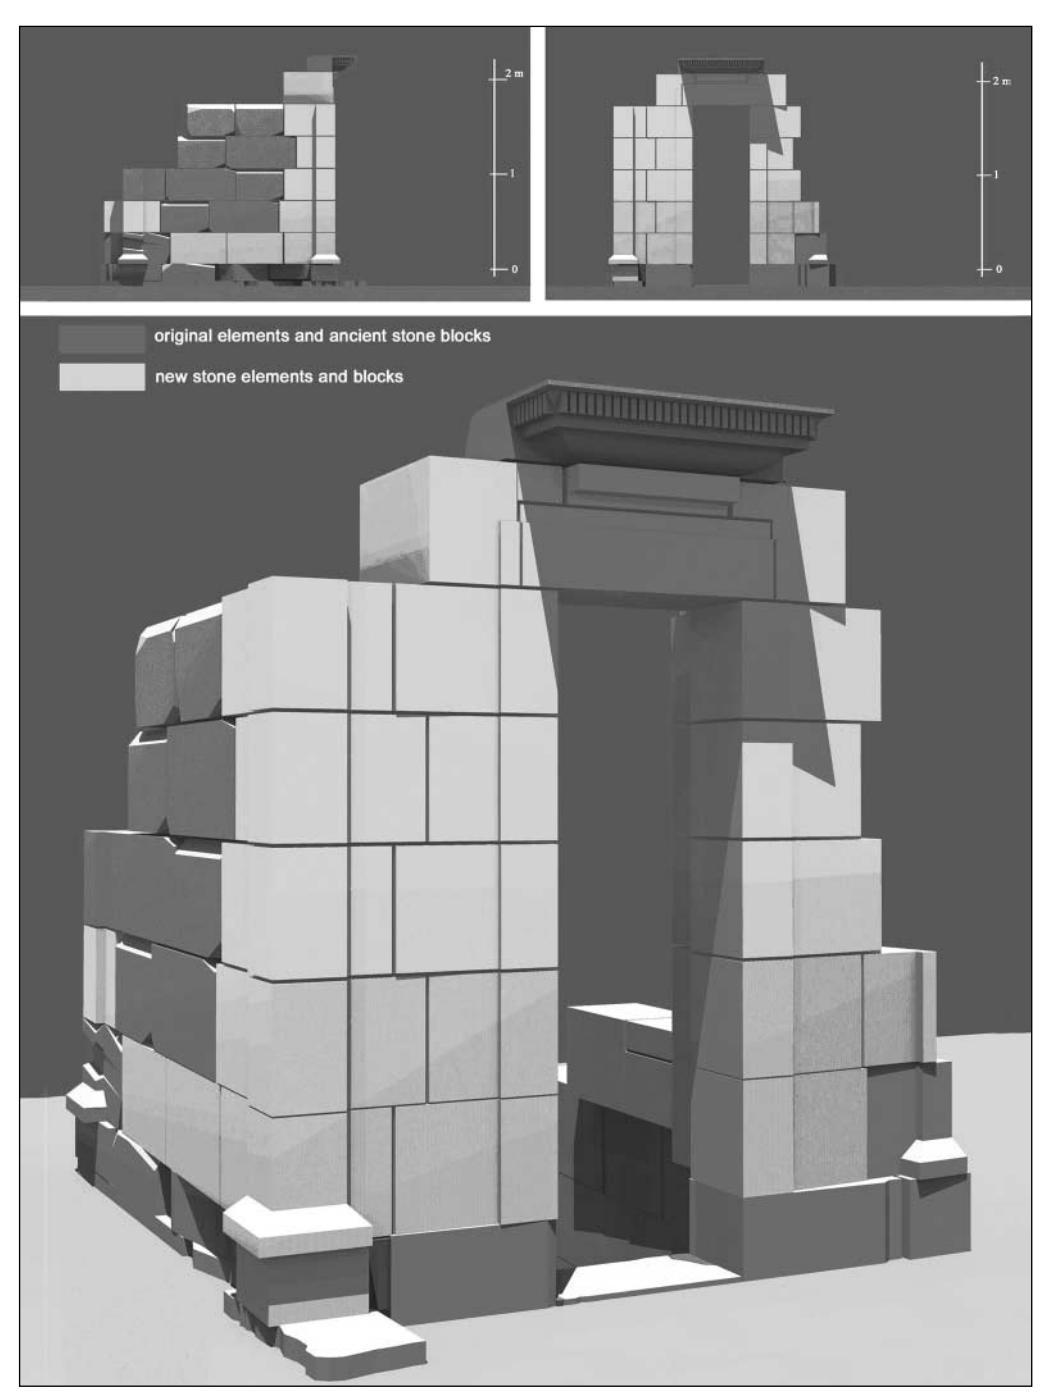
Fig. 6. Reconstruction of the kiosk of Tomb T1GH (Drawing R. Czerner)

structed (its lower walls stand on the lower parts of the western wall of the kiosk), the reconstruction on this side was not carried out. Only parts of the eastern and northern (front) walls were restored, including the entrance with the original cornice (preserved in 1998).

In earlier seasons, the underground structure of the dromos (G) with its virtually complete vaulting had been consolidated. All the foundation walls were in place, rising 0.24 m above ground level, but built up with five courses of stone blocks to a height of c. 1.50 m. The foundation courses preserved incised lines tracing the plan of the kiosk; also, two blocks of the first course of the walls in the southeastern and northwestern corners had been preserved, including carved bases and lower parts of small pilasters. The two blocks were 0.33 m high, equal to the upper foundation course and of the same width: 0.40 m in the eastern wall and 0.52 m in the northern one. These dimensions were adopted for all the new blocks used in the reconstruction of the walls and jambs.

The eastern wall was largely built up of original limestone blocks recovered from the fill, while the northern one with the northeastern pilaster, entrance jambs and doorframe were made of new blocks, following the evidence of traced lines on the foundation course. The height of the doorway was reconstructed as three times the width, a common design evidenced in contemporaneous structures discovered in the area. It corresponds to five courses of wall blocks, each measuring 0.33 m in height. The original cornice was placed above the successive, sixth layer containing the lintel. Its presentation at the proper height is didactic. The front wall west of the doorway was given a jagged form to suggest its collapse and to remind of the partial destruction of the kiosk when neighboring

tomb T1D was built. Elements of the kiosk were mounted using traditional methods with mortar following accepted proportions (sand to slaked lime to white Portland cement 6:3:1). The new elements were unified chromatically with the original stones using mineral pigments.
