PALMYRA

EXCAVATIONS, 1998

Michał Gawlikowski

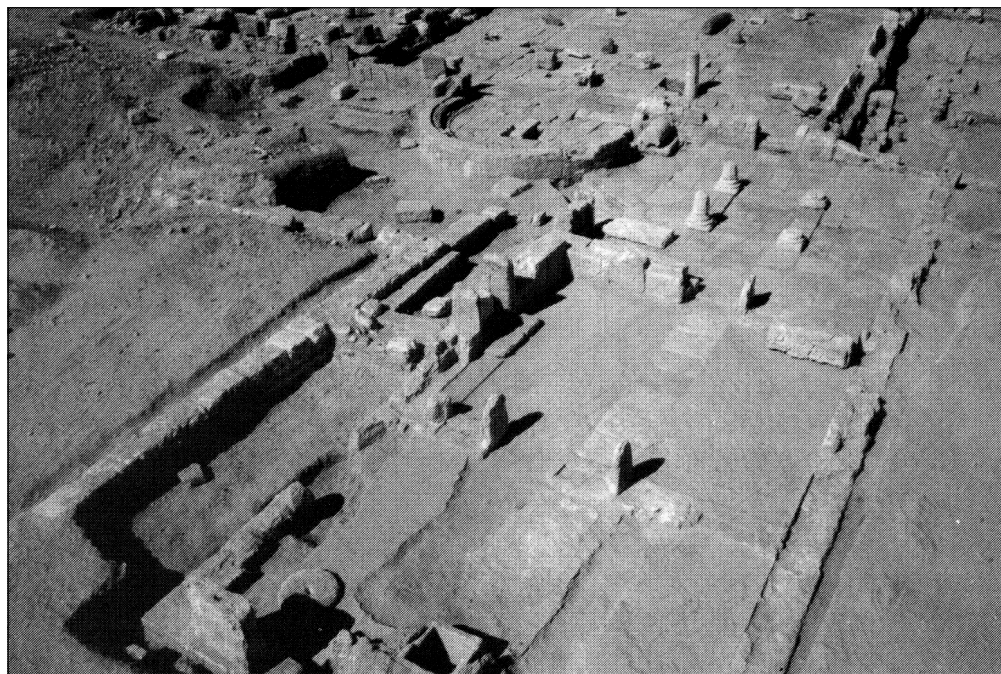
Fig. 3. *The Baptistery seen from the east*
(Photo T. Szmagier)

usually allotted to a sacristy, must have been inherited from some earlier, although already Late Antique building. We know now that it was not so. The colonnaded court led to a complex of rooms which was built together with the church and which displays features that allow it to be described as a Baptistery (G.4). This monument was excavated completely [Fig. 3].

Unfortunately, the Baptistery, in similarity to the church and at the same time, was systematically dismantled for the building stone. Consequently, the surviving walls are rather low, but the floors are practically complete and the plan is clear. We were able to identify in the fill some characteristic vertical members and to replace them, so as to make the monument more intelligible to visitors.

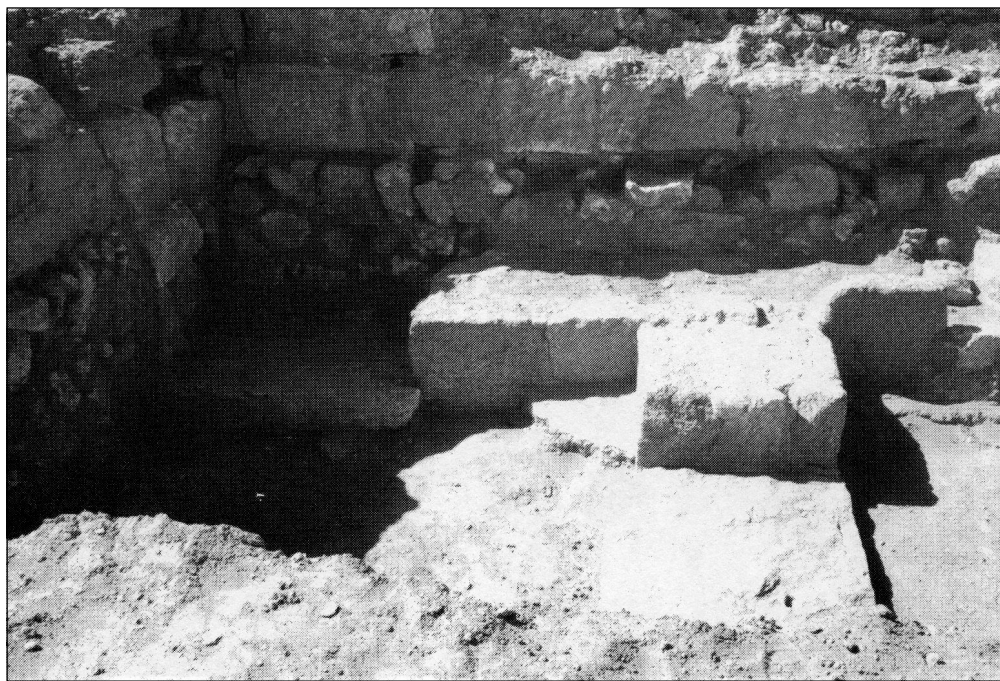
Fig. 5. Monumental entrance to a building beneath the northeastern corner of Church II
(Photo T. Szmagier)

At the other, northeastern corner of the church we can see the remains of a more important monument. Its monolithic threshold lies 1.50 m below the church level [Fig. 5]; it is part of a wall uncovered on 8 m of its length and 90 cm wide, running at a slight angle to the church wall above. Two courses of the western corner survive, and there is a perpendicular cross wall running north,

containing a flat stone which probably supported another threshold. It is clear that whatever survives of this building under the church flagstones is residual, left over from the dismantling which occurred some time before the church was built.
