MAREA

REPORT ON THE EXCAVATIONS OF THE POLISH ARCHAEOLOGICAL MISSION IN 2006

BYZANTINE BATHS

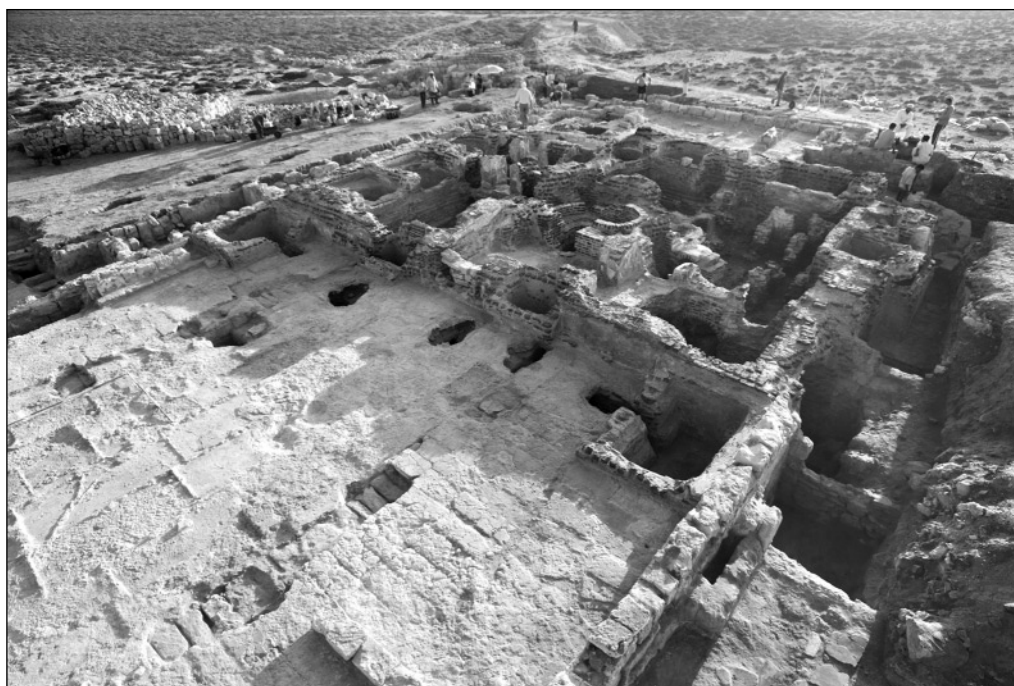
Fig. 1. Byzantine baths. Courtyard F6 with imprints of the marble pavement slabs preserved in the limestone bedding. View from the southwest (Photo P. Suszek)

The first task was to finish the excavation of the baths. The western courtyard (F6), which was excavated partly in 2001, had to be cleared completely. It turned out to measure 14.72 by 13.83 m and was paved with marble slabs, of which only imprints in the limestone bedding have survived [Figs 1, 2]. Apart from sections that were repaired, the slabs followed no size standards, ranging from 1.80 x 0.89 m to 0.80 x 0.80 m. Two marble slabs found in the rubble, a surprising 0.04 m thick, most likely originated from the courtyard. A small fragment of the marble revetment was preserved in the northwestern corner.

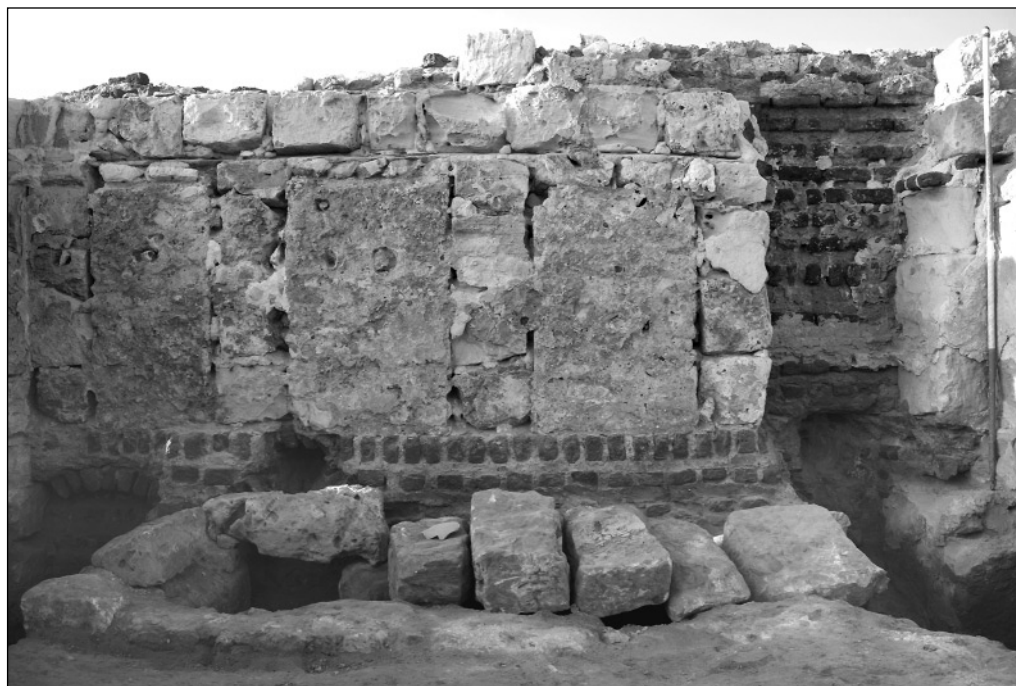
Fig. 3. *Byzantine baths. Technology of mortared rubble work employed in the north wall. View from the north (Photo P. Suszek)*

- 2 The north wall of the baths is constructed in typically Byzantine technology: pillars built of one or two courses of stone blocks in lime mortar and the space between them of mortared rubble. The surface of the wall was subsequently coated with a thick layer of mortar.

The courtyard was surrounded by a wall characterized by very varied structure. On the south and west it was built of stone blocks; an average three courses (1.50 m) bonded in mortar have been preserved. The north wall, which extended the wall behind the shops, was built in the same technology, that is, mortared rubble work² [Fig. 3]. The main entrance to the men's part, measuring 2.51 m in width, was in this wall [cf. Fig. 2]. The difference in the bondwork is not proof of a different time of construction, because Byzantine building allowed different bonds in the same building. The original doorways leading to the courtyard, observed in the west and

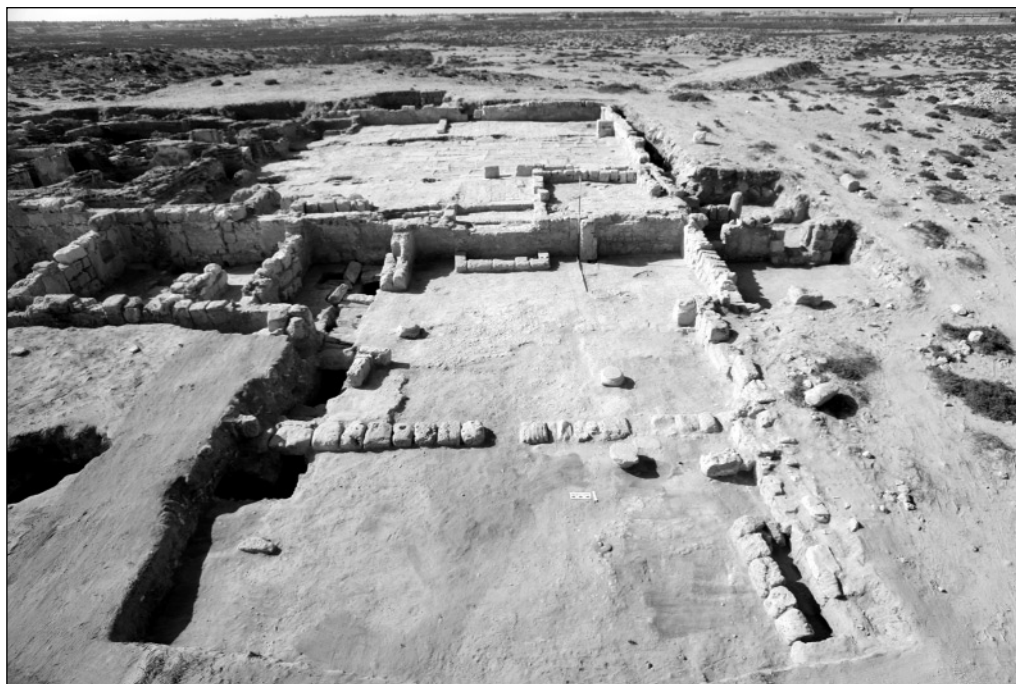
Fig. 4. Byzantine baths. The western entrance with a small space with two stylobates for columns in front of it. View from the north (Photo P. Suszek)

The first step of the stairs matched the western entrance in width [Fig. 4]. In front of it, a small open space was uncovered (B3), measuring 7.48 m by 6.71 m. The marble-slab pavement concealed two stylobates oriented E-W: one which is an extension of the wall lining the shops and the other 4.00 m to the north of it. An Attic marble column base was found *in situ* on the first of the two stylobates. An identical base lay in the rubble. This suggests the existence of a portico.

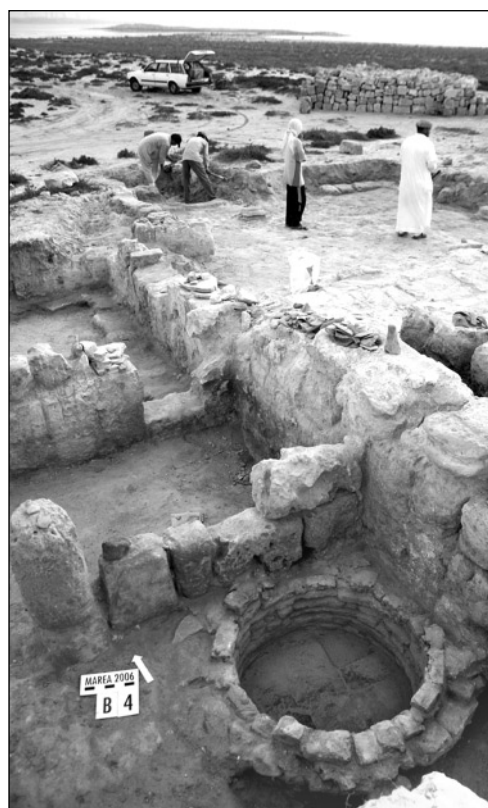
Fig. 5. Byzantine baths. Round bread oven of red brick beyond the west wall, view from the south (Photo P. Suszek)

The former protected a round bread oven (O5), 1.20 m in diameter, built of red brick (7 courses preserved, maximum height 0.50 m), surrounded by a row of stones, the filling hole in the southwestern side [Fig. 5]. The bottom was paved with limestone slabs.

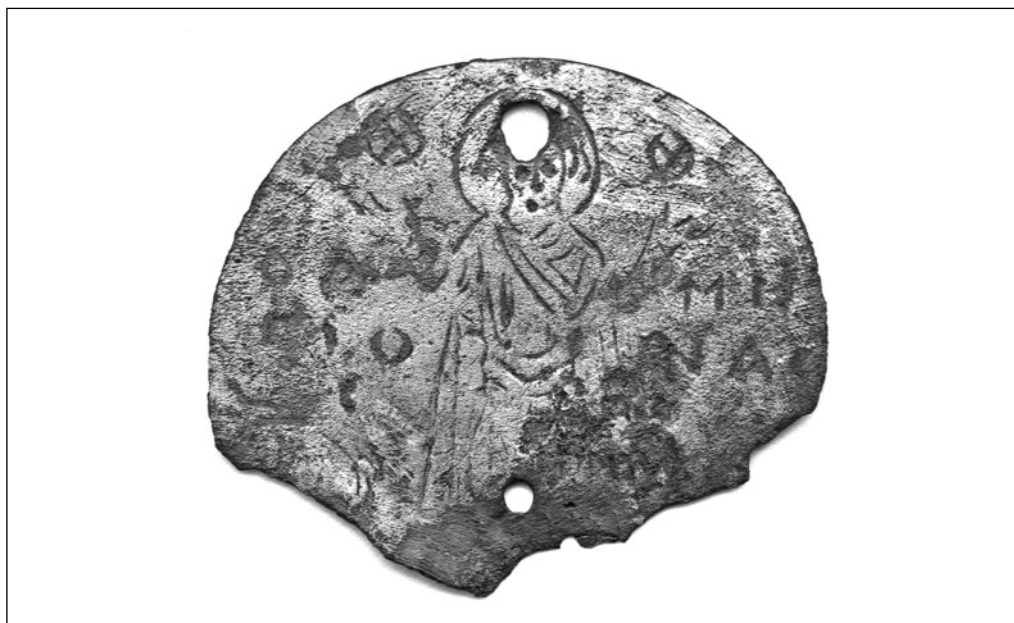
Fig. 6. Bronze medallion with an image of St. Menas found beyond the west wall of the Byzantine baths (Photo P. Suszek)

courtyard F6. Like the east wall of the baths, this spot functioned as a *favissa* for discarding objects which had been damaged and made useless in some way. A Corinthian capital of marble in excellent state was found here, as well as numerous potsherds, including pieces of a painted vessel with scenes of Dionysiac nature and an inscription in Greek translated as "I am healthy. Drink Kyria" [Fig. 7]. The *favissa* also yielded a few oil lamps repeating a type already known from previous seasons. An exceptional find is a bronze medallion with an image of St Menas and appropriate inscription [Fig. 6].

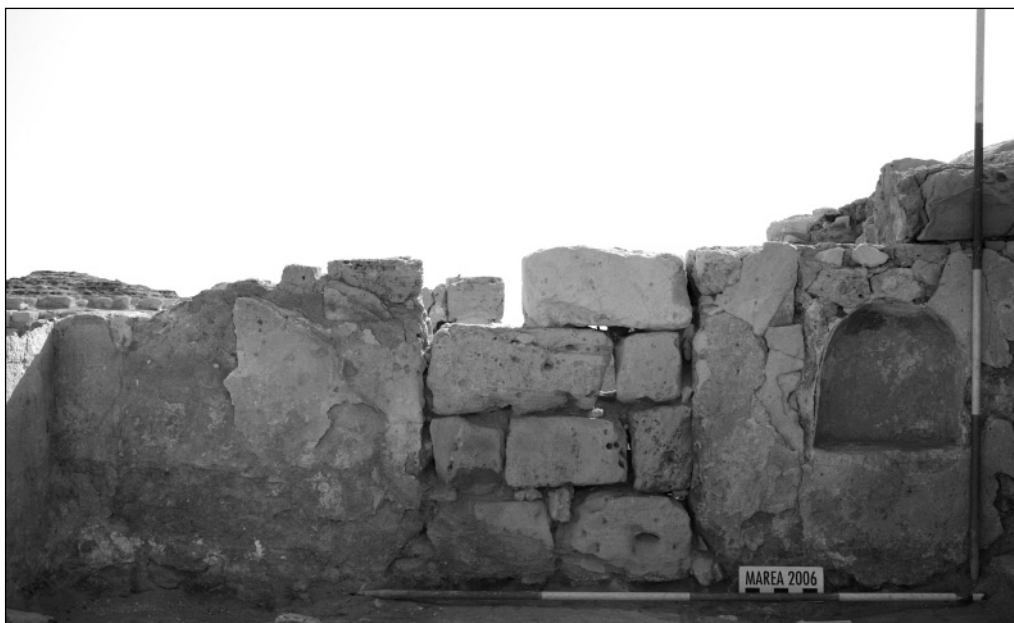
*Fig. 8. Blocked inner passage between shops B1 and C1. View from the west
(Photo P. Suszek)*

Four separate walls were built perpendicular to the north bath wall of stone blocks [cf. Fig. 2], forming four units of different size: starting from the east, E1 (2.26 x 3.48 m), D1 (3.48 x 4.48 m), C1 (3.61 x 2.18 m) and B1 (3.74 x 4.29 m). By parallel with other bath facilities, these units can be interpreted as shops providing bathers with the necessary bathing supplies, like fragrances etc. The present work (for previous exploration in 2001, see Szymańska, Babraj 2002: 56-57) extended the trench to the north, tracing the north wall of these rooms, which was located from 3.48 to 3.70 m away from the outer wall of the baths. All four shops were entered from the north and they were interconnected. Once the shops went out of use, these inner passages and the entries were all blocked [Fig. 8].

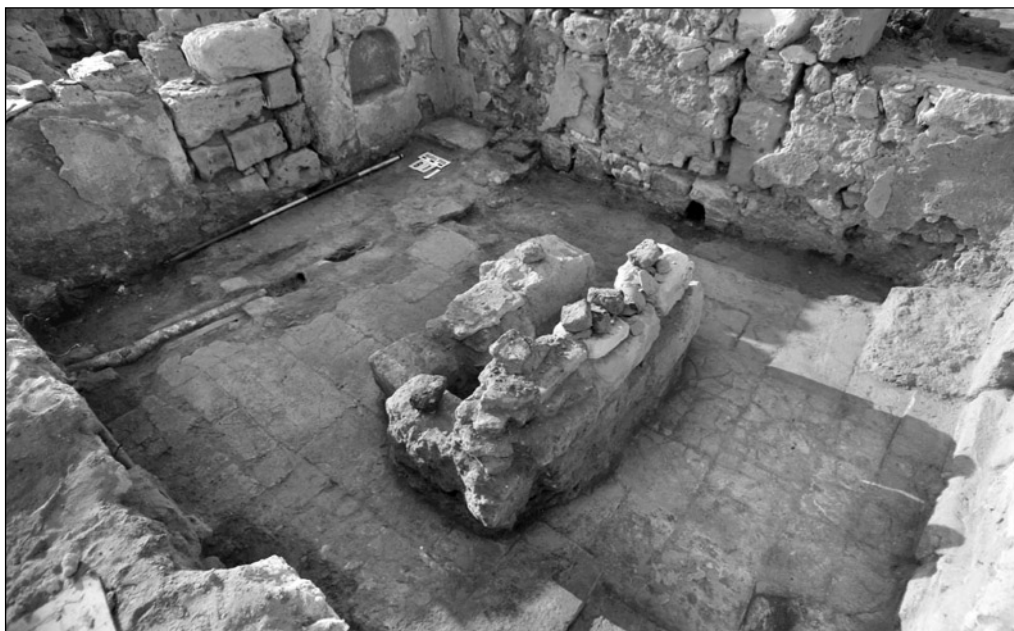
*Fig. 9. Shop B1 with stone structure in the centre. View from the northwest
(Photo P. Suszek)*

Almost all of the limestone flagstones of the pavement in shop B1 have been preserved in place. Running under them is a pipe supplying water from the saqiyah (see below). A stone structure measuring

1.80 x 0.50 m was found in the center of the shop. It was open from the south and its function remains in the sphere of conjecture [*Fig. 9*]. It most certainly belongs to a later phase in the operation of the shop, as it stands directly on the pavement.

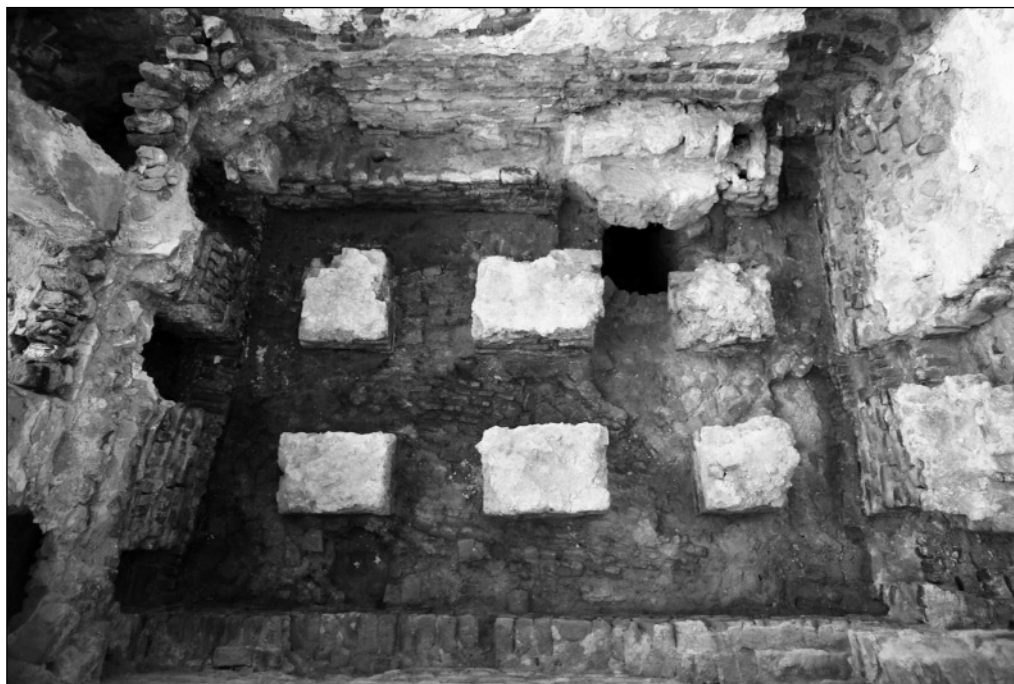
Fig. 10. Hypocaust C with installations comprising six brick pilae. View from the north (Photo P. Suszek)

The secondary floor in room C, consisting of two rows of irregular stone blocks occasionally bonded with mortar, was removed this season. It proved to conceal a hypocaust cellar underneath, the fourth such facility known from this baths and one of the two that heated the women's section. The secondary floor dates to after the Arab conquest as indicated by an Arab coin found underneath it in context with pottery of the 8th century. Some of the stones closed a flue from

furnace O1, running in the thickness of the south wall of the room and heating the two caldaria: C and F. The hypocaust measured 3.10 by 4.44 m [Fig. 10]. The stone floor all but destroyed the ancient *suspensura*, of which only a small section has survived in the southeastern corner; fragments of marble paving were recorded 1.80 m above the bottom of the hypocaust cellar. The inside installations are in fair condition, comprising six regularly spaced, square *pilae* of brick, c. 0.48-0.50 m high. The level of the original pavement indicates that the *pilae* were higher originally, even taking into account the presumed thickness of the *suspensura*. A wall screening the north wall from the heat was also found. Located behind this wall were pools E and D. A similar protective wall adjoined the south wall. Between the vent from furnace O1 and the west wall, traces of *tubulatio* were discovered. The next two installations of the type were placed symmetrically in the west wall. They each contained presumably three *tubuli*. Numerous fragments of obviously rectangular section were discovered both in the wall and in the nearby rubble. The *tubulatio*-heated walls also served to warm up the water in pool V located behind the west wall.

The east wall played the most important role in the circulation of hot gasses. Beneath it there were three arcades: in the middle, under the threshold to caldarium F, the flue bringing hot air into the latter room, flanked by smoke vents, one on either side. The walls between the smoke vents were constructed of bricks in alternating courses of headers and stretchers. The floor was made of irregularly laid bricks.

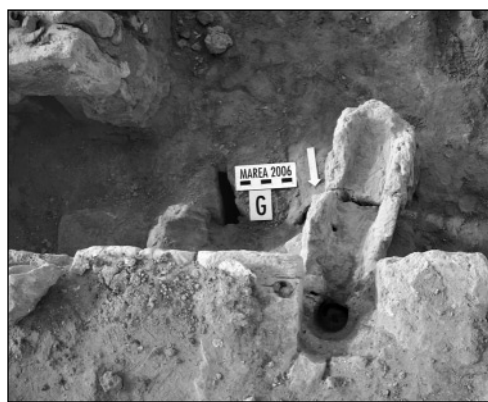
Fig. 11. Clay pipe under last block of *sāqiyah* pool and two sections of limestone casing (Photo P. Suszek)

of drawing water and transporting it to the baths had been presumed until now for lack of good archaeological data. The system was actually a simple hydraulic installation making use of the principle of connected vessels. Water was collected in the pool of the *sāqiyah*, from where it was pumped into clay pipes to run to the bath. Only one such supply pipe has been preserved, running to pool X by the west wall of the baths. The pipe, which can be observed under the last block of the *sāqiyah* pool, where also two parts of a limestone casing for the pipe are still standing in place [Fig. 11], ran under the floor of F3 for 5.20 m at an angle to the north wall of the baths, reaching the north wall (behind the shops) supported on stone slabs. It then ran behind the north wall for a distance of 18 m. Two segments of this part of the channels were recorded, set in stone casings of 0.30 m width. The pipe then turned at right angles (the turn has actually been preserved) into room B1, where it continued for a distance of 4.20 m until it reached the south wall; it then rose to a height of 1.50 m, being attached to

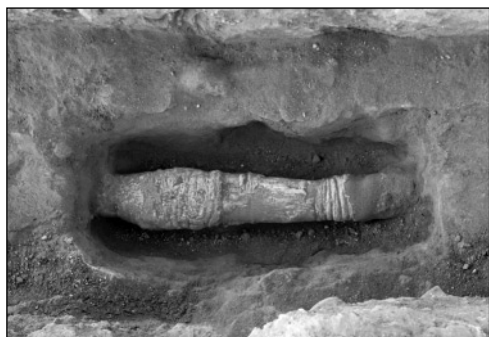
Fig. 13. *Joining of two segments of pipe behind room D1. View from the north*
(Photo P. Suszek)

the wall by lime mortar (traces still evident on the wall face) and ended in pool X. In shop B1, two long sections of this pipe were preserved, concealed under the limestone flagging on the floor. One section was 1.00 m long and had a stone bedding; the other measured 0.40 m [Fig. 12]. The pipes at the joining take on a spindle-shaped form, hence the different sections (5.5-7 cm of diameter) and lengths of particular pieces. A connection of two segments can be observed clearly behind room C1 [Fig. 13]. Apart from pipes *in situ*, there were many loose fragments in the fill nearby; one was 0.36 m long, found in a completely unexpected place under the paving in the center of courtyard F6.

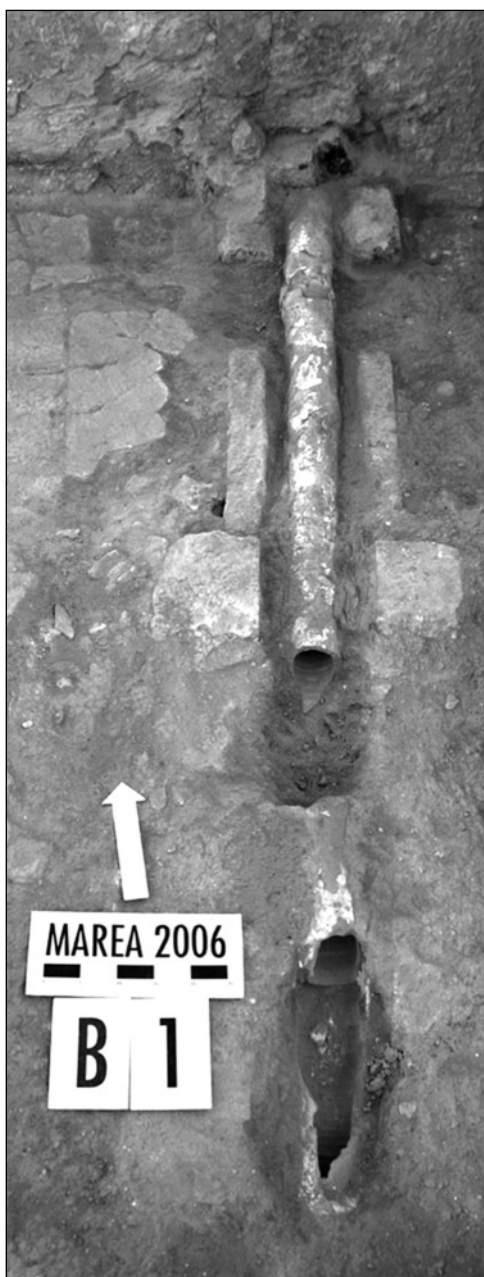
Fig. 12. *Two long sections of pipe, preserved in shop B1. View from the south*
(Photo P. Suszek)

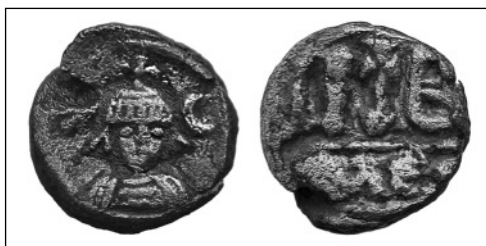
Fig. 14. Coin of Chosroes II (618-628)
(Photo P. Suszek)

This year's finds have confirmed the dating for the most intensive use of the baths in the 7th and early 8th century. The shops, and especially E1, yielded numerous coins of Chosroes II (618-621) [Fig. 14], while more than 10 of the legible Arab coins originated from the period around 689-750.³ The blind end of channel Q2, at the western edge of courtyard F6, contained numerous coins, including 25 *folles*, which
