OLD DONGOLA

KOM A (CITADEL), 2007

Włodzimierz Godlewski

BUILDING B.V ON SITE SWN

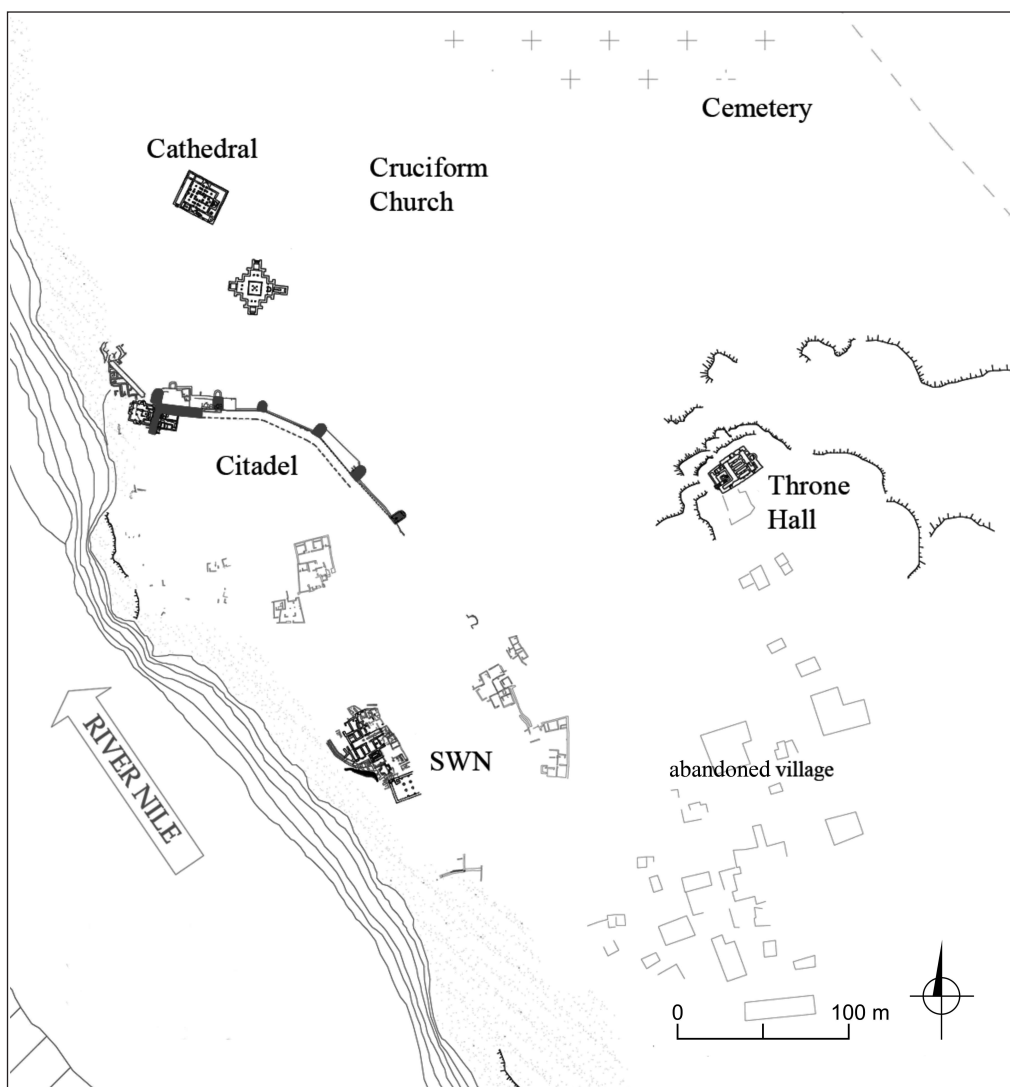
Fig. 1. Survey plan of the citadel in Dongola
(Drawing W. Godlewski, W. Małkowski)

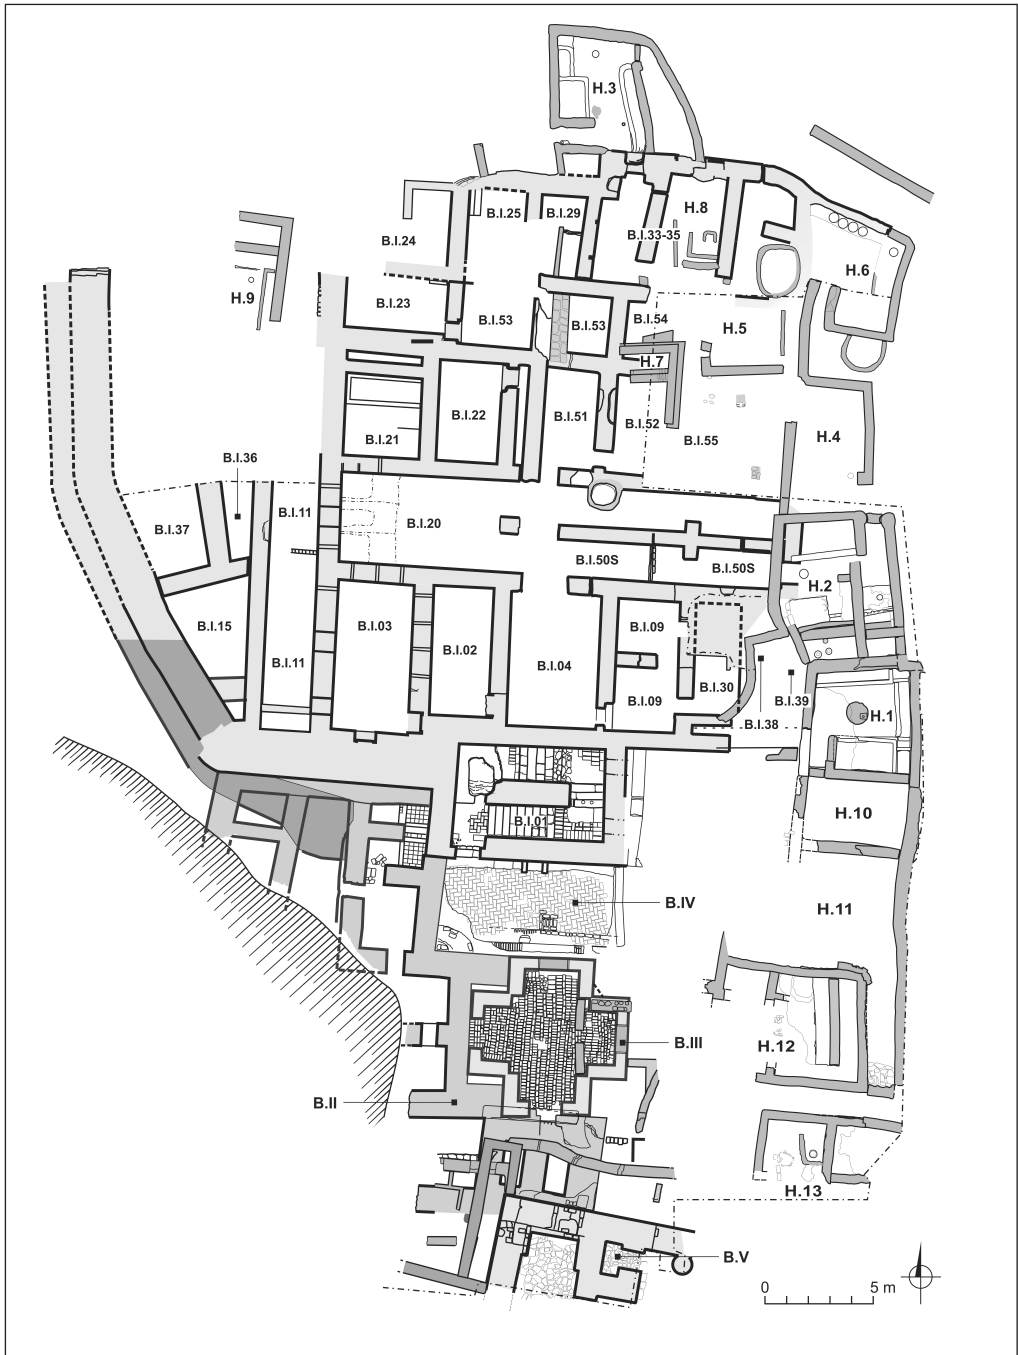
Fig. 2. Plan of site SWN on the citadel in Dongola
(Drawing W. Godlewski, M. Puszkarski, D. Zielińska, S. Maślak)

latter, cf. Godlewski 2004: 200–215; 2006a; Zielińska 2004: 216–223). The brick walls of this structure, designated as Building V [Figs 1, 2], had been dismantled

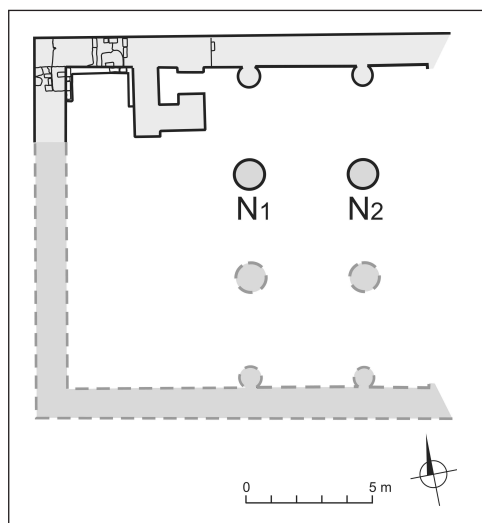
Fig. 3. Plan of Building V, after the 2007 season (dashed lines indicate presumed reconstruction of unexcavated part) (W. Godlewski, D. Zielińska)

A 10 m long trench dug this season along the north wall of the structure confirmed the earlier observations. A section 16.50 m long of the wall is now cleared and it proves to be in good shape [Fig. 3]. Only the west wall was robbed out, while the east wall appears to be standing at least 2.50 m high. Two round piers were located in the northern part of the building: N.2 preserved to its full height of 3.00 m above the floor and N.1 to a height of 2.15 m. Considering that the ground surface here rises to the south and east, it is extremely likely that the southern and eastern parts of the complex

The massive walls and piers (the latter of a diameter equal to 1.20 m), topped in the case of pier N.2 with an impost of sandstone blocks and bricks presupposing the existence of arches, vaults and domes. A preliminary reconstruction of the building plan suggests a central hall with piers and a developed western part, only partly recognized, and a completely unknown eastern part [Fig. 3]. Assuming only four piers in the body of the church, the minimal width of the building can be reconstructed at 14.50 m. Its archaeologically confirmed length is 16.20 m, but

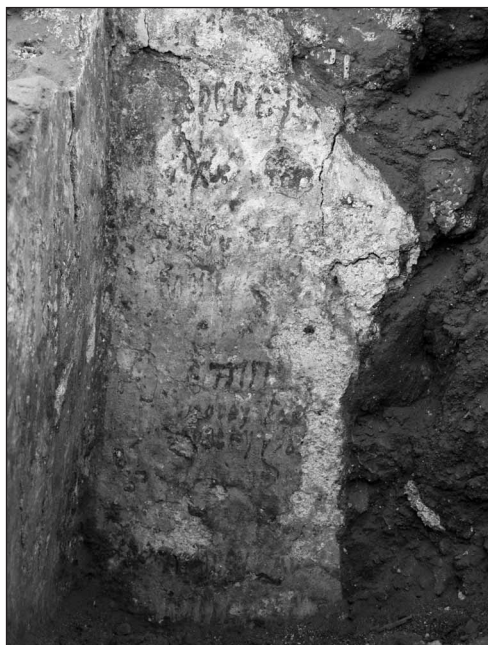
Fig. 4. Greek inscriptions on the north wall of Building V (Photo W. Godlewski)

are preserved as well or better. The technical parameters of this structure place it among the most important structures of the royal complex on the summit of the citadel in Dongola. Indeed, it finds no parallels either in Dongola or in all of Makuria. The walls are 1.20 m wide and are built of red bricks (35–37 x 19 x 8 cm) bonded in mud mortar. The round support by the north wall and the round piers in the center are constructed of red bricks suitably shaped as triangular wedges and trapezes with arching sides, set in lime mortar [Fig. 5]. A thick lime rendering with a very smooth surface covered the inside walls and piers. Similar plaster has been recorded to date only in the Cruciform Building (B.III) situated between the royal palace (B.I) and Building V. In other buildings, like the cathedrals in Dongola and Faras, walls were floated with lime-washed mud plaster and the painted decoration executed on thus prepared surfaces. The present work in Building V uncovered on the north wall and on pier N.2 murals and inscriptions painted directly on the lime plaster, similarly as in Building III [Fig. 4]. The painting technique needs to undergo lab analyses, but it is most likely also oil tempera.

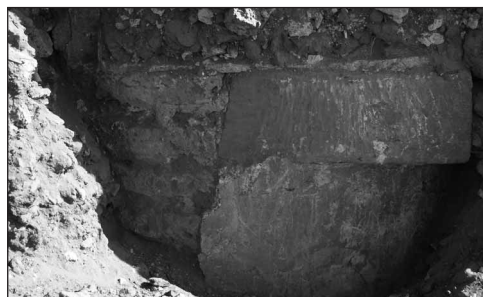
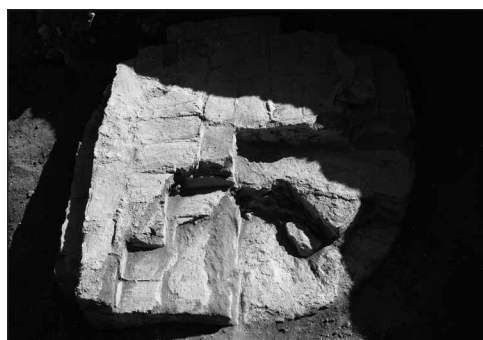
Fig. 5. Top of pier N.2, view from the north side (top) and top (Photo W. Godlewski)

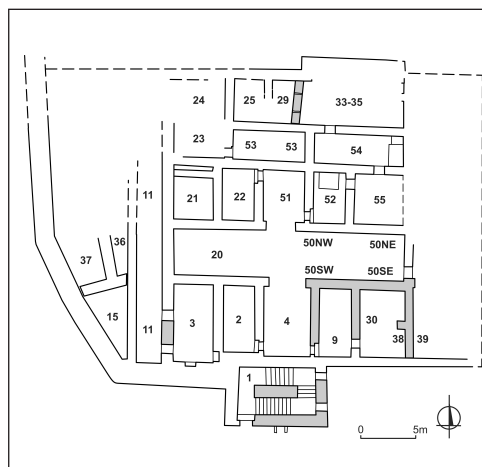
Fig. 6. Plan of the third phase of occupation of the palace building on the citadel (3B.I) (W. Godlewski, D. Zielińska)

In the third phase, the building seems to have comprised 13 rooms [Fig. 6]. The entrance from the city side led to room B.50.SE and the entrance from the south via the still functional staircase remained in use. Most certainly the original walls of Building B.I were still standing. The only new construction was the west wall in units 51, 53 and most probably 50, in similarity to the west wall of room 33. Partitions were introduced in some of the rooms (9, 30, 50) as well as a number of masonry benches of different dimensions, all approx. 0.20–0.30 m high (in rooms 9, 38, 52 and 54). The interiors were plastered and whitewashed; red pigment was noted on some of the walls, often on the entrance jambs. Some Old

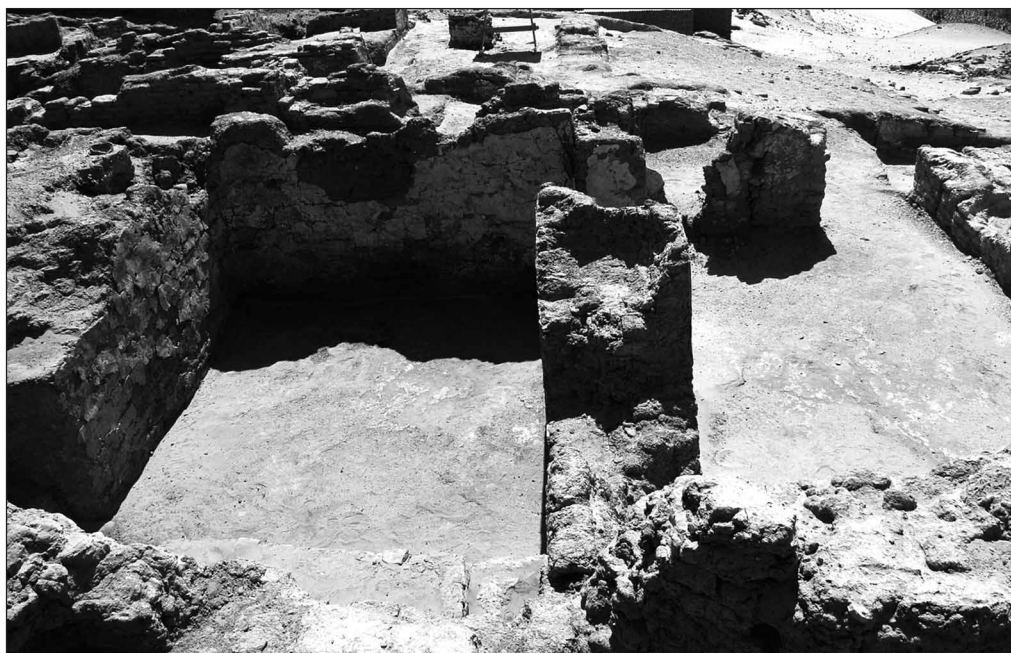
Fig. 7. Room 52 from the 3B.I phase of the palace, view from the north (Photo W. Godlewski)

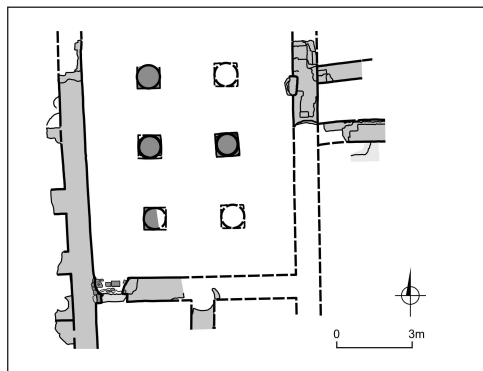
Fig. 9. Preliminary plan of Building C.1 (Drawing S. Maślak, A. Obłuski)

The function of this structure remains to be determined. It may have been a civil structure of special importance or a sacral building. It definitely was part of the royal complex which also included the Palace (B.I) and the small Cruciform Building (B.III). It was erected later than the other two, which are dated to the first half of the 7th century (B.I) and the middle of the 7th century (B.III). Acting upon the presumption that the appearance of round piers built of profiled bricks in the church architecture of Dongola is linked to the rebuilding of the Third Cathedral (Church of the Granite Columns), currently dated to the second half of the 9th century (Godlewski 2006b: 281–282; Gartkiewicz 1990), and the founding of the so-called Pillar Church on the northwestern platform next to the fortifications, also dated to the second half of the 9th century (Godlewski 2006b: 279–280), we can suggest a date in the 9th century, and rather the first half of that century, for the construction of this building. The quality of execution and homogeneity of the conception are such that it could have been a model for the Pillar Church and the Fourth Cathedral. It should be noted that pillared interior designs were popular in the architectural milieu of the capital. The building uncovered in the northwestern part of the citadel (07.C.1; cf. Fig. 9) also had a central hall with round piers built of bricks.

The other site, which started to be explored in the northwestern corner of the Citadel, is C.1. A large mud-brick building (B.VI) uncovered here (its full size is not yet known) is situated at the edge of a rocky cliff, rising steeply from the river at this point. So far, a big hall has been explored, its ceiling supported on six round piers constructed of brick, and a number of chambers of different size in the southwestern part [Fig. 9]. While it was certainly in use in the 11th–12th century, there is no doubt that its construction falls at a much earlier date.

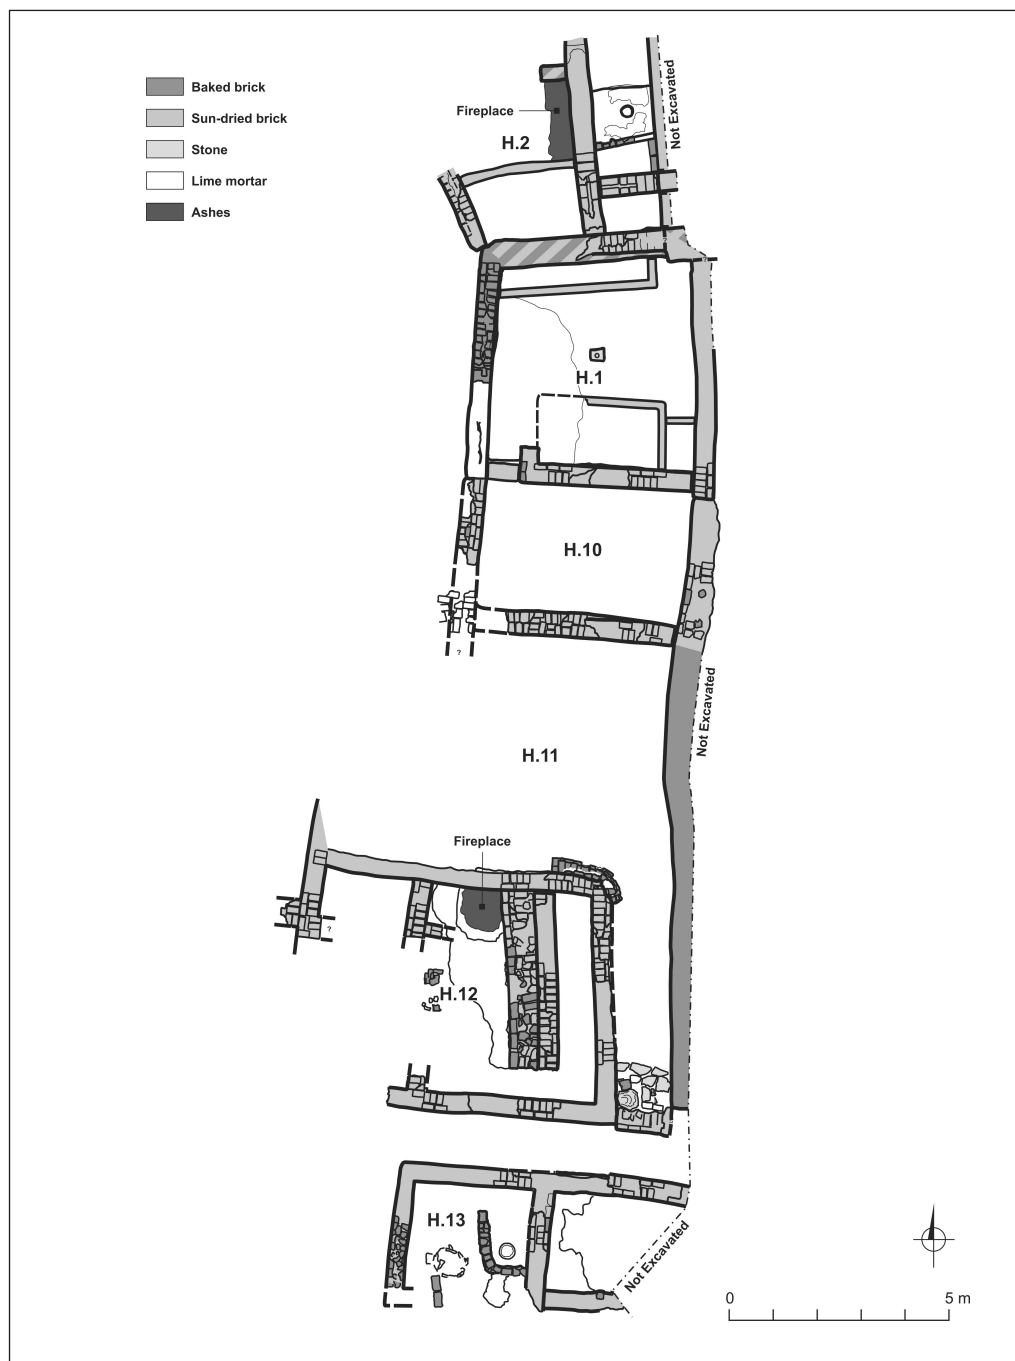
Fig. 11. Plan of 16th–17th century houses on the citadel (site SWN)
(Drawing S. Maślak)

The work in the southeastern part of Building B.I also encompassed a continuation of the exploration of houses H.1 and H.2 uncovered in 2003 (Godlewski 2004: 206–207) and the habitations situated to the east of B.III, between the palace and B.V. Another two houses, H.12 and H.13, were cleared, as well as two courtyards — H.10 connected with H.1 and H.11 connected with H.12 [Fig. 11].
