# Title: Khone-ye Div. Preliminary report on the second and third seasons of Irano-Polish excavations (2009 and 2010)

Author(s): Barbara Kaim, Mohammad Bakhtiari, Hassan Hashemi

Journal: Polish Archaeology in the Mediterranean 22 (Research 2010)

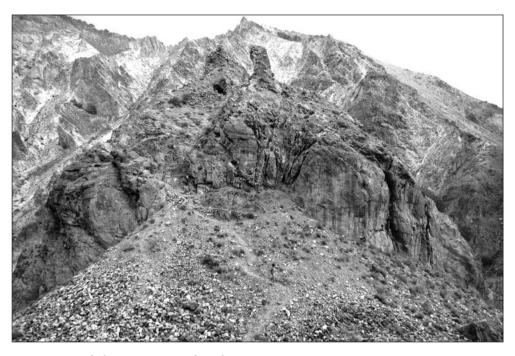
Fig. 1. Ruins of Khone-ye Div, view from the west (All photos B. Kaim)

Some stone steps were discovered in the northern part of a narrow corridor [Figs 1, 4], adjoining the northeastern wall of the *chahār tāq*. It is not clear to which phase they should be assigned. The corridor ends blindly just before the sharp edge of the hill, hence the steps should be seen rather as shelves of sorts.

In the next phase a room of the ayvān type (4.40 x 3.00 m) was built adjoining the northern part of the northeast wall of the chahār tāq and the fragment of wall parallel to the eastern part of the same wall. The west wall of the *ayvān*, constructed to the right of the entrance [see Fig. 1], hugged the exterior face of the *chahār tāq*, the north wall was set directly against the rock face. Both were built of mud bricks  $(46 \times 46 \times 10 \text{ cm})$ . The lower part of the east wall was built of irregular stone rubble. A brick barrel vault may have covered the ayvān. Three high, L-shaped steps or benches were constructed inside the ayvān [Fig. 5, top], the top of the lowest one being level (1663.23 m a.s.l.) with the top of the third of the stone steps described above. The highest bench stood about 0.66 m above floor level. Just as the stairs,

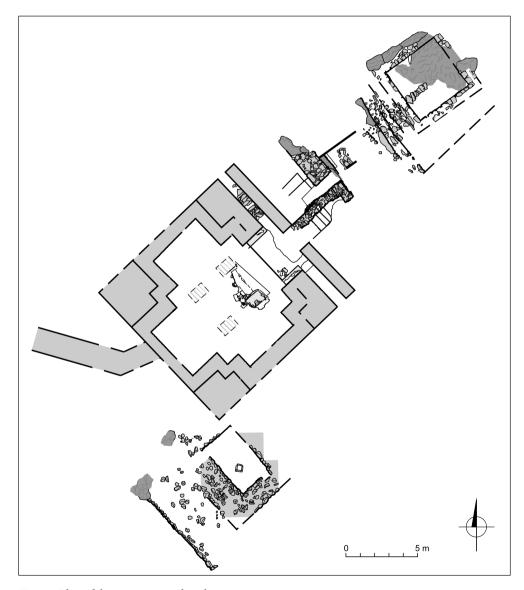
Fig. 2. Plan of the area excavated in the 2009–2010 seasons (Drawing and digitizing M. Grabowski)

The building turned out to be a *chahār tāq* (meaning "four arches" in New Persian) considered the most characteristic form of Sasanian architecture. The central part consisted of four corner piers once supporting a dome [Fig. 2] and was closed by relatively thin walls. Short barrel vaults

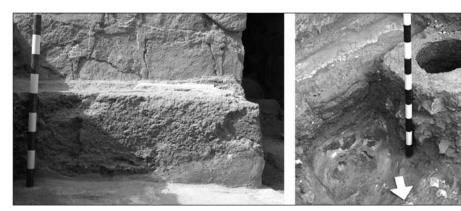
Fig. 3. Clay bench along the northeastern side of the entrance to the chahār tāq (left) and oven leaning against the southeastern bench

A small T-shaped trench, designated as number 2, was located in the area encompassing an entrance bay and two narrow corridors running to the northeast. A floor covered by a thick layer of gypsum plaster was found at approximately 0.70 m depth. Mud-brick benches [Fig. 3, left] ran along the side walls of the entrance bay: the southeastern bench was 0.42 m wide and 0.48 m high, and the northeastern one 0.42 m and 0.56 m respectively. The bricks used were square (39 x 39 x 10 cm) and the surface of the benches was rendered with polished gypsum plaster. Traces of a red-painted wavy pattern were noted

The second building phase encompassed a small clay oven filled with ashes leaning against the southeastern bench [Fig. 3, right]. A layer of mud-brick fragments scattered on the floor seemingly represented the remnants of a collapsed vault. It was overlaid by a thick layer of mudbrick fragments mixed with stones which were occasionally coated with gypsum mortar and fragments of gypsum plaster.

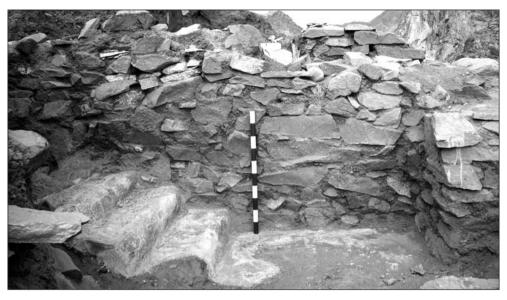
Fig. 4. Stone steps leading to the chahār tāq

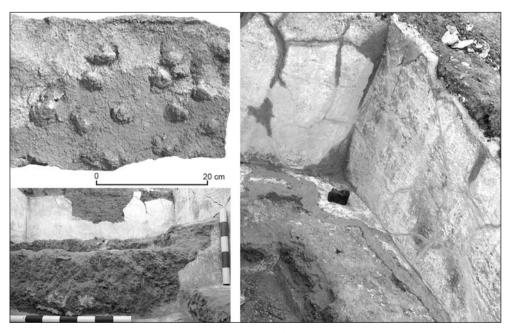
Fig. 5. Gypsum plastered steps in the ayvān (bottom left), and the wall plastering in the ayvān during conservation (right); back of a fragment of gypsum plaster showing the pock-marking of the bricks (top left)

the benches inside the *ayvān*, as well as the walls and floor, were covered with a thick layer of gypsum. The bricks were pockmarked in order to increase the adhesion of the plaster [*Fig. 5*, bottom left]. In the case of the stone wall, the gypsum when wet could have penetrated into the cracks between the stones.

A conservation program was carried out on the gypsum plaster of the walls of the water reservoir and the steps of *ayvān* [Fig. 5, bottom right] and a proposal was submitted to the Iranian Center for Archaeological Research on how to preserve the walls of the *chahār tāq* (drawn up by engineer M. Michiewicz).

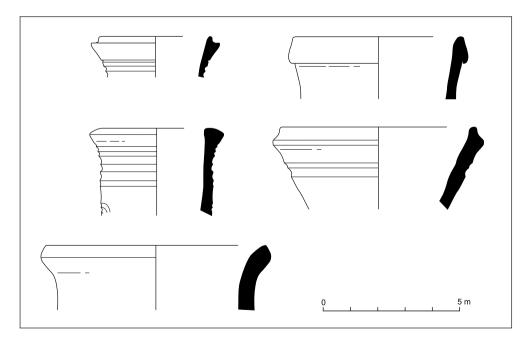
Fig. 6. Sasanian/early Islamic pottery (Drawing and digitizing M. Wagner)

the walls of the second and third phases. The area south of the entrance to the *chahār tāq*, enclosed by a stone wall, was probably unroofed. Prior to the construction of the wall perpendicular to the *chahār tāq* entrance, its function must have been connected with activities that took place in the *ayvān*. Unfortunately, in the absence of any parallels, the nature of these activities remains unknown. The pottery finds from the season included, early Islamic wares as well as some Sasanian vessels [*Fig.* 6].

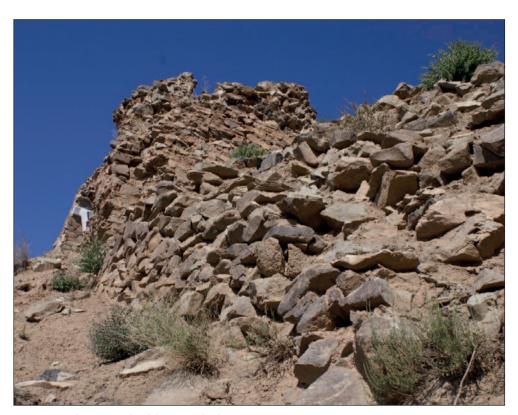
Fig. 7. Southeastern side of the stone platform

A small trench (Trench 6), 3.50 m by 1.50 m, was opened behind the stone wall enclosing the area to the left of the entrance to the *chahār tāq*. A stone platform was discovered, extending from the highest of a series of steps leading from the reservoir unearthed in 2007 and the wall parallel to the eastern part of the northeast wall of the *chahār tāq*. Not only the wall to the left of the entrance to the *chahār tāq*, but also presumably the southeastern part of the *chahār tāq* were built on this leveling platform. The southeastern side of the platform [*Fig. 7*] may have been higher and formed an enclosing barrier.
