Title: **Nea Paphos: Seasons 2010 and 2011**

Journal: *Polish Archaeology in the Mediterranean* 23/1 (Research 2011)

**Abstract:** The campaign of 2010 was mainly a study season devoted to analysis of finds collected during three previous years of intensive salvage excavation. The study was focused on finds from the 2007 campaign. The only fieldwork undertaken was cleaning necessitated by inundation of trenches during the very wet winter of 2009/2010, especially in room 1SW of the Villa of Theseus and rooms 19, 25, 31 and 32 of the "Hellenistic House". In 2011, the western limit of the Hellenistic House was excavated, with hot-air exhaust channel between rooms 31 and 32, paved room 28S, cistern/basin pedestal, staircase 28N and corner room 33. The other main area of excavation was the northwestern corner of the main courtyard where remains of an aboveground cistern(?) were found. Indications of the existence of a lower courtyard level were uncovered in the form of balustrade fragments well below the late surface.

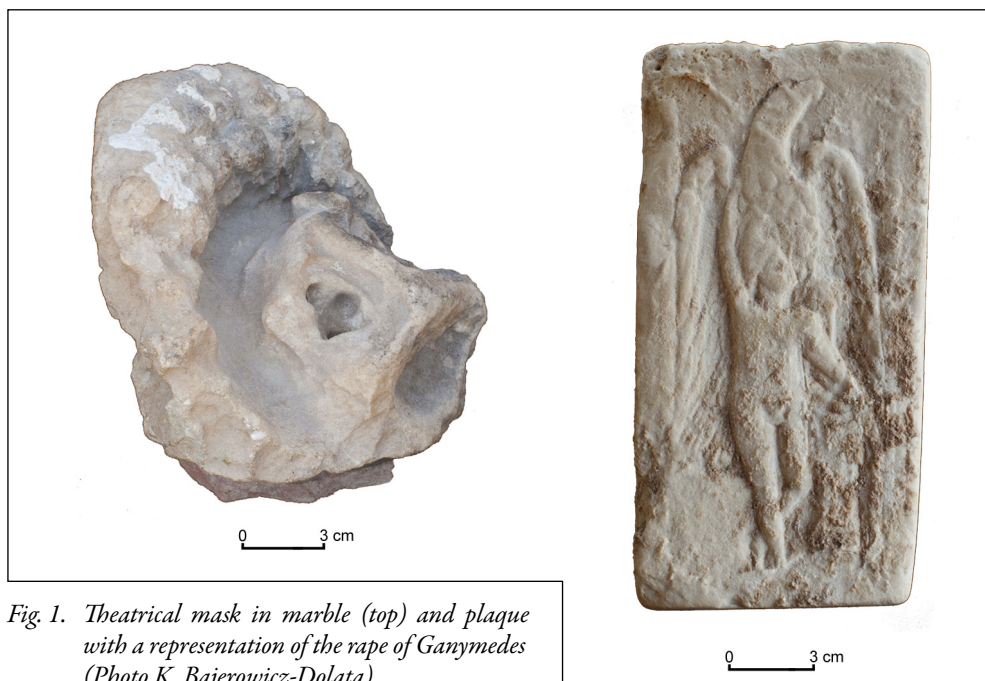
Fig. 1. Theatrical mask in marble (top) and plaque with a representation of the rape of Ganymedes (Photo K. Bajerowicz-Dolata)

ment 2, a floor of an Early Roman (i.e., 1st–2nd century AD) building preceding the Villa was fully cleared [*Fig. 3*] and a carved plaque was found alongside an iron saw. A local stone called *marmara* was used to make it. It is a soft, laminating rock, classified as medium-grained gypsum, with small addition of calcium carbonate. Both in Cypriot antiquity and in modern times, it has served as material for paving, thresholds, slabs for table-tops etc., but it is ill-suited for carving. The plaque is barely 19.2 cm high and 4 cm thick. One of its larger faces features a scene in low relief showing an eagle and a boy in conical cap with his right arm stretched over his head

[*Fig. 1*, right]. There is only one myth corresponding to this representation, which therefore poses no interpretational challenge (Meyza 2010). Images referring to the myth of the rape of Ganymedes by Zeus show the god as an eagle as early as the 4th century BC, however, this theme gains popularity in the 1st century AD. In Paphos, other examples of this type of image were found in the 3rd century AD House of Dionysos.<sup>1</sup> Still, the plaque must be earlier, as other objects from the room where it was found were dated to the late 1st or beginning of the 2nd century AD. It is therefore the earliest relief representation of this scene found in Cyprus.

In room 19 of the Hellenistic House, excavated in 2006, heavy winter rainfall had washed out a fragment of a marble statue remade into an image of a theatrical mask, 16.9 cm long and 16 cm wide (Meyza 2011: 379–386). It was found during cleaning of a previously uncovered floor; the piece protruded from an even, consolidated layer of earth but was actually embedded in an underlying layer of ash, probably debris of a preceding phase of the building. One side of the object retained its original shape, allowing it to be identified as a fragment of a large, possibly life-size human statue, with polished surface. The other side, that is, the broken-off surface, has been roughly remodeled into a crescent of curly hair over a coarsely sculpted face, with protruding, gaping mouth and deep-set eyes, made by multiple drilling

[Fig. 1, top]. The mask seems to have been unfinished, abandoned and finally reused in a wall, as parts of it were in places caked with plaster.

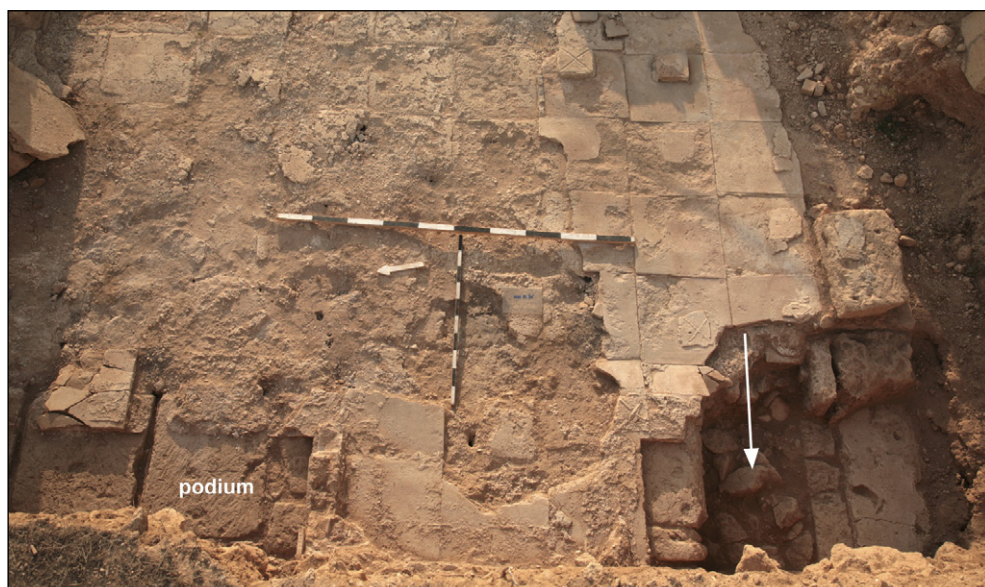
*Fig. 2. Room 31 (Villa of Theseus) robbed out flagstone pavement under probable second podium (Photo H. Meyza)*

In room 31, the east face of the west wall was cleared. The wall had been dismantled, but a levelling layer for its foundation remained in place. The room had a hypocaust floor, but most of the terracotta tiles forming the surface of the lower floor had been removed. Close to the west wall there remained a rectangular area without tiles [Fig. 2], perhaps a gap left by a dismantled podium. Both here and in the southwestern corner of this room a floor paved with massive flagstones, approximately 15 cm thick, could be seen beneath the tiles. It may have been an element of the hypocaust floor construction, supporting the considerable weight of the structure.

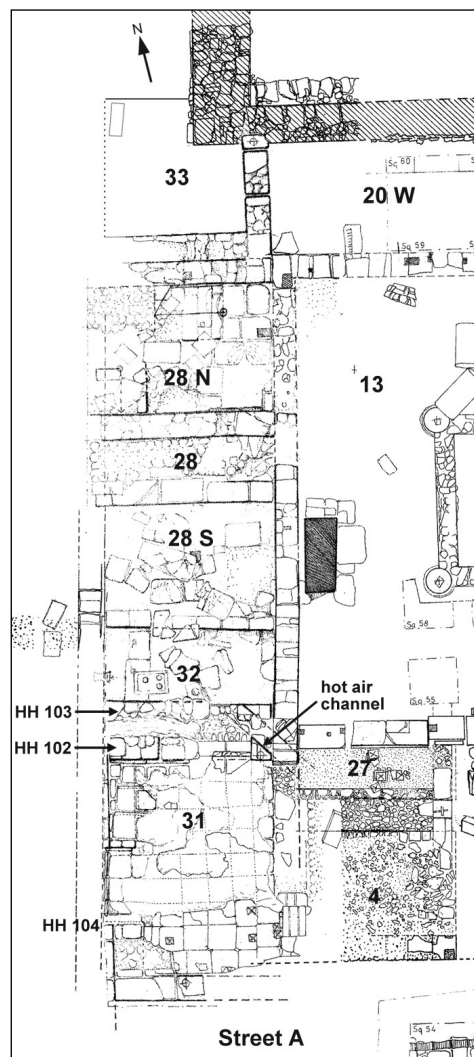
Fig. 4. Western part of the so-called Hellenistic House (Plan M. Słowińska, A. Brzozowska, S. Medeksza)

The 2011 campaign had two aims: excavation and study, with only four archaeologists active in the field and the remaining staff working on analysis of finds from salvage excavations in 2007–2009. Excavations concentrated in two parts of the so-called Hellenistic House: rooms 28N and 28S, 32 and 33 in its western part [Figs 4, 5] and in the main courtyard (1).

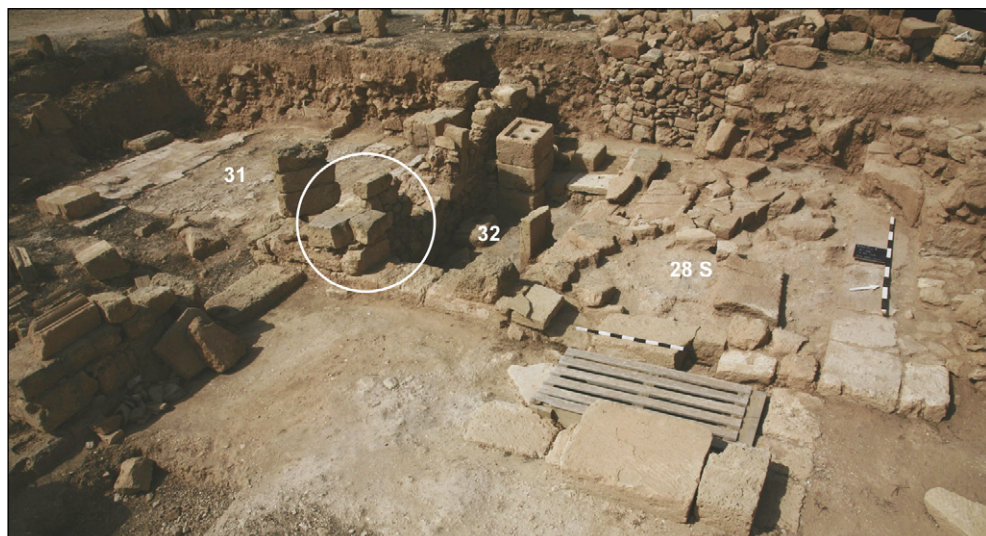
Fig. 5. Southwestern part of the so-called Hellenistic House with hypocaustic floor in room 31, heating area 32, and heavily disturbed pavement in room 28S (Photo H. Meyza)

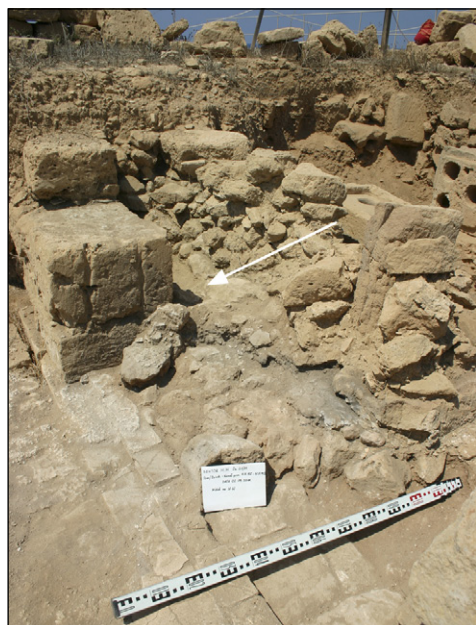
Fig. 6. Inside of a hot-air channel with ash deposit on the floor (arrow)  
(Photo M. Woźniak)

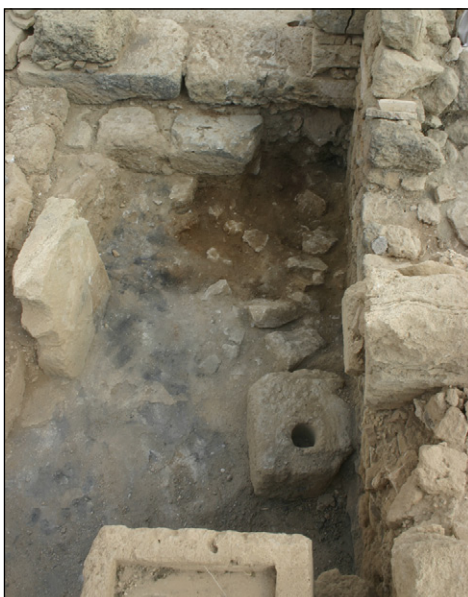
Fig. 7. Eastern part of heating area 32 with remains of thick ash and soot deposit abutting stairs leading to courtyard 13  
(Photo M. Woźniak)

of brown soil with small stones. This layer penetrated below steps leading down from the courtyard (13), evidencing a change in the room's function [Fig. 7]. The furnace,

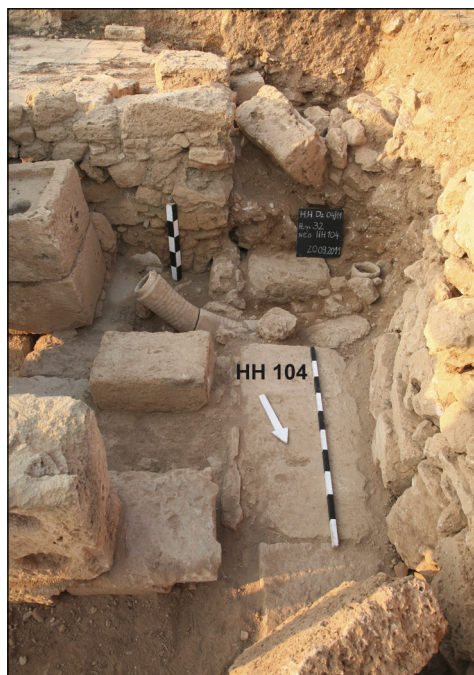
Fig. 8. Western edge of heating area 32: reused siphon and water pipes. In the background, a heating channel abutting the west wall of the complex, now dismantled (Photo K. Bajerowicz-Dolata)

however, was not found. A source of heat located west of the building, in street 10, seemingly suggested by the direction of the channel, has to be ruled out, as the channel walls (HH102 and HH103) were clearly set against the west wall of the building (HH104, presently robbed out) rather than cut across it [Fig. 8]. At the eastern end of the channel, an oblique slit in a masonry pillar directed the hot air into the hypocaustic space of room 27. A previously entertained hypothesis concerning the existence of a vertical channel in this masonry pillar had to be abandoned, as the oblique channel proved to have a solid stone

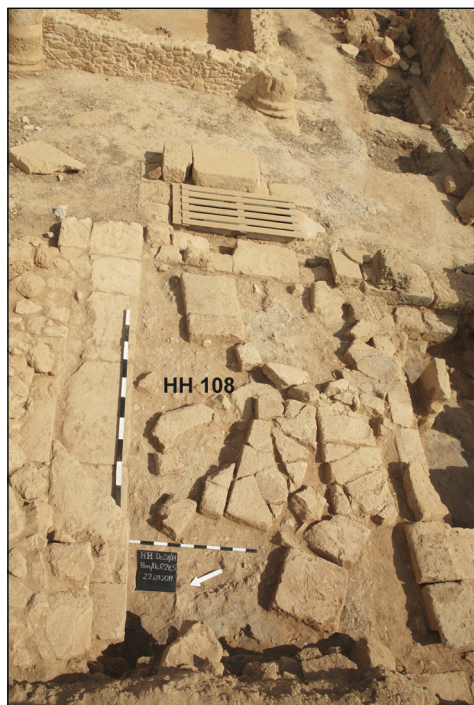
Fig. 9. Room 28S: lowest remaining level of disturbed pavement, wall and southern part of podium; southern and central part of courtyard 13 with remodelled tetrastyle impluvium in the background (Photo H. Meyza)

The paving in room 28S (HH108), situated north of heating area 32, was very disturbed, most probably by an earthquake, with broken and displaced slabs resting in two layers and standing on end [Fig. 9]. A massive masonry wall north of this pavement, together with the south wall of stairwell 28N, supported a platform made of packed, medium-sized unworked stones (S.6/11) and accessible by steps. This structure seems to have supported

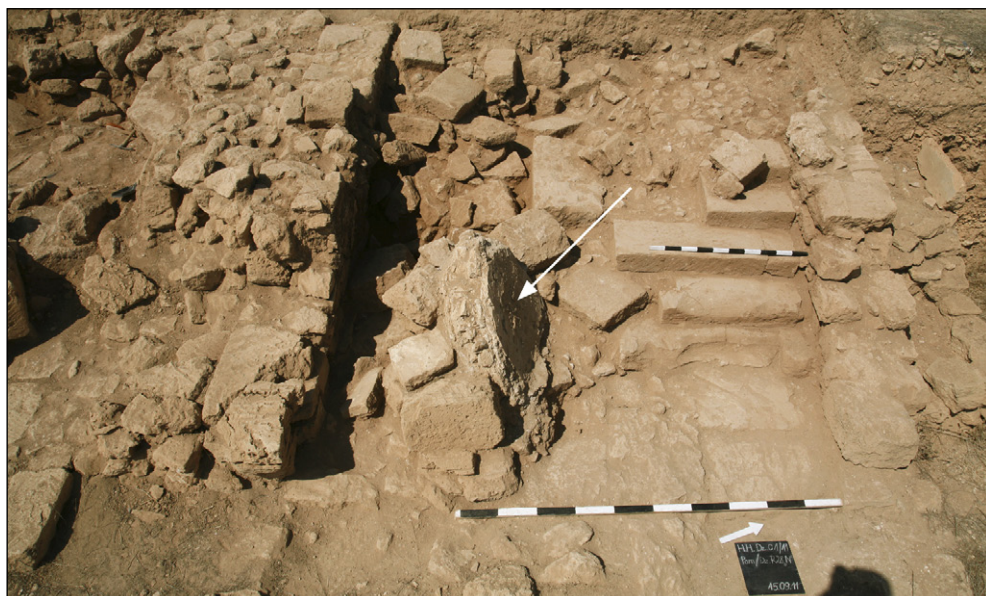
Fig. 10. Western staircase 28N with a fragment of collapsed basin floor tipped over from a podium south of it (Photo K. Bajerowicz-Dolata)

a basin with a plastered floor of peculiar construction, a large fragment of which was found further to the northeast [Fig. 10]. Two other fragments of a similar plastered floor were found in 2009 further east. The earthquake that displaced these heavy floor fragments, consisting of two layers of bedding made of fist-sized stones covered by a thick plaster layer with a smooth outer coat, must have been of enormous force. The staircase itself (S.5/11) was also affected; it was further damaged when blocks from its walls were robbed out, leaving *in situ* only the remains of (all?) five steps of the lowest flight ascending from courtyard 13 east of it. The first two steps are heavily worn. The (presumed) paving of the landing had been totally robbed out, while another two steps of the middle course running north–south were found loose. Most probably, another course existed there, taking off eastward from the second landing to the upper floor, above the peristyle of the courtyard.

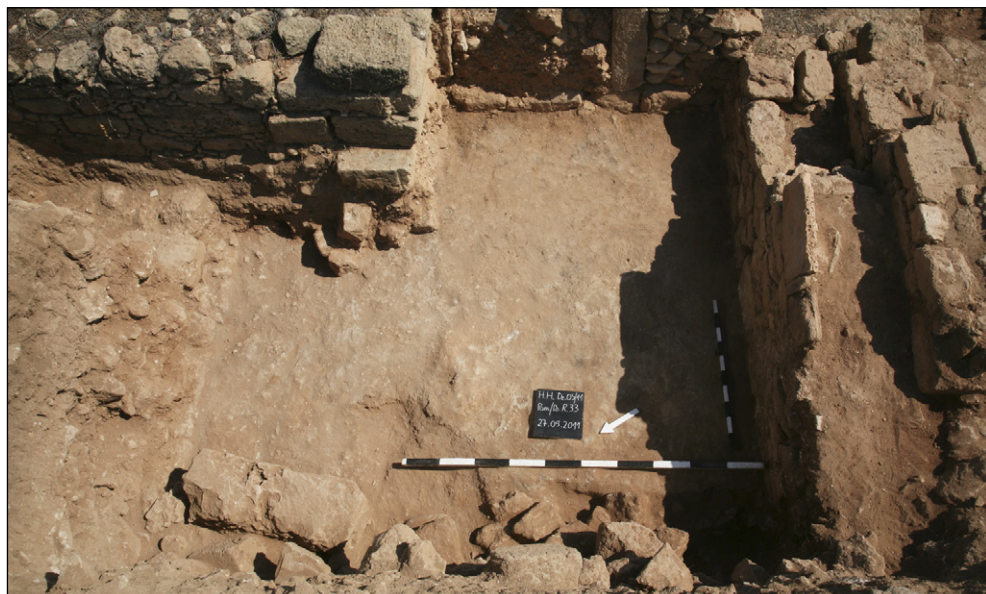
Fig. 11. Room 33 of the so-called Hellenistic House, situated below the southwestern corner of the Villa of Theseus (Photo M. Woźniak)

Further north, room 33 (partially uncovered in 2009) was fully cleared [Fig. 11]. A corner of the Villa of Theseus is superimposed over its northeastern corner. Its west wall, being also the west wall of the Hellenistic House, was completely robbed out, as was its north wall, of which only the remains of the foundation leveling course remained in place. However, the fill immediately above the floor was little disturbed and consisted of large fragments of plaster from the walls; higher the deposit was mixed with medium stones loose in soil. A preliminary study of the finds from the sector suggests that the earthquake which brought about the destruction occurred in mid-2nd century AD.

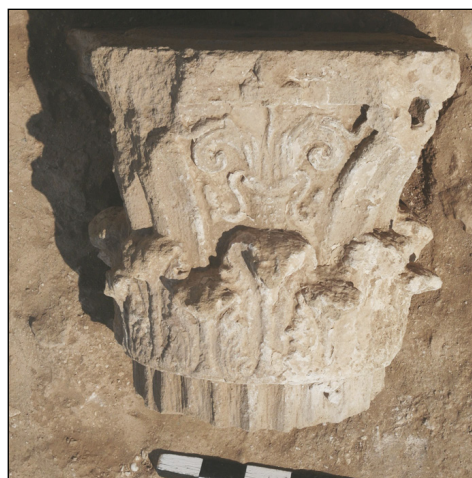
Fig. 12. Corinthian capital from the main courtyard of the 'Hellenistic House' (Photo K. Bajerowicz-Dolata)

Above the final usage level of the courtyard, a Corinthian capital was uncovered, almost exactly matching one

found in 1989 close to the southwestern corner of the peristyle [Fig. 12]. It differs from the latter in that it still has preserved a part of fluted shaft. This find and its location support a reconstruction, put forward previously, according to which the columns in the western portico of the peristyle were much higher than those in the remaining two or three porticoes.

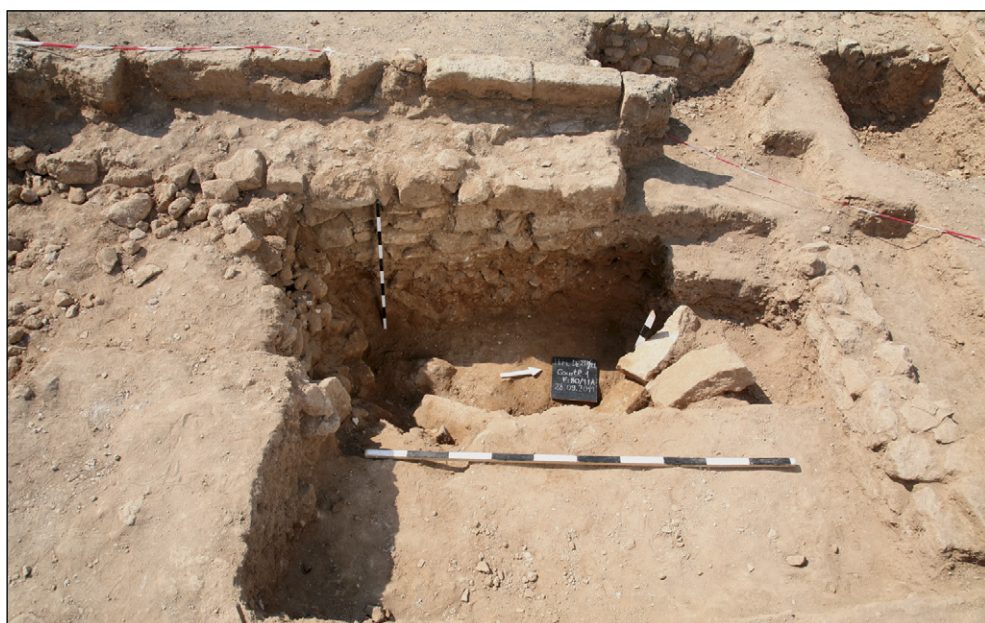
Fig. 13. Foundation of the stylobate of the western courtyard peristyle ('Hellenistic House'); note the shallow foundation and fragments of railing below (Photo H. Meyza)

A trial pit made on the courtyard side of the western portico stylobate uncovered its very shallow foundations, unsuited for the large Corinthian columns, and below the foundations, fragments of a slab railing, similar to that closing the intercolumnar spaces in the eastern portico of the same courtyard [Fig. 14].

This find seems to indicate that there had been an earlier colonnade at a lower level; its destruction took place probably in the 1st century AD, a hypothesis to be verified in further excavation).
