Title: Research and conservation in the Roman baths of Marina el-Alamein in the 2012 and 2013 seasons (Polish-Egyptian conservation mission).

Author(s) : Rafał Czerner, Grażyna Bąkowska-Czerner, Grzegorz Majcherek

Journal: *Polish Archaeology in the Mediterranean* 24/1 (Research)

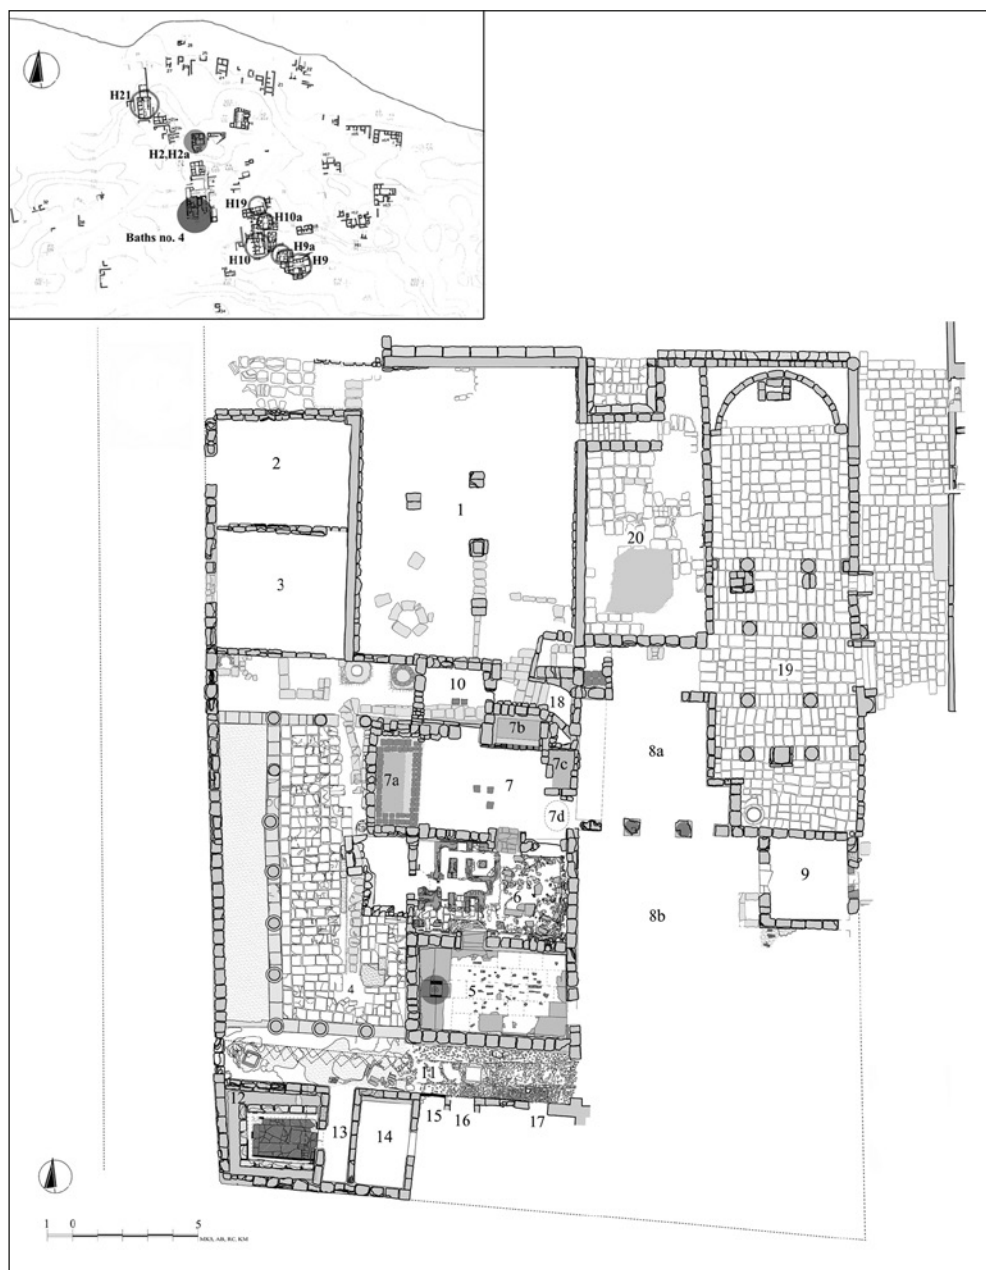
Fig. 1. Plan of the baths and the civic basilica located south of the central square at Marina el-Alamein; inset, location of the bath complex on the city plan (Drawing A. Błaszczyk, A. Brzozowska, R. Czerner, M. Krawczyk-Szczerbińska, K. Majdzik)

The small baths with their asymmetrical layout, occupying an insula in a densely built-up urban area, are typical *balnea* (Nielsen 1990: 3) [*Fig. 1*]. The layout of the rooms serving the main functions indicate that it was a row-type

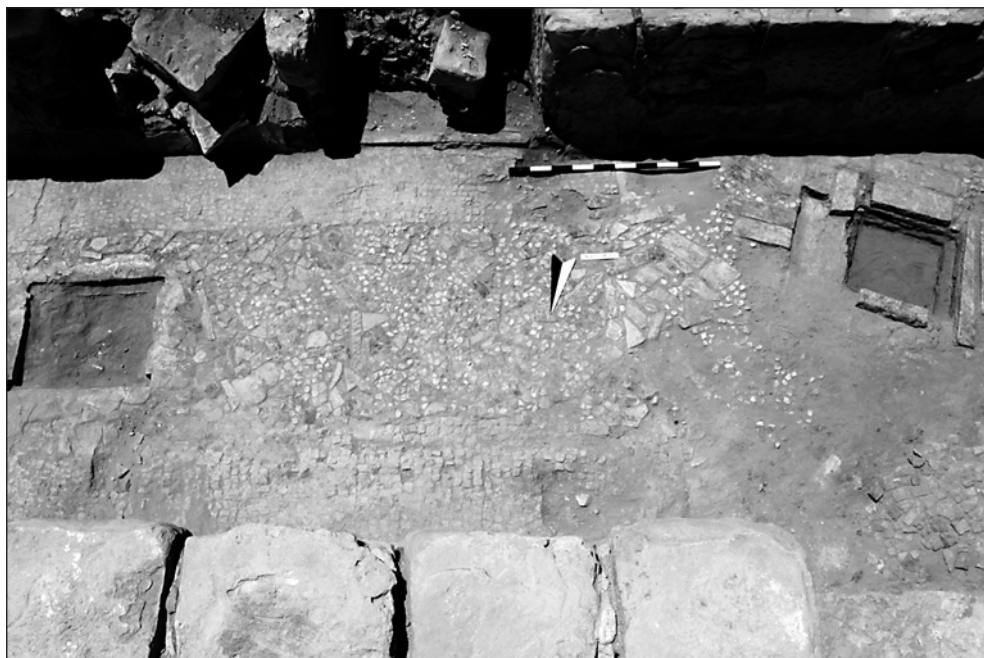
*Fig. 2. Southern baths, mosaic in corridor 11
(Photo R. Czerner)*

A mosaic floor in this room [see *Fig. 2*] consisted of bands 0.45–0.60 m wide, made of large cubes of grey limestone (3.0 cm to each side) along the north and south walls, surrounding a mosaic of marble tiles of different color and size in the center. A well opening, 0.46 m square in size, was found in the center with remnants of the original frame of four wooden beams and surrounded by larger marble tiles.

An important surviving element of the joined rooms described, the southern portico of courtyard 4 and corridor 11 [see *Fig. 2*], is a mosaic floor of large tesserae. In 2009, the edges of the mosaic fragments preserved in the portico were protected and in some parts of it the mortar was filled in. After finishing the work in the current season, the whole mosaic was covered with geotextile and buried.

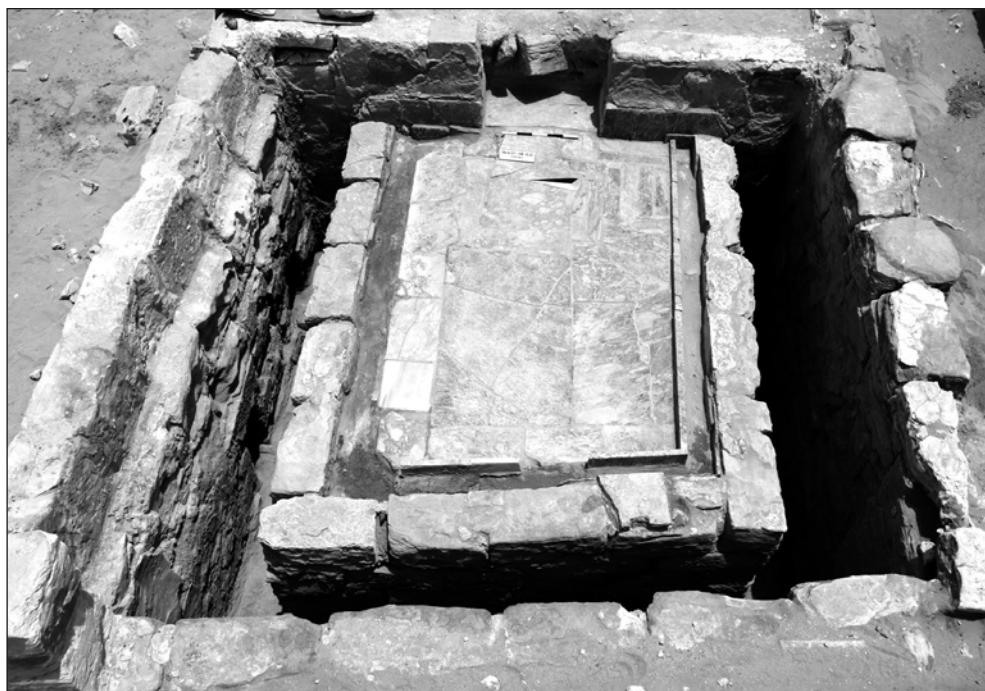
Fig. 3. Southern baths, latrine in room 12 after conservation in 2013
(Photo R. Czerner)

The shape was irregular: N–S, 3.86–3.31 m, E–W, 3.49–3.51 m; the floor with small drain: N–S, 2.80–2.66 m, E–W, 2.02–1.89 m [Fig. 3]. The walls of the latrine were built of large stone blocks (0.50 m by 0.42 m by 0.25 m). The north wall was 3.77 m long and preserved to a height of about 0.62 m; the west and east walls were 2.60 m high. A door in the east wall, 0.83 m wide (0.77 m measuring with the mortar), led in from the corridor. Traces of white plaster have survived on the walls above the threshold (0.28 m wide). Two column drums, 0.30 m in diameter and 0.17 m high, were found

The most interesting room in the bath complex of those which underwent conservation in 2013 was room 12 housing the latrine [see *Fig. 3*]. Having survived in exceptionally good condition, the rich decor of the interior, comprising marble floor and revetment at plinth level, as well

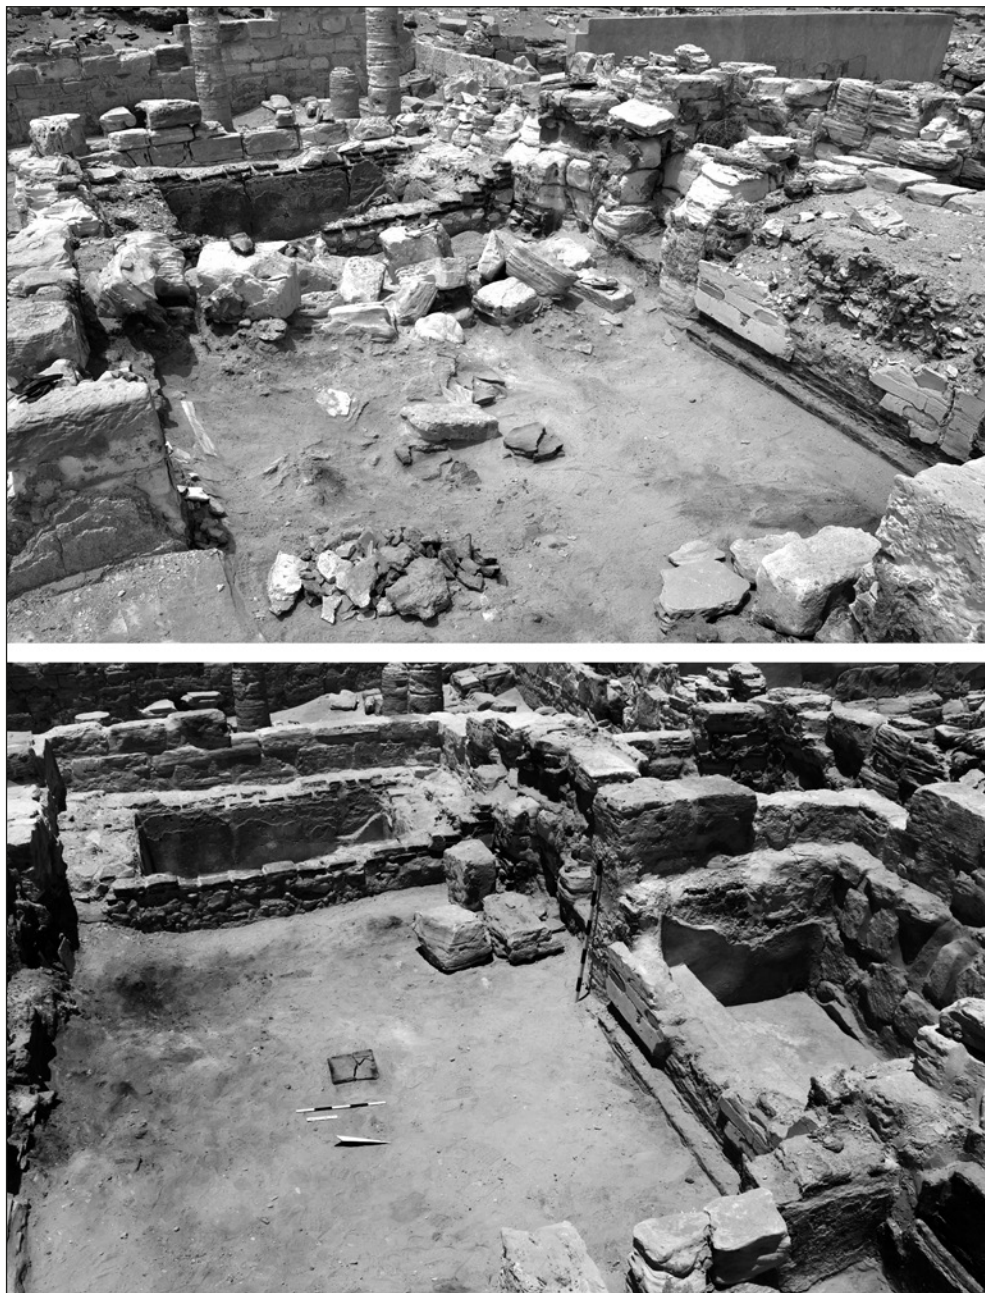
Fig. 4. Southern baths, caldarium in room 7 before (top) and after (bottom) conservation in 2012 (Photos R. Czerner)

The most comprehensive work was carried out in 2012 in room 7 (caldarium) [see *Fig. 4*], this owing to the complicated layout and presence of various installations and facilities, such as two heated and one unheated bath plus elements of a heating system: relics of a hypocaust and of *tubuli* flues in the walls. The walls were consequently of different thickness, incorporating recesses, and the edges of the two bathing basins formed extra walls inside the room. Different materials were also used: stone blocks of varied size and ceramic bricks. Various mortars were also used. The layout of the interior was

The outer walls of the caldarium were in poor condition. Most of the limestone blocks it was built of were seriously and deeply eroded. The blocks from the northwestern and southwestern corners, that is, from the side of courtyard 4, were almost completely destroyed. Similarly, the blocks from the highest preserved layers were crumbling away. The filling in of joints in the facade had started in some sections in 2009 already, but for the wall as a whole it would not have been enough just to add another course of blocks to protect it. Sockets for the patches were cut in the eroded surfaces of blocks. The process concerned the outer facade of the part of the caldarium added later, that is the one to the west, housing *alveus* 7a. It was restored from the west, north and south, and the damaged corners were also reconstructed. One or two layers of blocks were added on the top of the walls. Of course, it was impossible to replace all the blocks in the walls, hence the task was limited to only the most needy ones in the top courses of the south and north walls of the caldarium further to the east.

condition and almost to their full height, but their tops were crumbling. There was also a large breach in the side of the bath from the entrance (east). Reconstruction with original bricks recovered from the rubble reached different heights. These salvaged bricks were 24–25 cm squared and 3 cm thick. The mortar used for the reconstruction was similar to the original one, with filler of finely crushed bricks. In this way the shape of the bath was made more recognisable. Missing stretches of plaster in the bath and on its edges were not reconstructed, just the original parts were protected.

The second well-preserved bath (7b) in a recess in the north wall of the caldarium underwent the same process of conservation. It was located on a higher level and its front edge was more damaged. It was partly reconstructed and sections of the walls around the basin on the west, east and north were partly rebuilt. The upper two courses in the west wall were reconstructed. Blocks which had tumbled from the top preserved course of the wall in its northern and eastern section were restored, and the collapsed outer northeastern corner was rebuilt. Eroded surfaces of the blocks in the facade were also replaced with patches.

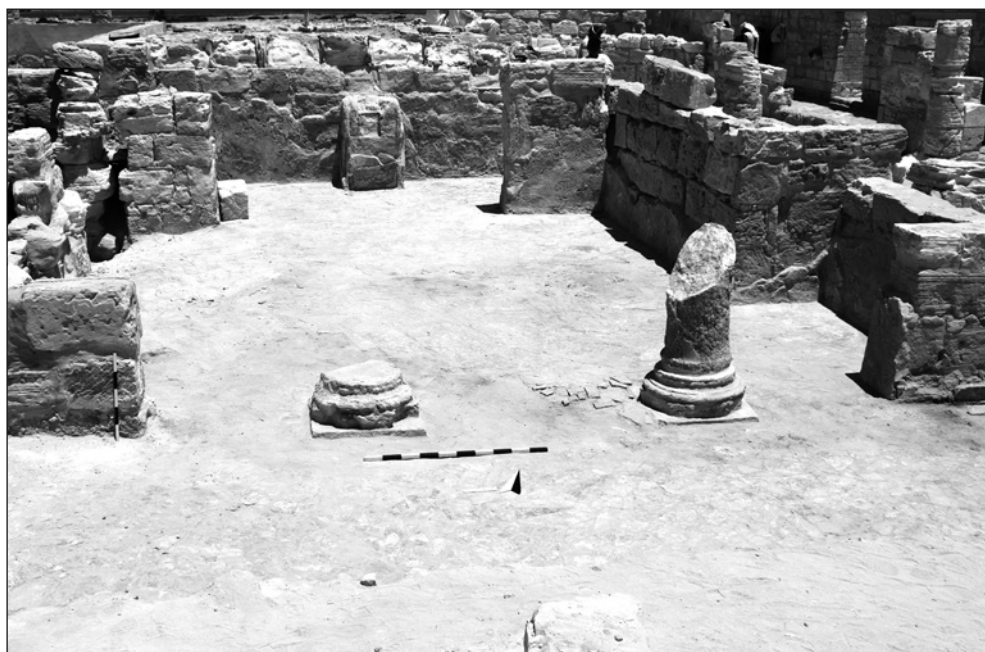
Fig. 5. Southern baths, rooms 8a and 8b after conservation in 2012
(Photo R. Czerner)

Rooms 8a and 18. Room 8a had been excavated partly in the 2011 season. Two marble columns had once separated room 8a from room 8b [*Fig. 5*]. The floor now was cleared for a section measuring 2 m south of the columns. A low course of marble revetment, 0.10 m high, was observed on the east wall. On a corresponding level on the west wall there was only a thick layer of mortar. A small hearth stood in the northeastern corner. A large iron hook, small potsherds, glass vessels and pieces of windowpanes, as well as animal bones were found in the fill on the floor.

Building and conservation work other than the protection of the northwestern corner proceeded in room 8 [see below and *Fig. 5*]. The east wall was partly protected by replacing damaged blocks and building over it. Two marble bases and

a fragment of marble column shaft were put in place on preserved plinths situated in the passage between rooms 8a and 8b. The lower part of the shaft had been found inside the room in the 2011 season, but the provenance of the two bases could not be established with any measure of certainty. The bases had been moved to a nearby spoil heap when the site was first excavated, after some building work using heavy equipment carried out in 1985. Their size, however, matched precisely the bottom diameter of the preserved fragment of the column shaft, and the plinth itself. The material was also similar, substantiating the decision to use them in this position for display purposes. To protect the bases from salt and humidity rising from the ground, their bottoms were separated from the foundation with a layer of bitumen paper.

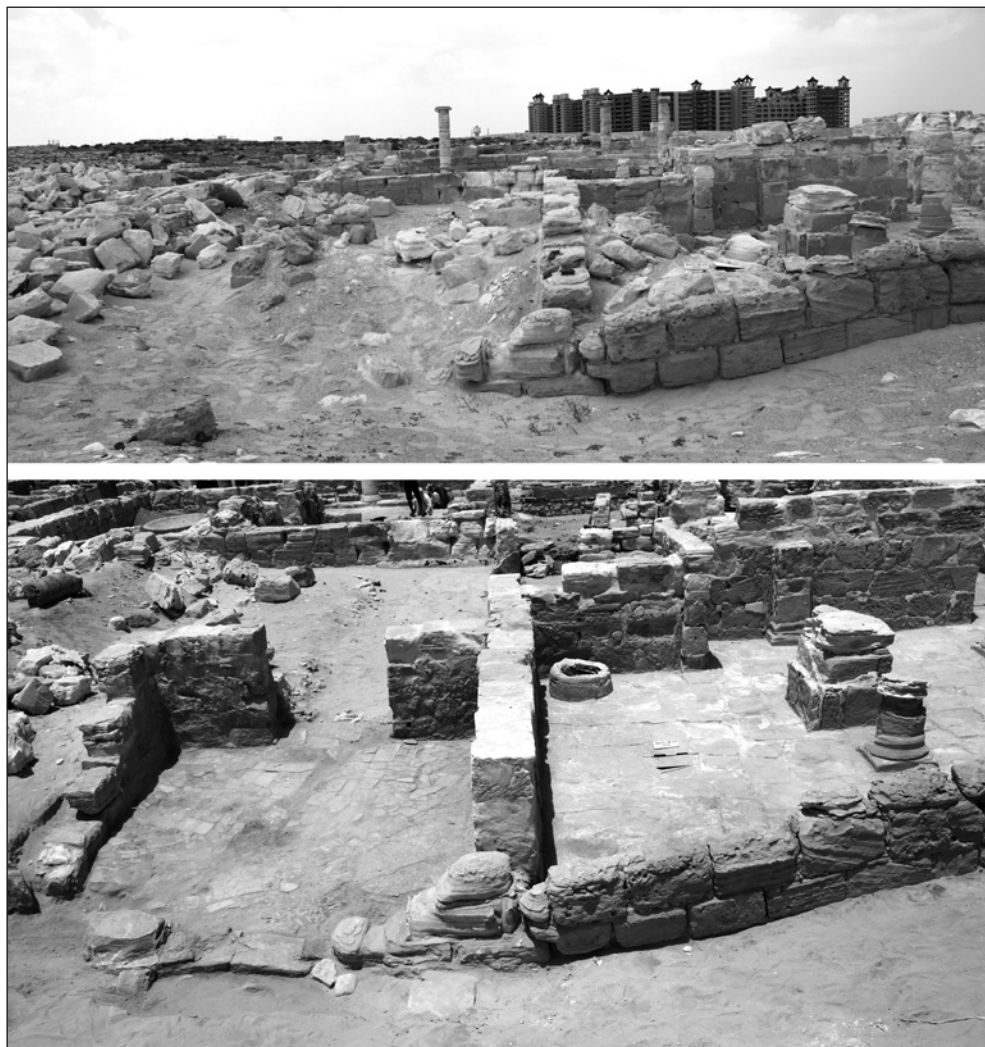
Fig. 6. Southern baths, room 9 and the southern part of the civic basilica, before (top) and after (bottom) conservation in 2013 (Photos R. Czerner)

The shared wall between room 8a and the civic basilica in its southern part continued to be protected in 2013. Damaged blocks were replaced and new courses were added on the wall top. A new course of stone blocks was also added on top of the remaining part of the basilica wall in its northern section to protect the heavily eroded surface. A pilaster adjacent to the wall was also reconstructed with two layers of blocks on top. Likewise, one or two layers of stone blocks were added on top of standing walls in rooms 9 and 19, that is, in the southern part of the basilica and a neighboring room. The wall separating the two interiors and the wall between rooms 9 and 8b with a door frame in it were similarly extended upwards and protected [see *Fig. 6*]. Damaged and eroded parts were replaced with good quality blocks of the same size.

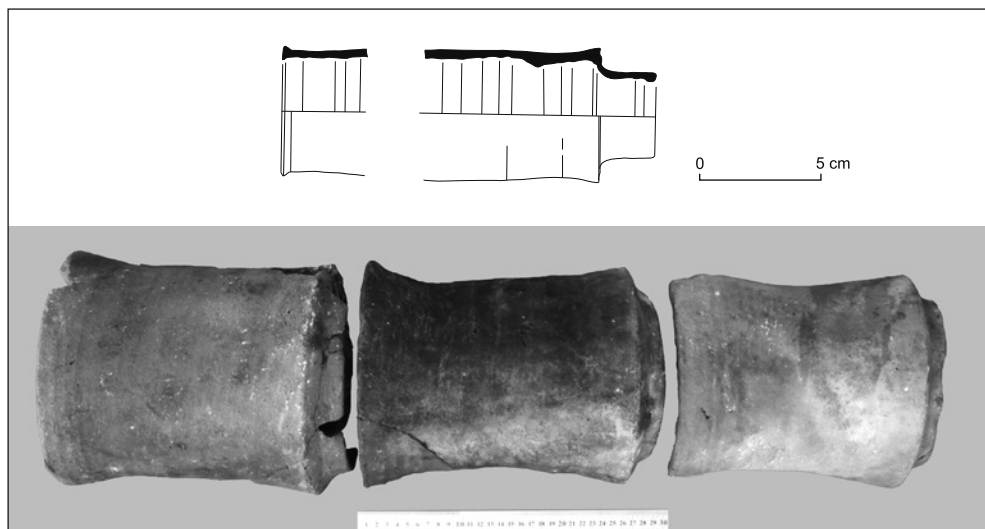
Fig. 7. Ceramic pipes
(Drawing G. Majcherek, W. Wójtowicz; photos R. Czerner)

Ceramic water pipes [Fig. 7] were found in fragmentary condition, fixed to the wall with mortar in the south-eastern corner. They used to carry the water from the roof through a drain (0.17 m wide, 0.15 m deep) into a cistern located below the floor in the southern part of the basilica. A well set in the southwestern corner of the room led to the cistern

Several types of ceramic pipes were identified in the bathhouse. Larger, wider ones (Dia. maximum 22 cm) were apparently used as flues, as attested by their smoke-blackened inner surface [see Fig. 7 bottom]. Another type of pipe, slender and thin walled (Dia. maximum 12 cm, length approximately 30 cm) similarly to those

mentioned earlier was also made in alluvial clay [see *Fig. 7* top]. One fragmentarily preserved example was found still fixed to the wall in the southeastern corner of the building (room 19), apparently serving as a downpipe in the water-supply installation.

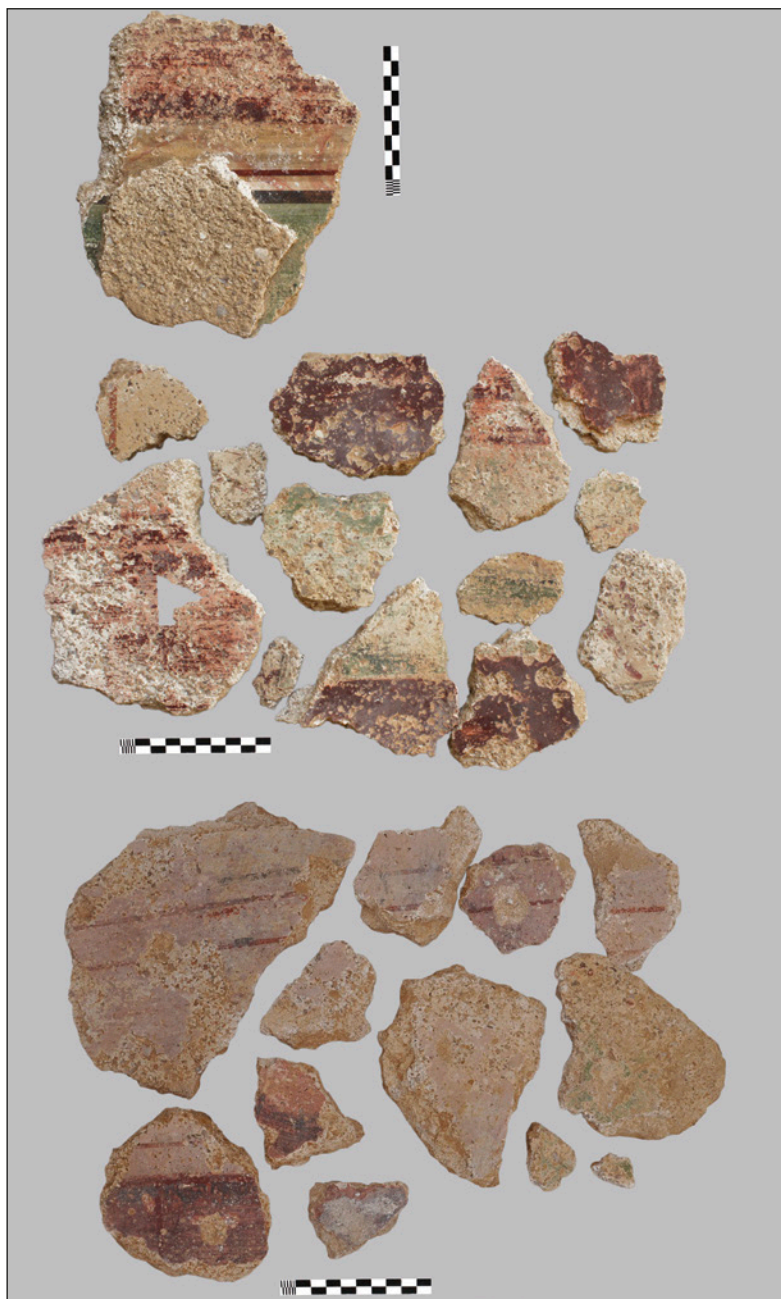
*Fig. 8. Fragments of painted plaster
(Photos R. Czerner, W. Wójtowicz)*

The floor of the latrine was covered with marble slabs of various size. The largest were 1.26 m by 0.72 m, the smaller ones measured 0.28 m by 0.45 m. Long thin marble slabs (0.46 m by 0.10 m) in the southeastern part suggested repairs to the floor in this spot. Marble tile revetment was preserved fragmentarily on the lower parts of the east wall (up to a height of 0.24 m). Above that the wall was painted (there were probably three layers of paint). Pieces of painted plaster found in the latrine documented wall decoration referring in design to the structural style [Fig. 8]. Plant motifs were also apparent in the assemblage.

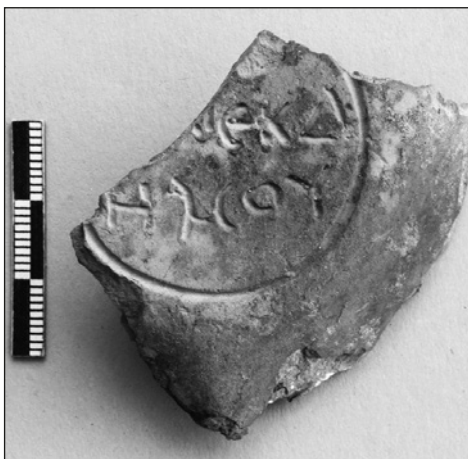
Fig. 9. Inscribed base of a clay lamp, inscription reading *Synekdemou* (Photo R. Czerner)

Small pieces of plaster painted red, pottery and glassware, as well as a fragmentary inscribed base of a clay oil lamp were found clearing the layer on the floor [Fig. 9]. The inscription on the lamp is probably the name of the lamp producer: Synekdemou (Synekdemous means “traveling companion”, A. Lajtar, personal communication).

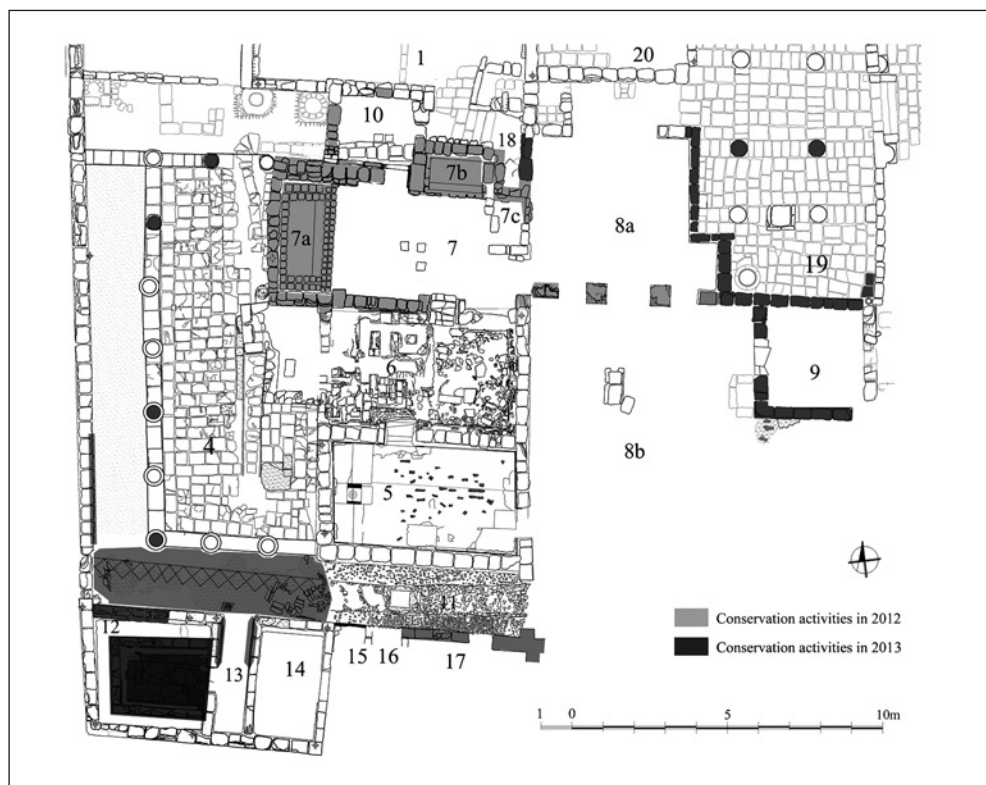
Fig. 12. Southern baths: areas of conservation activities in 2012 and 2013 shown in grey (Drawing A. Brzozowska, R. Czerner, A. Kubicka, K. Majdzik)

In 2013, conservation work proceeded in rooms 4, 8a, 9, 12 of the southern bath and room 19 of the basilica [see *Fig. 12*]. In courtyard 4, the deteriorating shafts of columns were protected. Dilapidated areas were pointed. Some sections were also plastered. The southernmost two columns of the civic basilica were similarly protected.
