Title: Alexandria: excavations and preservation work on Kom el-Dikka, seasons 2012 and 2013

Author(s): Grzegorz Majcherek

Journal: Polish Archaeology in the Mediterranean 24/1 (Research)

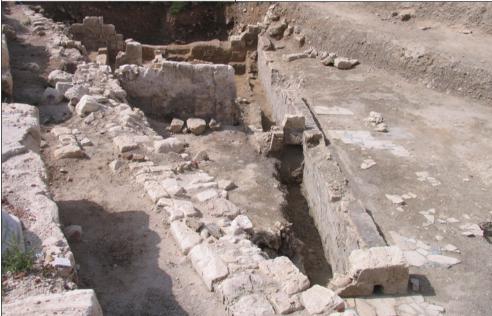
Fig. 3. Latrine channel: top, northern end; bottom, looking south (Photos G. Majcherek)

Kucharczyk 2014: 33–35) [*Fig. 3* bottom]. On the western and northern sides of the channel, several patches of flooring made of assorted fragments of marble tiles were cleared [Fig. 3 top]. A fragmentary preserved section of the perpendicular wall marks the end, or rather the beginning of the channel. A small hole pierced in this wall (approximately 18 cm in diameter) at floor level was most probably used as an outlet for water spilling over the pavement, draining it into the channel. No evidence of a water supply system has been found so far. Users may have actually brought the water needed for hygienic purposes with them in vessels. The western limits of the latrine could have been marked by a huge wall, the negative of which parallels the channel at a distance of approximately 2.30 m [Fig. 4]. Remnants

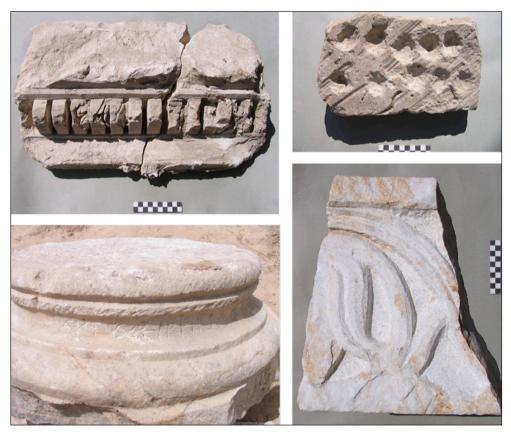
Fig. 5. Limestone and marble elements from the excavations: top left, fragment of a limestone cornice; top right, limestone mancala game board; bottom right, fragment of a marble frieze reused as a latrine gutter; bottom left, inscribed marble base from area Q (for the bottom two, see below, pages 43 and 48 (Photos G. Majcherek)

Repeating the results of earlier work in the area, a substantial quantity of loose fragments of painted plaster and numerous broken architectural limestone elements were found in the collapse. These included: fluted half-columns, capital fragments and denticulated cornices [see Fig. 5 top left]. A large amount of broken marble revetment representing imported and Egyptian stones (travertine, porphyry, green lapis lacaedemonius, various Aegean marbles, etc.) was also noted. Among other finds one should mention a portable mancala game board cut in a block of soft limestone [Fig. 5 top right]. The tumble itself was found to be over 1.20 m thick in places. Its westward slumping may be interpreted as a result of destruction of a yet unknown structure further to the east. The collapse was formed at the end of the 3rd-beginning of the 4th century AD and subsequently covered with accumulation associated with the construction and usage of the civic center (including Portico and Bath).

Next to them a large number of discarded marble elements was found, including two marble fragments of a latrine gutter, apparently recut from decorative elements of earlier date. On one of them a large-scale carved floral decoration motif was preserved [see *Fig. 5* bottom right].

During cleaning operations seen as a preplanned conservation. requisite for a column marble base was cleared. The Attic type base was quite well preserved save for the broken-off corners of the plinth. A crudely scratched Greek inscription was identified on the scotia:  $E\Upsilon T\Upsilon X[\Omega]\Sigma$ EIPHNO $\Sigma$  AIANIO $\Sigma$  [see *Fig. 5* bottom left]. The inscription (of an acclamation type) was dated provisionally to the 6th century AD on paleographic grounds (reading by Prof. Adam Łukaszewicz). The base is of slightly smaller size (0.84 m by 0.84 m, upper torus Diam. 0.66 m) than those used in the southern portico of the bath. It is quite probable that it may have originally supported one of the columns in the lateral wings of the palaestra, and the inscription was made while the base was still in its original position.

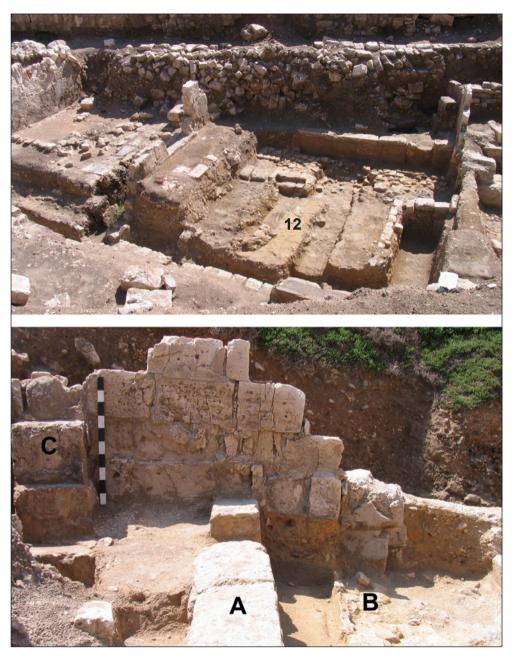
Fig. 7. Earlier structures in room 12 in area US: top, view of the remains below the floor of room 12, looking east; bottom, view looking south, A – earlier wall, B – later wall, C – wall enclosing the area from the east (Photos G. Majcherek)

In the 2013 season, the excavation was focused on the underfloor layers in room 12, in order to assess architectural develop-ment and chronology (trench supervisor Walter Wójtowicz). results were somewhat ambiguous and disappointing however. It turned out that the area was occupied continuously at least from the late 1st century AD. Minute exploration produced a series of occupational layers that could not be dated precisely and several earlier structures which also could not be identified satisfactorily owing to a fragmentary state of preservation of the architecture [Fig. 7 top]. Remains of a solid wall (about 0.35-0.40 m wide) were discovered in the eastern part of the trench [A in Fig. 7 bottom]. Structured of large regular

masonry and retaining the plaster coating, this wall ran northward for a distance of 3.70 m; at this point it breaks off before reaching a later wall dividing units 12 and 13. It was replaced apparently by another wall, built on a foundation of small assorted stones, set in clay mortar [B in *Fig. 7* bottom]. Only its southern end, exceeding 0.70 m in width, has been preserved. The function of the latter remains unknown, although one should note that it was built parallel to the wall of the *forica*.

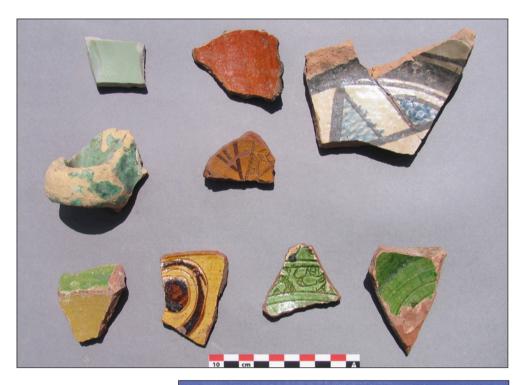
Fig. 9. Medieval pottery from layers overlying the cemetery in area U: top, Islamic glazed pottery, 12th–15th century; bottom left, Italian protomajolica sherd; bottom right, sherds of Chinese celadon wares (Photos G. Majcherek, A. Zawadzińska)

Study and documentation activities centered on ceramological and anthropological studies. Medieval glazed pottery originating from various production centers in Sicily and southern Italy, mostly protomajolica wares from the 13th–14th century AD [see *Fig. 9* bottom left], was studied by Anna Zawadzińska. Skeletal

The strata overlying the necropolis proved to be particularly rich in pottery finds and produced the usual broad range of ceramics of the 12th-15th century AD originating from Egypt and other Mediterranean regions [Fig. 9 top |. Egyptian production was represented mostly by Mamluk Sgraff and Slip Painted wares. A waster from a Mamluk Slip painted bowl is an interesting find, pointing once again to the possibility of glazed pottery production in medieval Alexandria. Some Cypriote and Aegean examples were also

identified. Western imports, although less numerous, were also recorded. Some tiny sherds of Spanish luster wares were found along with fragments of large Tunisian vessels of Hafsid date. Several glazed oil lamps of Ayyubid–Mamluk age were likewise recognized. Quite surprising was a relatively large number of fragments of Chinese celadon wares [Fig. 9 bottom right]. The same layers yielded also a blue glass coin weight, bearing a stamped inscription in Arabic.

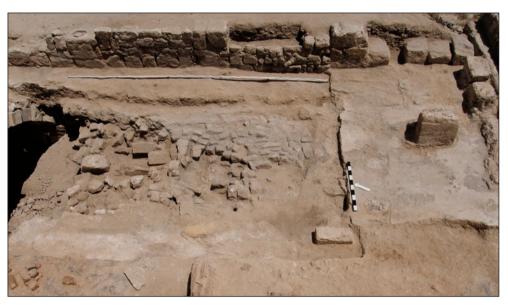
Fig. 12. Underfloor layers and cleared extrados of the bath vaulted chambers, uncovered in auditorium B in area G (Photo A. Smilgin)

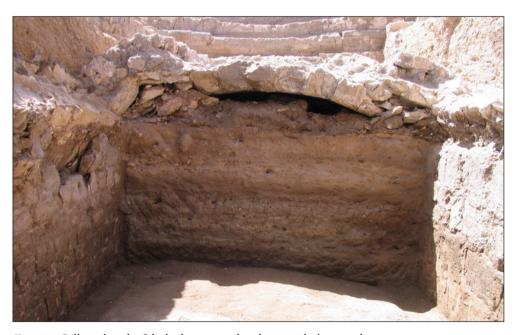
Fig. 13. Collapsed vault of the bath entrance chamber, view looking south (Photo G. Majcherek)

retained most of the blocks in the original position. An outer coating, made of small assorted stones set in ashy mortar, was preserved over a large part of the vault, applied directly onto the extrados.

The vault, which was preserved on the whole as loose and dislocated blocks resting directly on accumulated fill, turned out to be shattered and subsided, but still strong in a few locations, to the extent that it retained space, 0.30–0.40 m high, under the keystones. All the identified layers accumulated there ran almost horizontally through the entire span of the underground chamber, pointing to a rather slow and regular deposition process [Fig. 13].

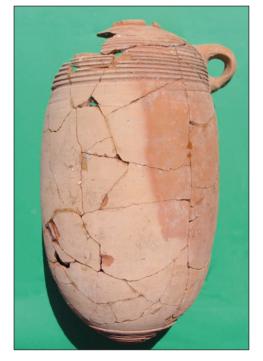
Fig. 15. Example of a Gazan amphora (LRA4a) from the H(e) test trench in area H
(Photo G. Majcherek)

The cut of the foundation trench of the huge wall and the buttress was identified in the compact soil. Dating material from the trench and predating the accompanying layers was rather modest in number and largely inconclusive, consisting mostly of common ware sherds. Un unexpected find was a nearly complete Gazan amphora (LRA4a), found in the northeastern corner of the foundation trench [Fig. 15]. It must have obviously served as an impromptu burial, evidenced by infant bones found inside it. Apart from some earlier, residual examples, most of the pottery finds pointed to the 4th century AD as the most plausible date for the wall construction event. It is therefore reasonable to treat it as part of the original design of the late antique civic zone. The assumption conforms well to previous observations on the urban and architectural development of this quarter of the ancient city.

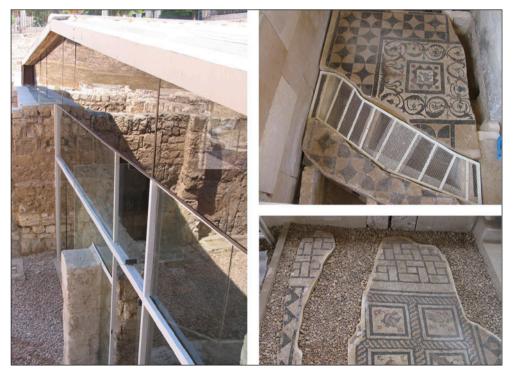
Fig. 17. Maintenance conservation in the Mosaic Shelter: left, repaired west glass wall; top right, ventilation grille around the mosaic with panther  $(\alpha-6)$ ; bottom right, restored edges of the mosaic with birds  $(\alpha-5)$  (Photos G. Majcherek)

Necessary repairs were made to the structure of the shelter itself, especially to the west wall of panel glass which had suffered extensive damages in the part of the gables and the gap between the shelter and adjoining architecture. Some of the smoked glass panels here had been broken and these were now reinstated. A new wall coping was shaped, and the gap itself covered with new panels set in fittings fixed to the shelter's horizontal steel frames [Fig. 17 left]. They were laid slightly inclined outward to secure rainwater drainage and additionally secured with silicone foam to prevent leakage.

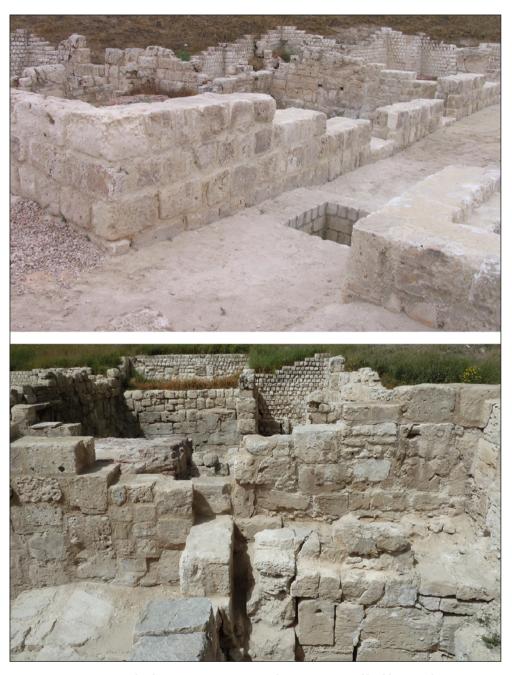
Fig. 19. Restoration in the domestic quarter: top, southwestern corner of building H after restoration; bottom, restored north wall of rooms H8a and H8b (Photos G. Majcherek, M. Polak)

pleted with new mortar. In order to prevent further water penetration, new wall copings were shaped using new stones separated with a layer of bitumen tar paper, acting as an insulation layer as well as a marker separating modern wall fabric from the ancient one. Similar rules were also adopted in other limited restoration operations.

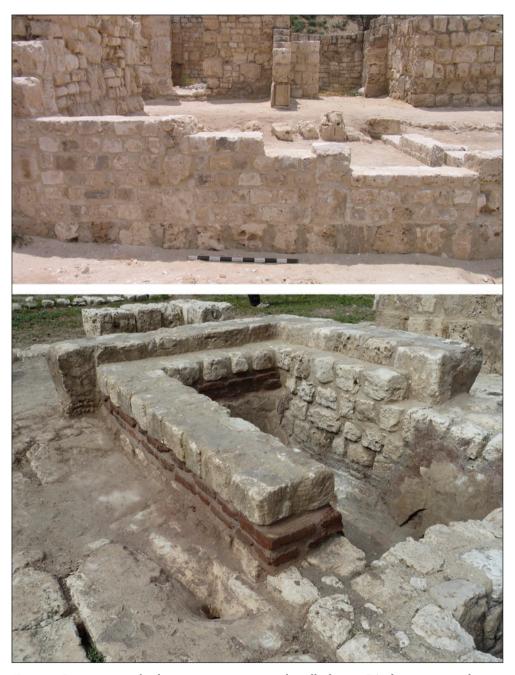
Fig. 20. Restoration in the domestic quarter: top, north wall of room G6 after restoration; bottom, basins in room G8 following conservation (Photos G. Majcherek, M. Polak)

conservation measures. They were uncovered already in the 1989 season and were then temporarily protected (Majcherek 1990: 82-83, Fig. 1). The complete installation consists of two basins of unequal size (the larger one measuring 1.00 m by 1.85 m, the smaller one 1.00 m by 0.85 m). Both were constructed in mixed technique, of small stones and bricks set in mortar with substantial amounts of ashes added. On the inside of the basins the walls were covered with a red opus signinum (cocciopesto) plaster. Each of the basins was furnished with an outlet for discharging the fluid contents. The western, northern and southern sections of their mixed stone and brick structure were consolidated and partly restored [Fig. 20 bottom].

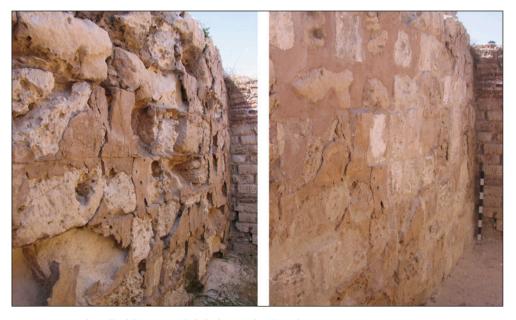
Fig. 22. North wall of the cistern: left, before, and right, after conservation (Photos G. Majcherek)

Monitoring revealed that some sections of the original cistern walls had suffered from long-term exposure to the elements. Some mortar joints had totally disappeared, wide and deep cracks were common, and several low quality masonry blocks lost more than half of their original mass. Such walls were in imminent danger of collapse. This was the case of a large wall (No. 30) built in the northwestern part of the building across earlier structures (corridor and adjacent water tanks).

The wall, 8.50 m long and preserved 3.00 m high in places, arching slightly northward, required immediate intervention. Constructed in the latest phase of the cistern (6th century AD), it was originally built of large regular masonry blocks (0.30 m by 0.40 m) set in lime mortar (Rodziewicz 1986). All the joints were now thoroughly repaired, missing or deteriorated blocks were replaced with new similar ones and the whole structure stabilized [Fig. 22].

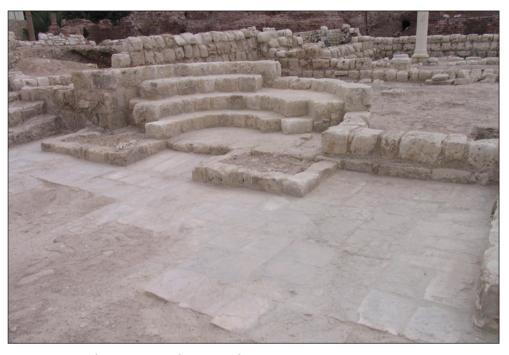
Fig. 23. Apse and pavement in auditorium S after restoration (Photo A. Pisarzewski)

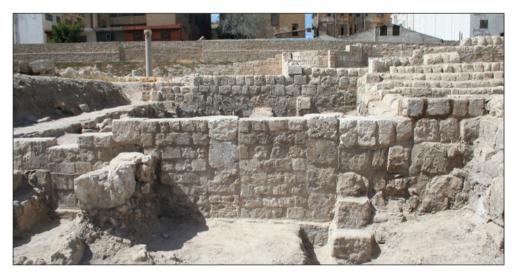
Fig. 24. North wall of vestibule R after restoration (Photo A. Pisarzewski)
